FIRE DEPARTMENT CITY OF NEW YORK

INVESTIGATIVE REPORT

10826 AVENUE N, BROOKLYN, NY

FATAL INJURY

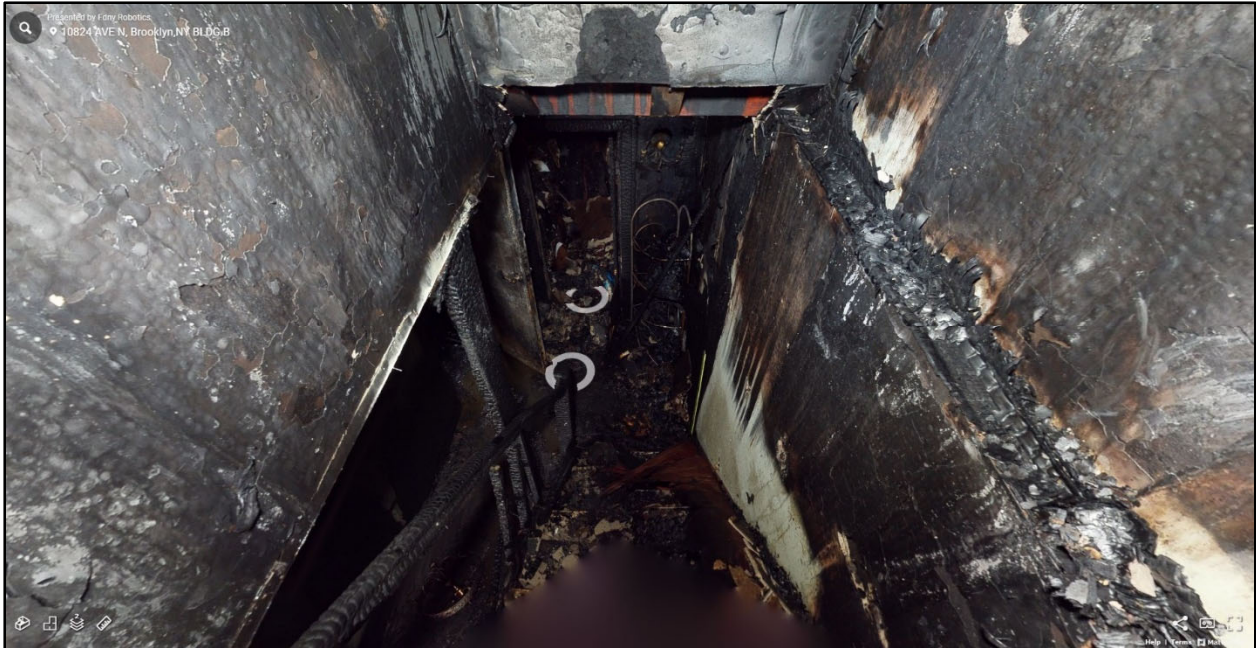
Figure 32. Burning clothes from view of the first floor into the basement of 10824 Avenue N, the Exposure #4 Building.

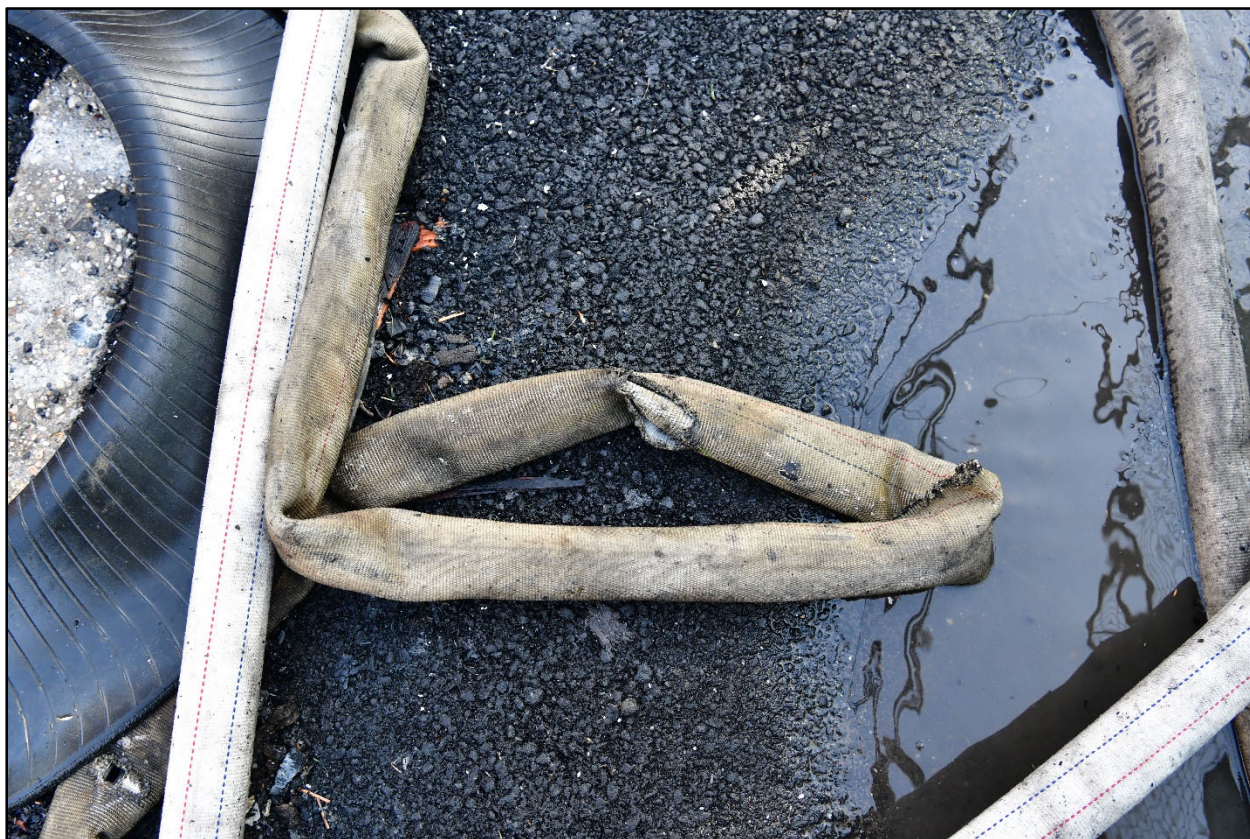
The extreme temperature of the environment on the second floor heated the wrought iron railing to such a degree that it caused severe damage to E257’s charged hoseline near the top of the stairs.

The hoseline burned through at the point of contact with the wrought iron railing. This burst length critically reduced the water flow available at the nozzle and immediately rendered the hoseline inoperable. Without an operating hoseline on the second floor, members resorted to emergency tactics to escape the extreme heat and untenable conditions enveloping them (see Figure 36).

Figure 36. E257's hoseline with burns that caused a burst length.

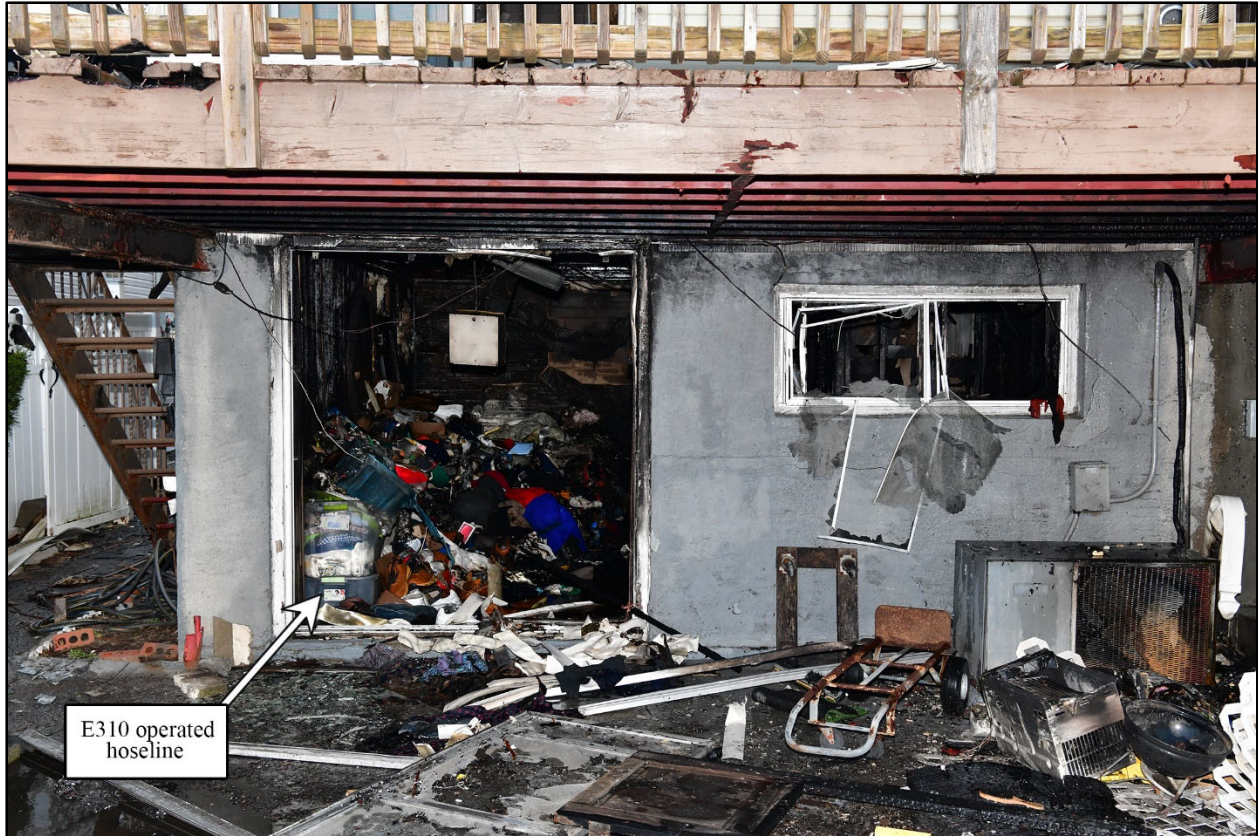
Unknown to the members operating this hoseline, the laundry room area was adjacent to the bottom of the building's vertical utility shaft, the source of the rapidly extending fire. By extinguishing this fire, E310's hoseline effectively extinguished the main seat of the fire. Once this was accomplished, at approximately 1414 hours, conditions throughout the Exposure #4 Building significantly improved (see Figure 38).

Figure 38. View of the rear basement level of 10824 Avenue N.

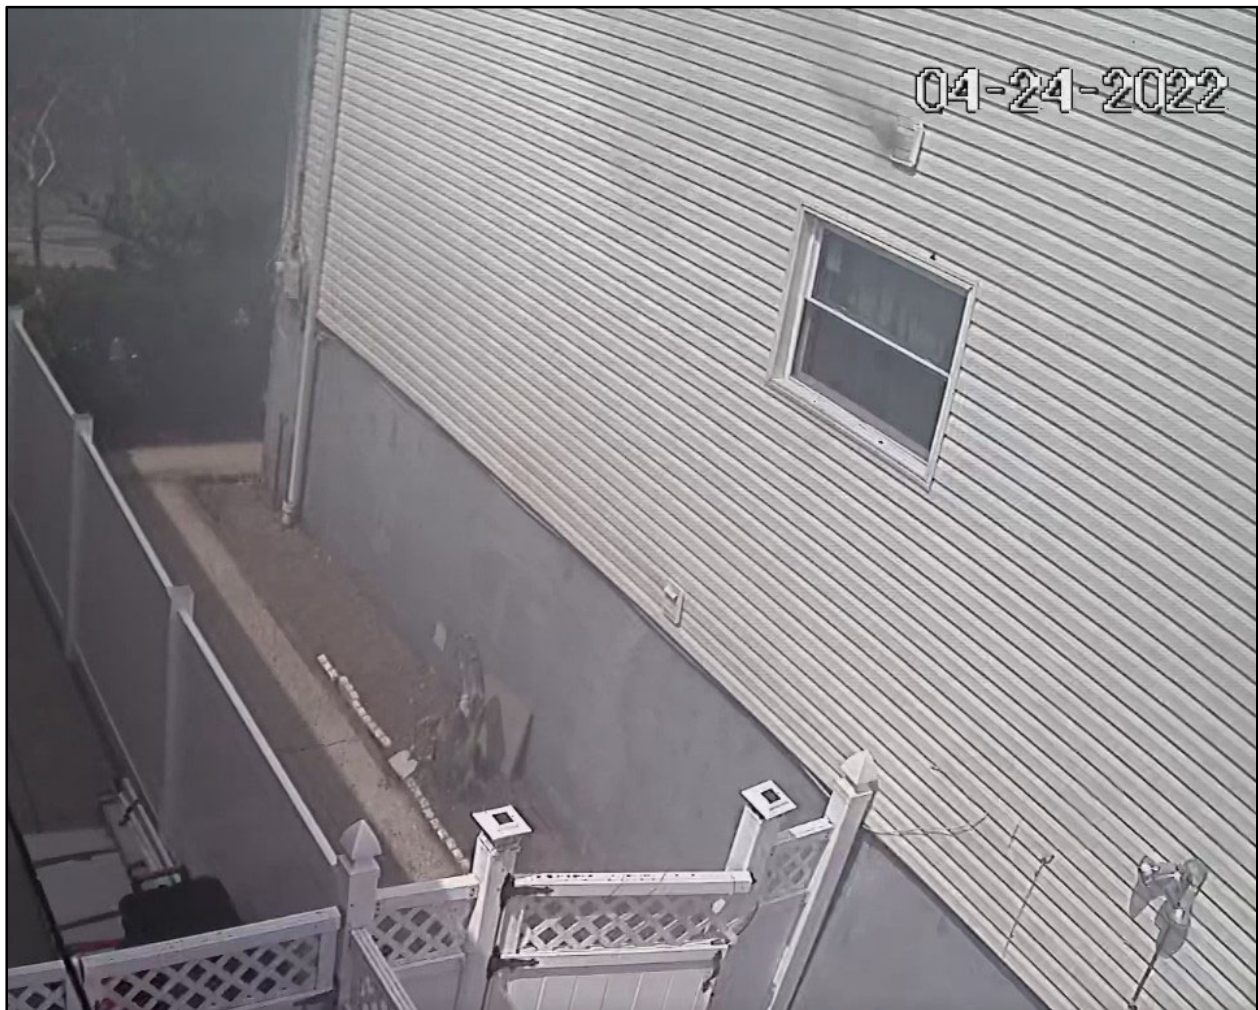
Figure 39. Side of Exposure #4 Building showing smoke from a vent pipe in the ceiling of the first floor.

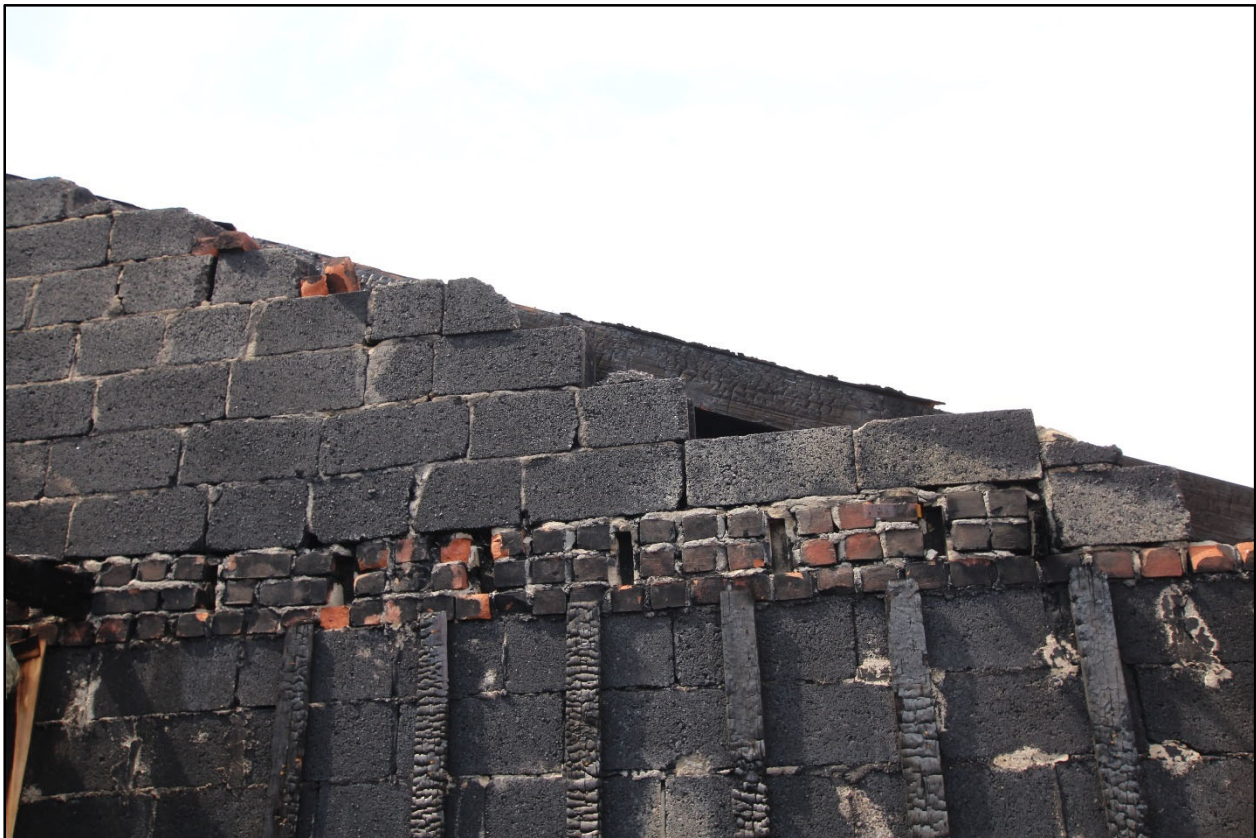
Figure 41. View of the top of the demising wall toward the front of 10826 Avenue N, where fire extended from the Fire Building to the Exposure #4 Building.

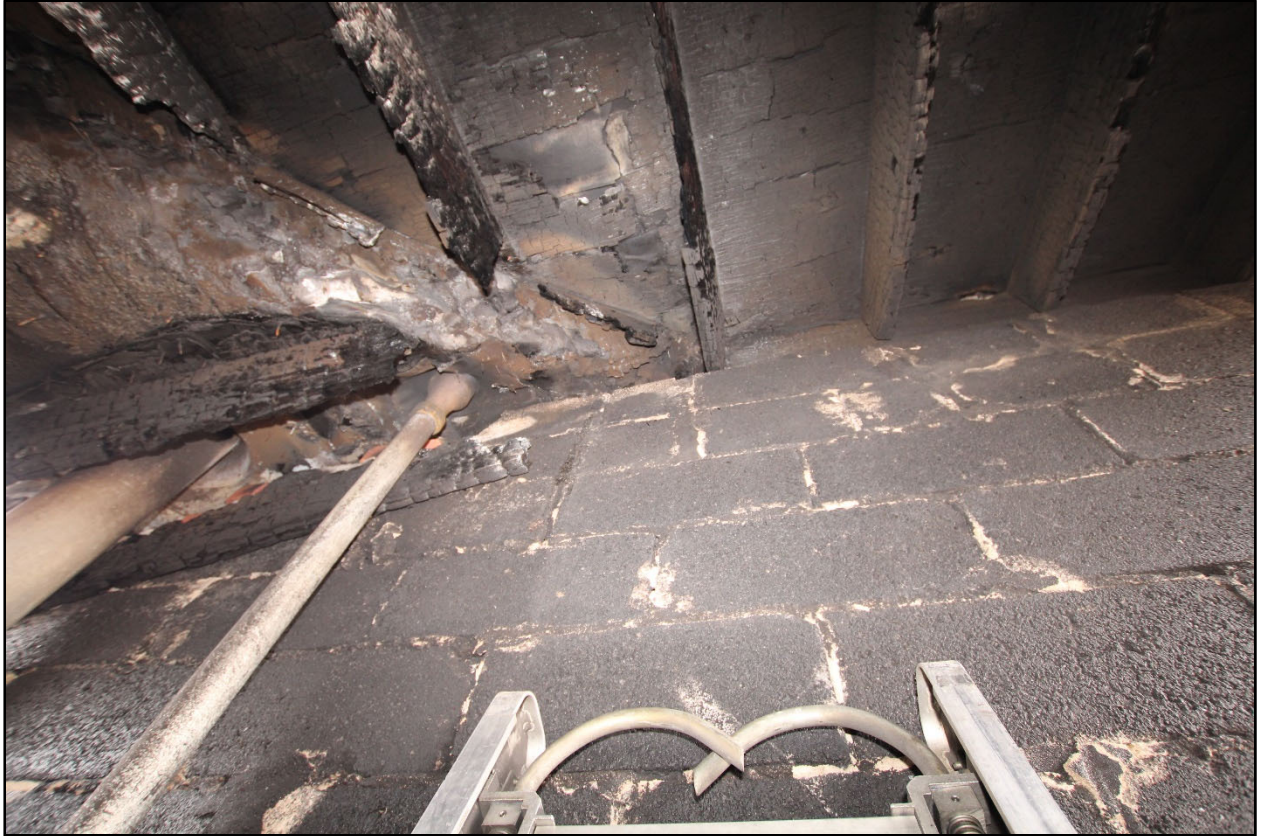
Figure 42. View of the top of the demising wall in the Fire Building toward the rear where flue pipe extends through the roofline.

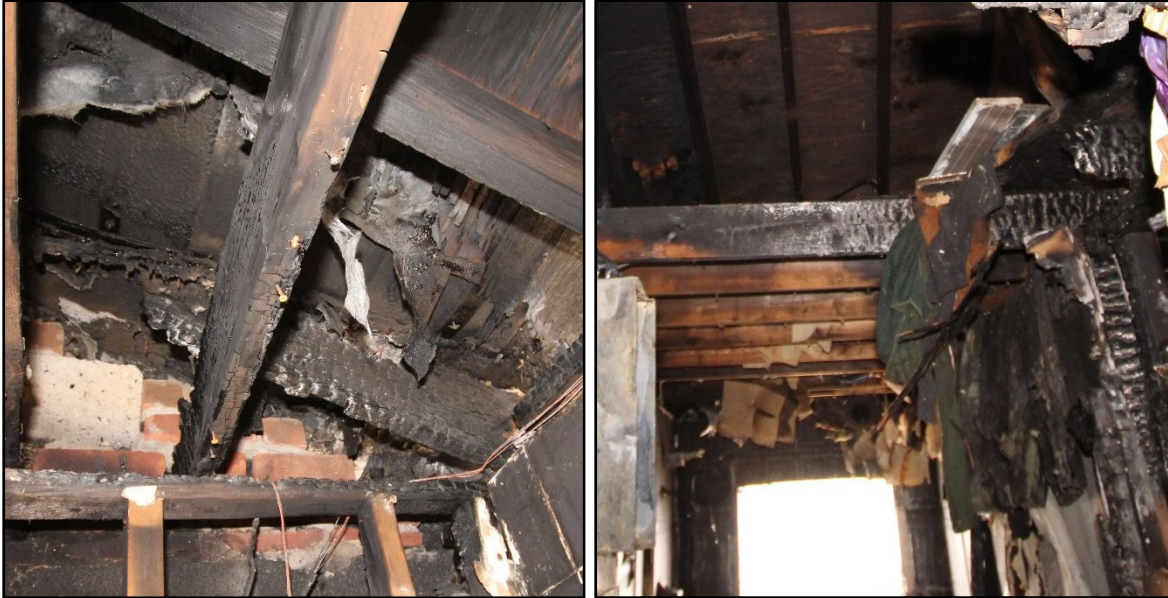
Figure 44. Lower rear section of the attic of Exposure #4 Building where the roof rafters rest on the rear wall of the second floor (left); attic space over the bathroom and hallway of the second floor of Exposure #4 Building (right).

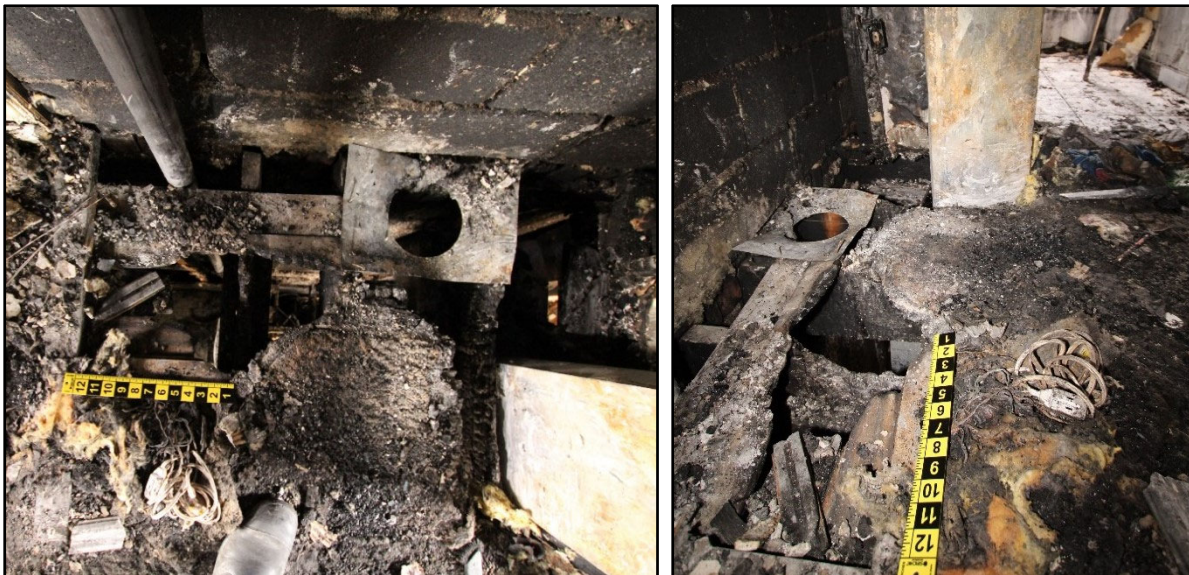
Figure 45. View of vertical shaft on the second floor looking down (left); view of vertical shaft on the second floor showing the saddle burns on the floor beams (right).

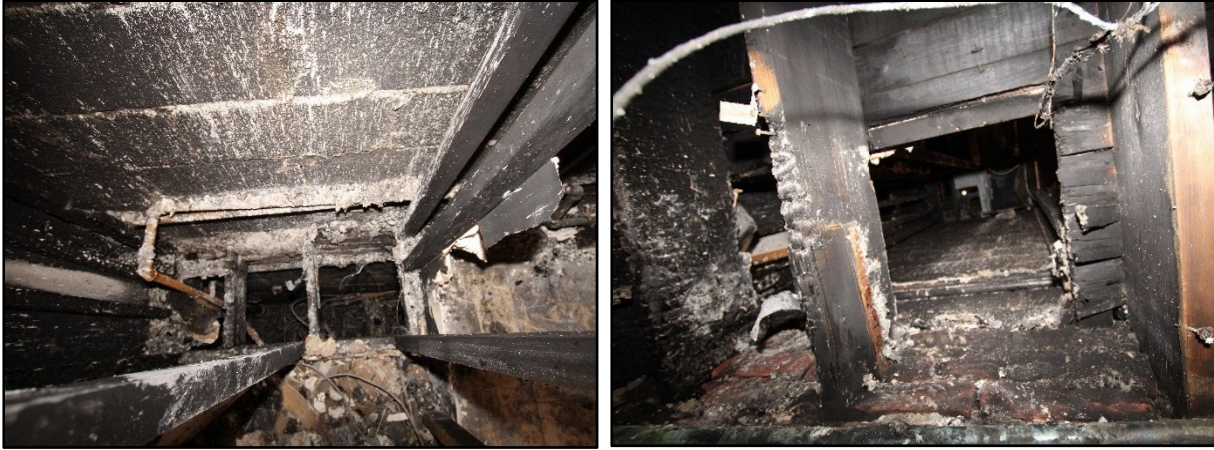
Figure 46. View of vertical shaft on the first floor looking down (left); view of vertical shaft from the basement level looking up (right).

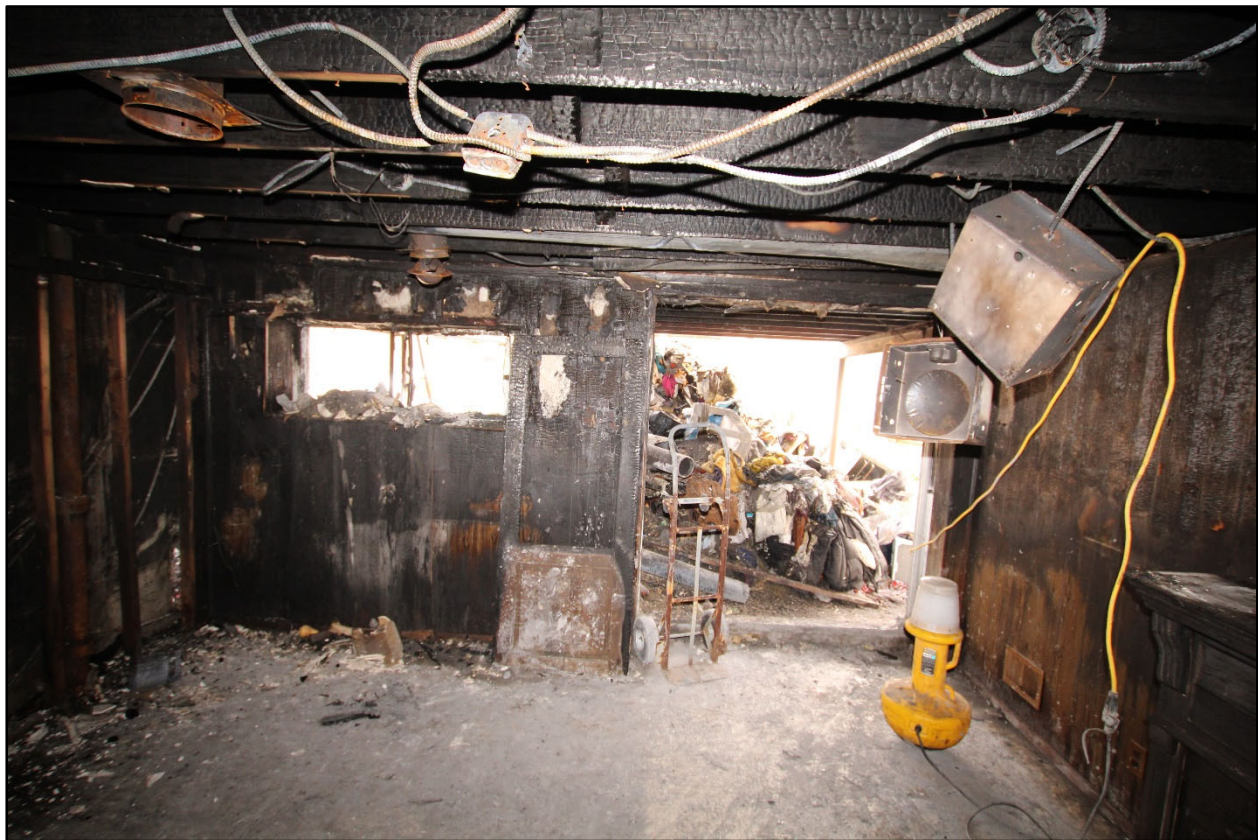
Figure 48. View of the rear exterior wall on the basement level of the Exposure #4 Building where the open sliding door provided the low intake.

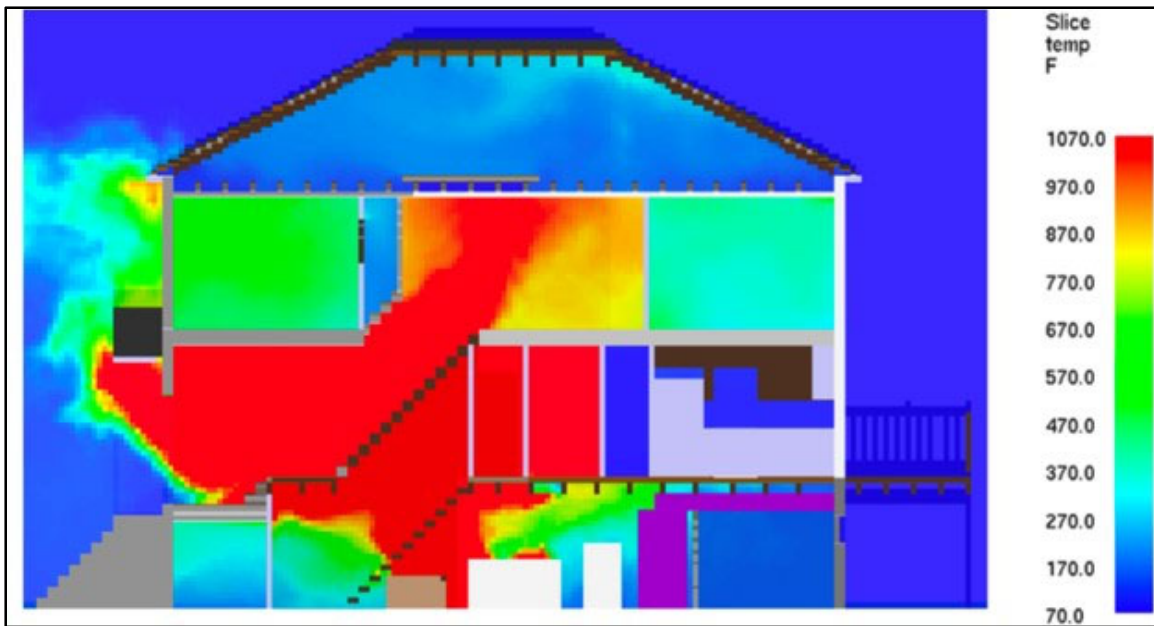
Figure 55. UL Research Institute modeling showing a cross section of 10824 Avenue N with fire travel and temperatures demonstrating the low-intake, high-exhaust flow path.

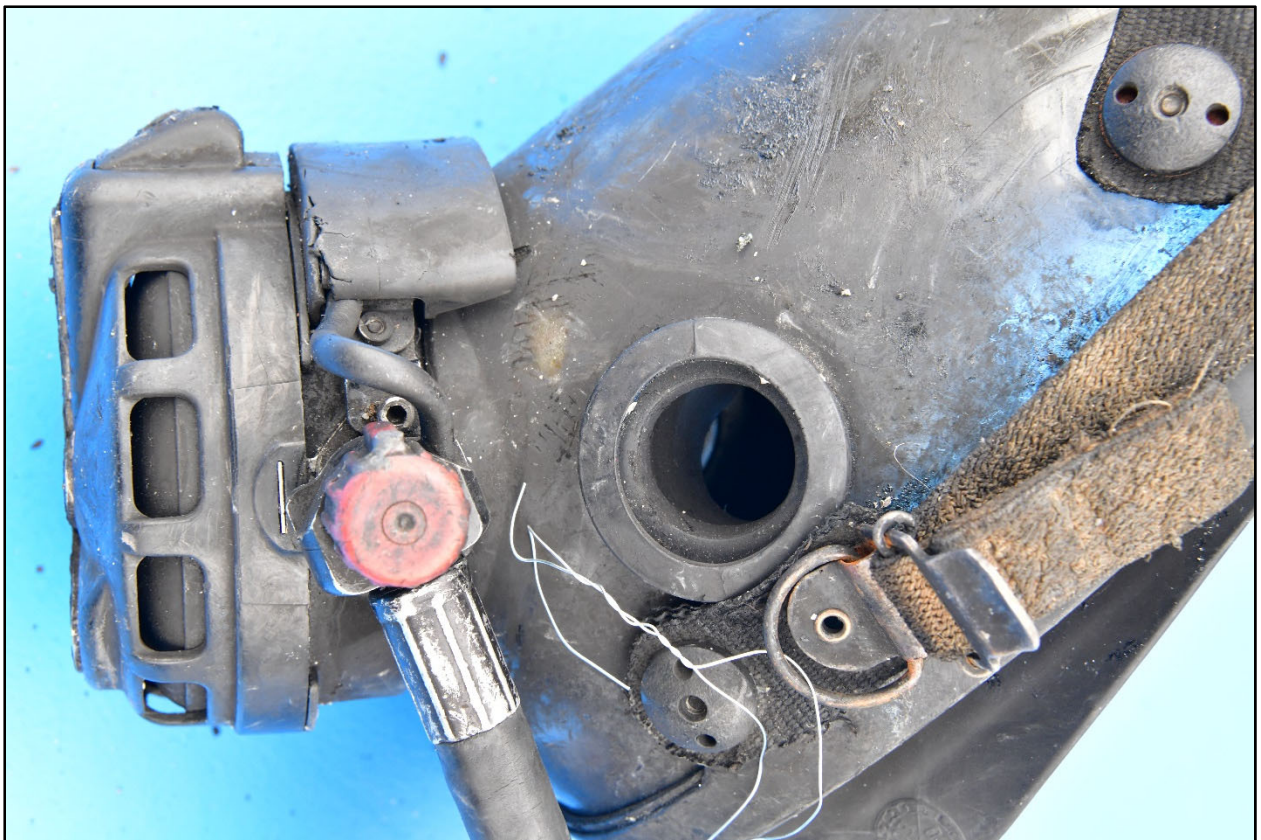
Figure 56. Facepiece attached to the regulator of E257's back-up position SCBA worn by Firefighter Timothy Klein.
