FIRE DEPARTMENT CITY OF NEW YORK

INVESTIGATIVE REPORT

10826 AVENUE N, BROOKLYN, NY

FATAL INJURY

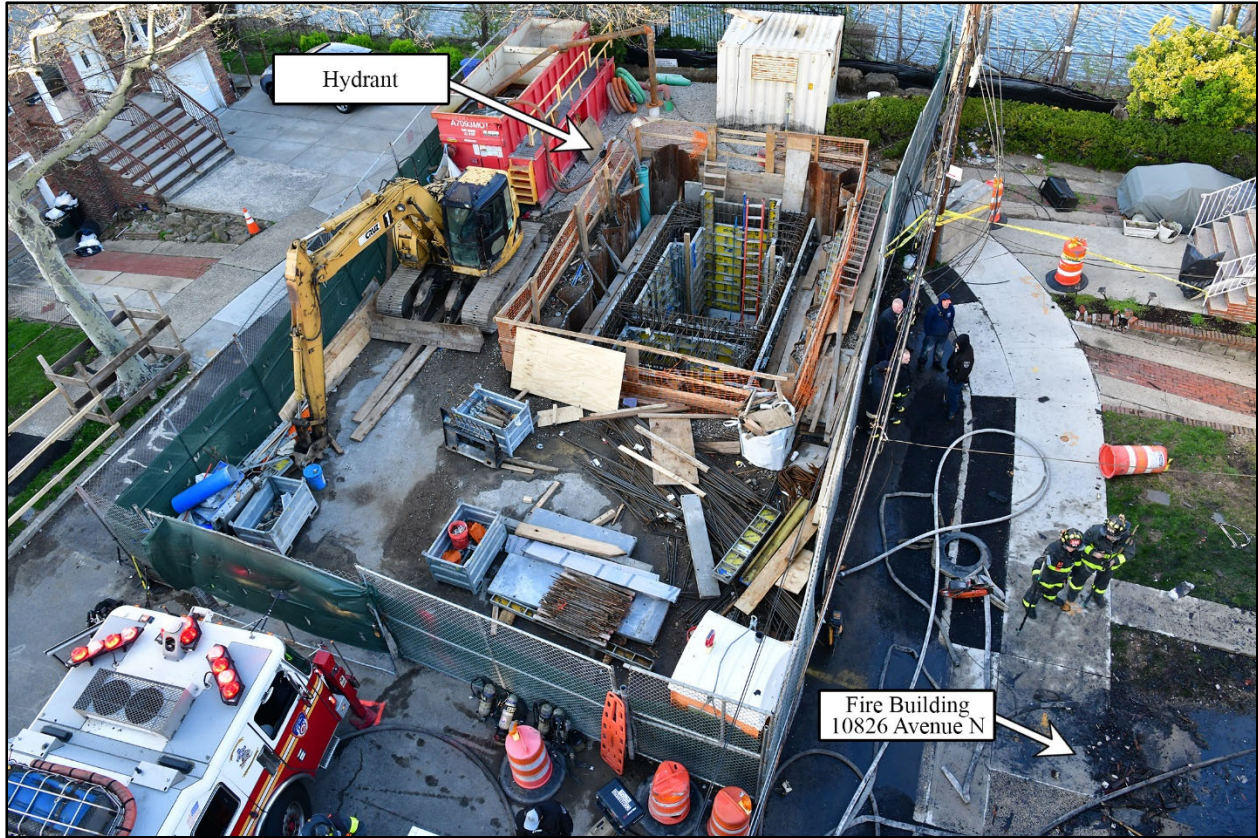
construction site encompassed the street area from curb to curb and was fenced in by chain link on all sides. A hydrant within this fenced-off area was the closest hydrant to the Fire Building, but it was not readily visible to responding companies (see Figures 5 and 6).

Figure 6. View of the construction zone at the dead end of Avenue N.

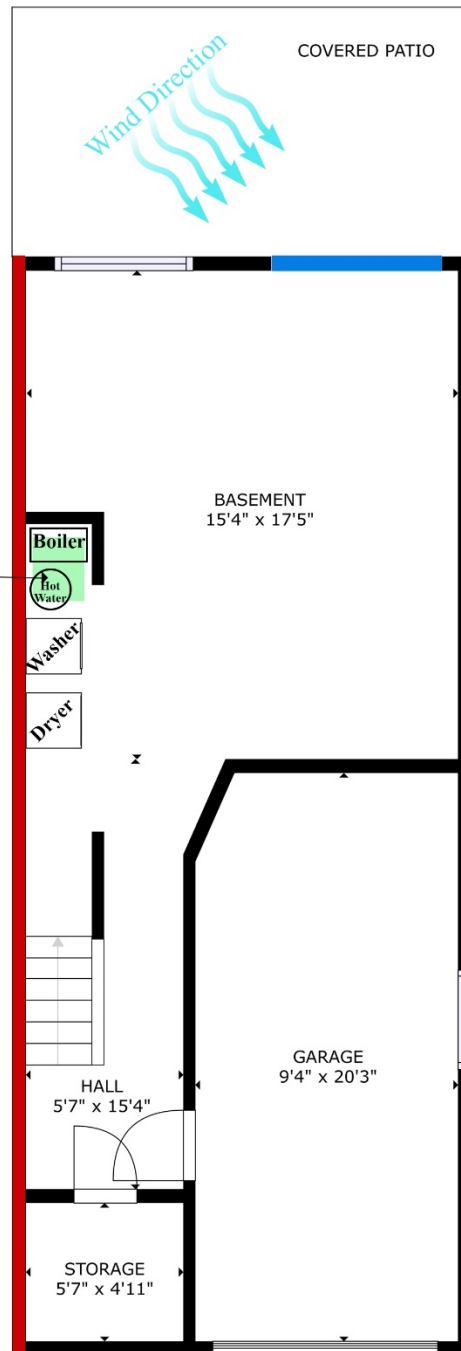
Figure 12. Basement level of 10824 Avenue N, Exposure #4 Building.

Downward fire travel from attic to the basement through the vertical shaft prior to the rapid fire extension event.

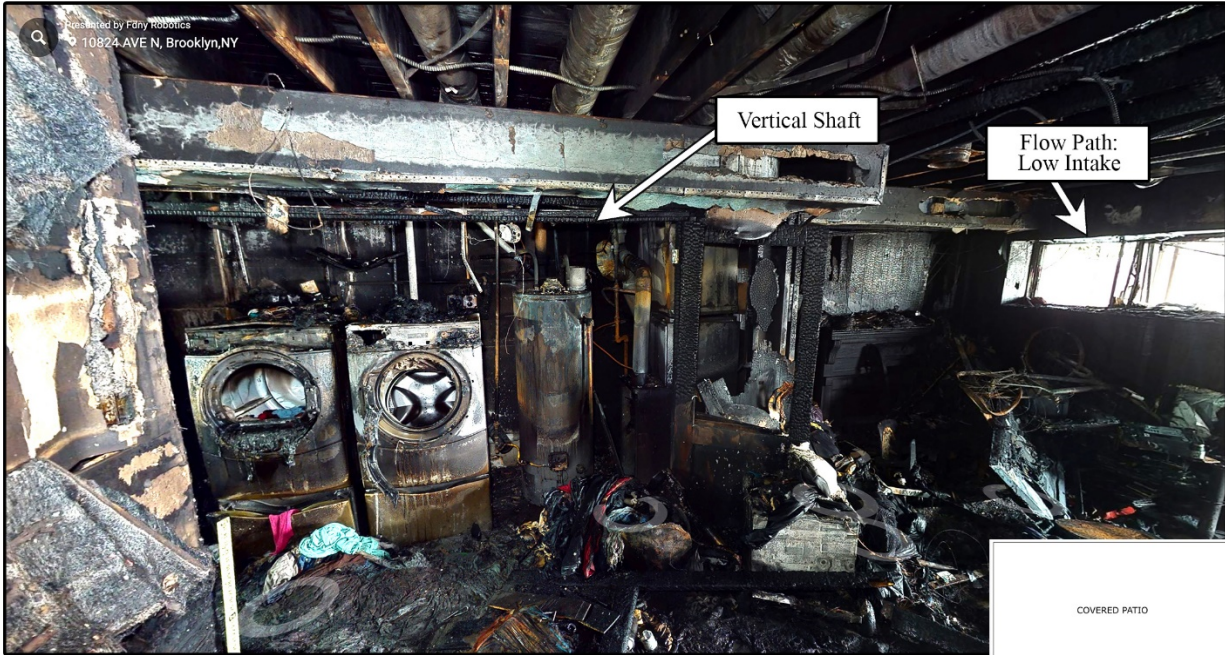
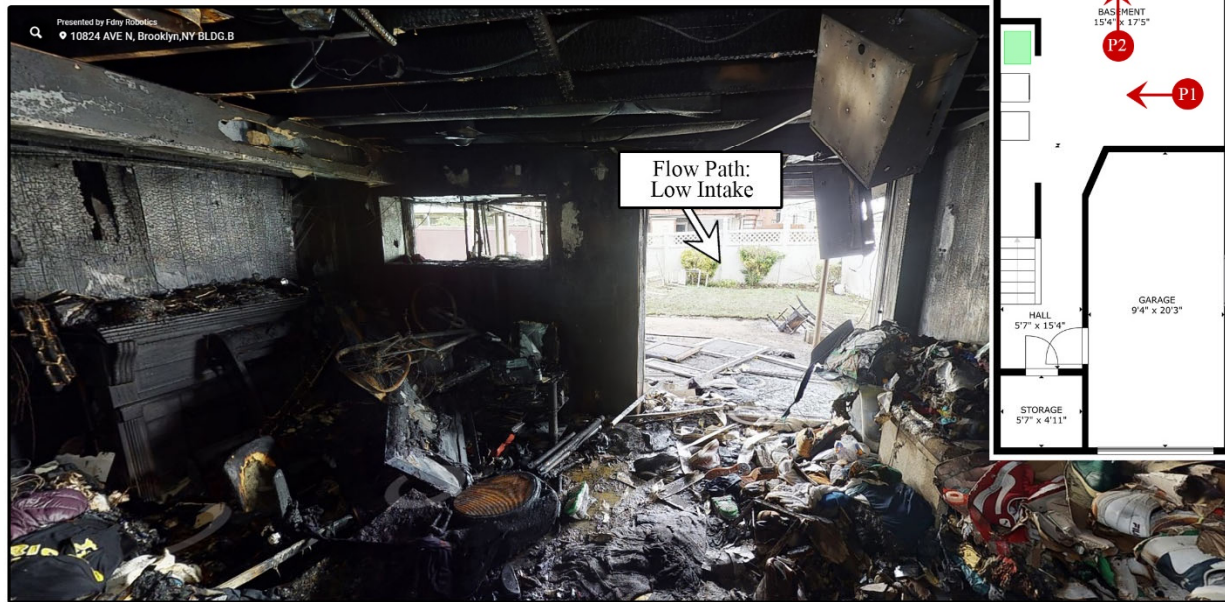
Figure 13. Photograph of utility room on the basement level of the Exposure #4 Building, showing vertical shaft and source of low intake (top); view of backyard from inside basement, showing another source of low intake (bottom).

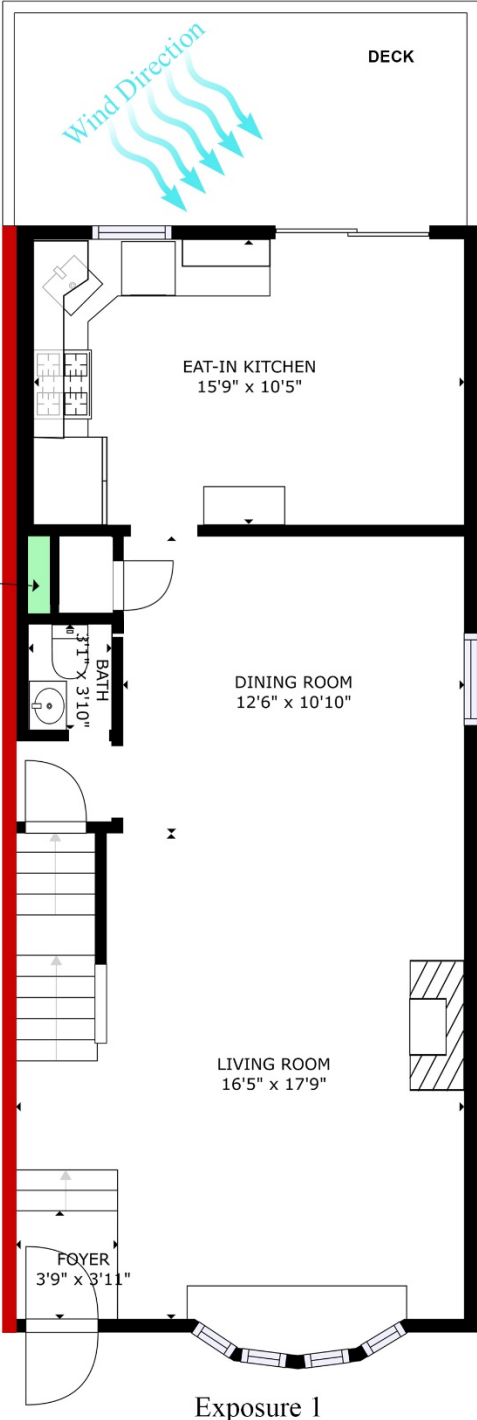
Figure 15. First floor of 10824 Avenue N, Exposure #4 Building.

Downward fire travel from attic to the basement through the vertical shaft prior to the rapid fire extension event.

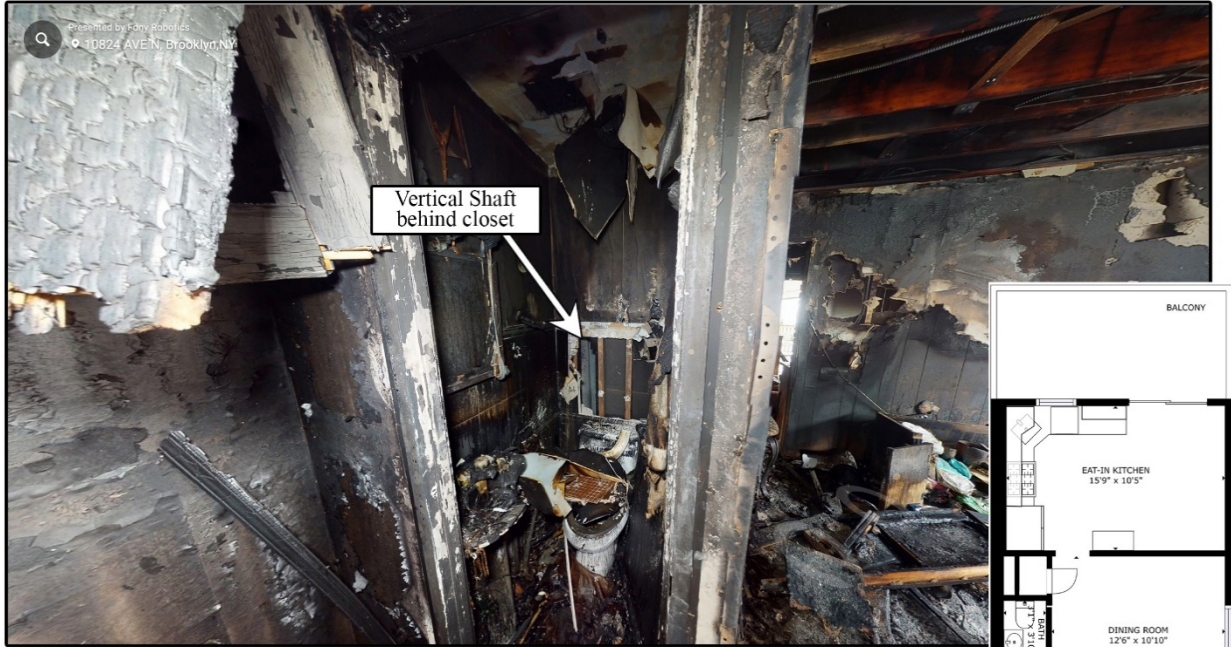
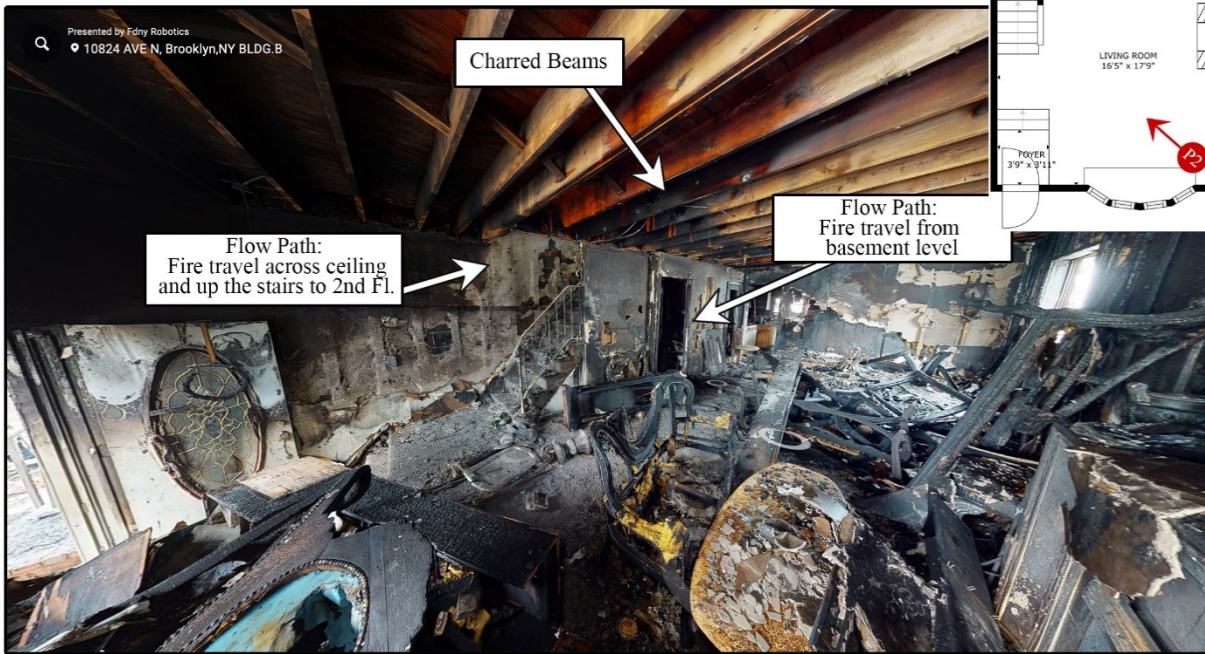
Figure 16. View of the first-floor bathroom and the vertical shaft in the wall (top); view of the first floor from the living room (bottom).

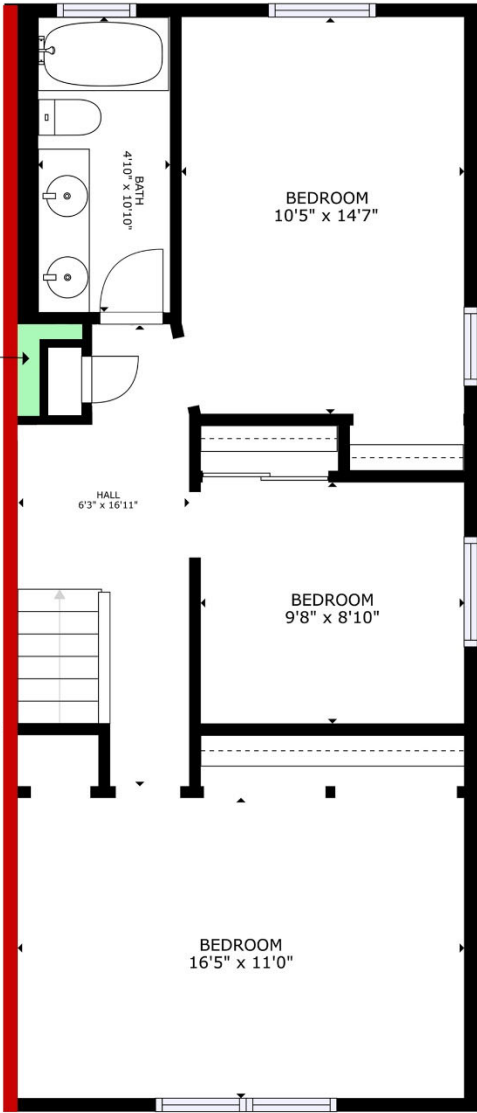
Figure 17. Second floor of 10824 Avenue N, Exposure #4 Building.

Downward fire travel from attic to the basement through the vertical shaft prior to the rapid fire extension event.

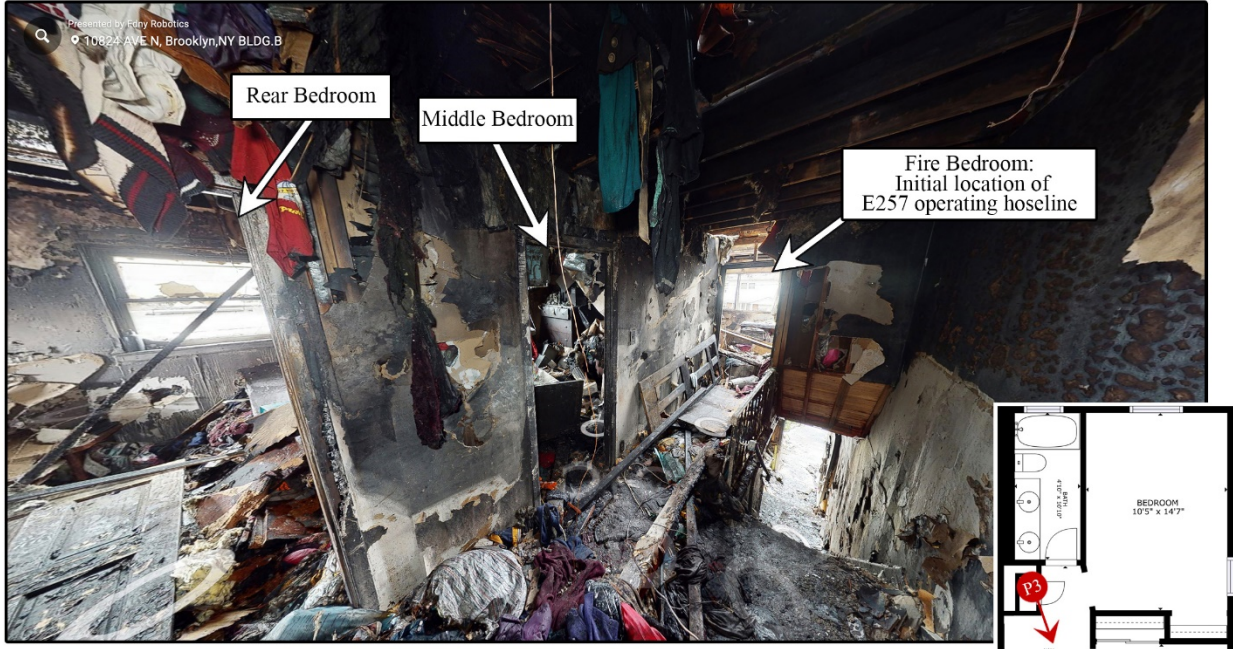
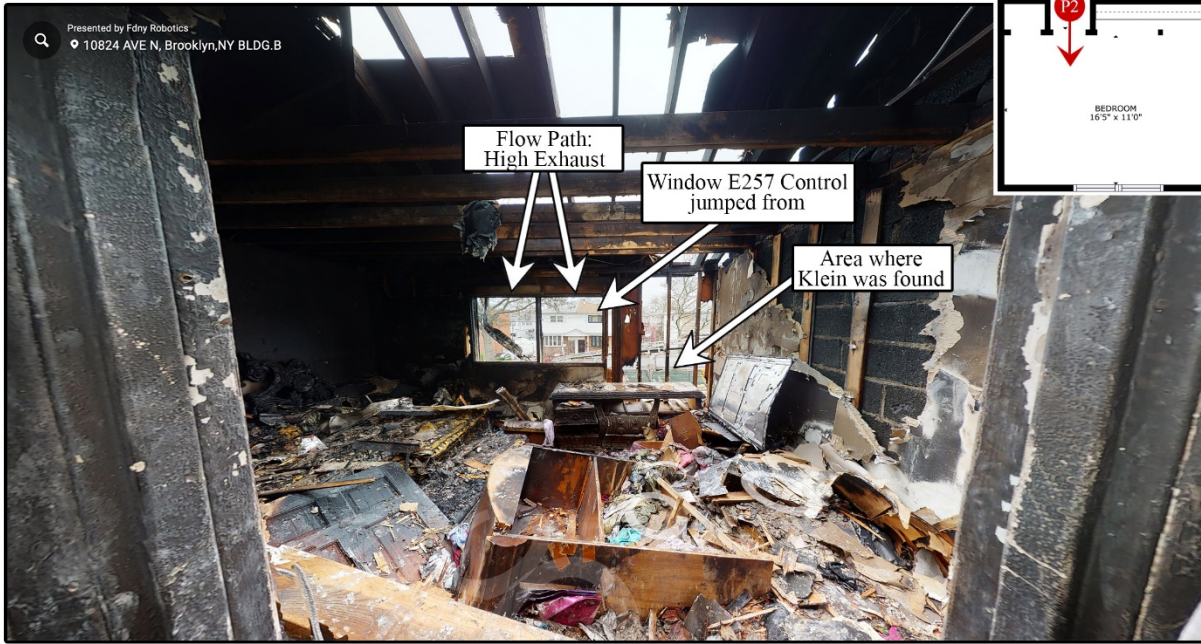
Figure 19. View of the hallway to the front bedroom on the second floor (top); view of front bedroom on the second floor, where Firefighter Timothy Klein was found (bottom).

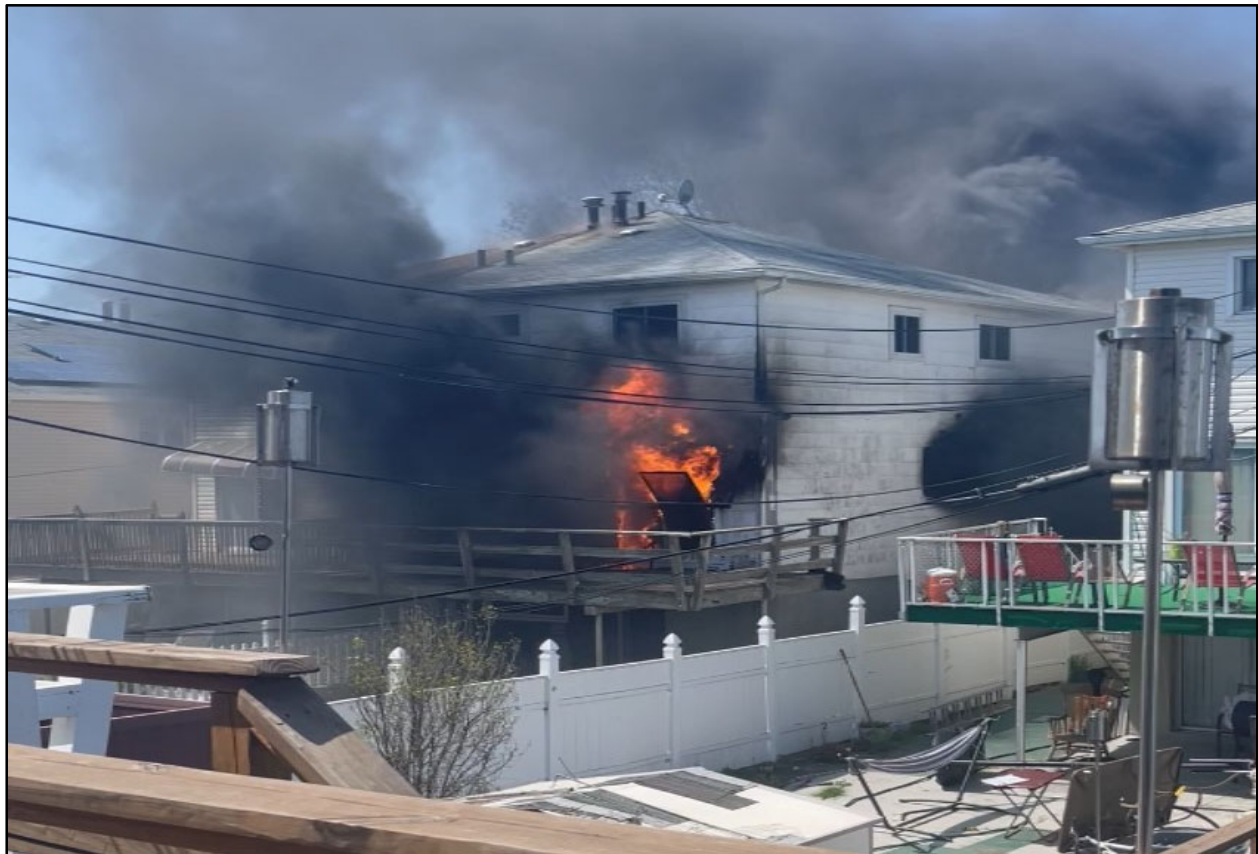
At 13:55:46, the L170 Roof Firefighter on the way to the rear of the Fire Building via the alley on the exposure #2 side transmitted via handie-talkie, “Heavy fire coming out the two side, second floor, in the rear” (see Figure 24).

Figure 24. View of exposure #2 and #3 of 10826 Avenue N.

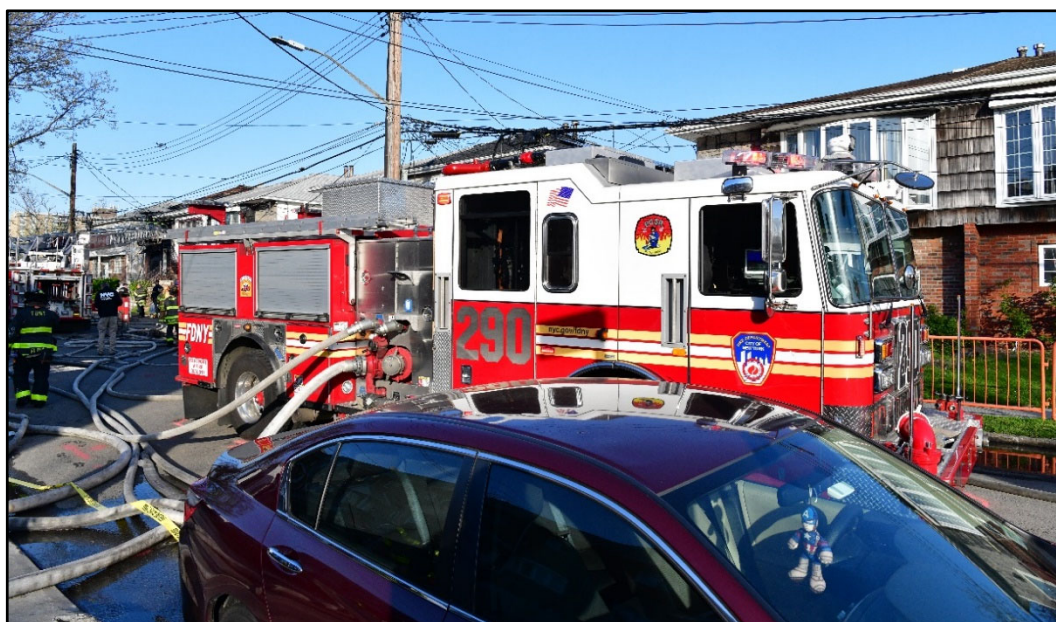
At 13:58:37, the E257 Chauffeur transmitted via handie-talkie, “We’re having issues with the rig.” This transmission was followed by another transmission at 13:58:47, stating, “We’re having issues getting water intake to the pumps.” Engine company chauffeurs on the scene tried unsuccessfully to engage E257’s pump.

Figure 30. E290 in position after E257’s apparatus experienced pumping issues.

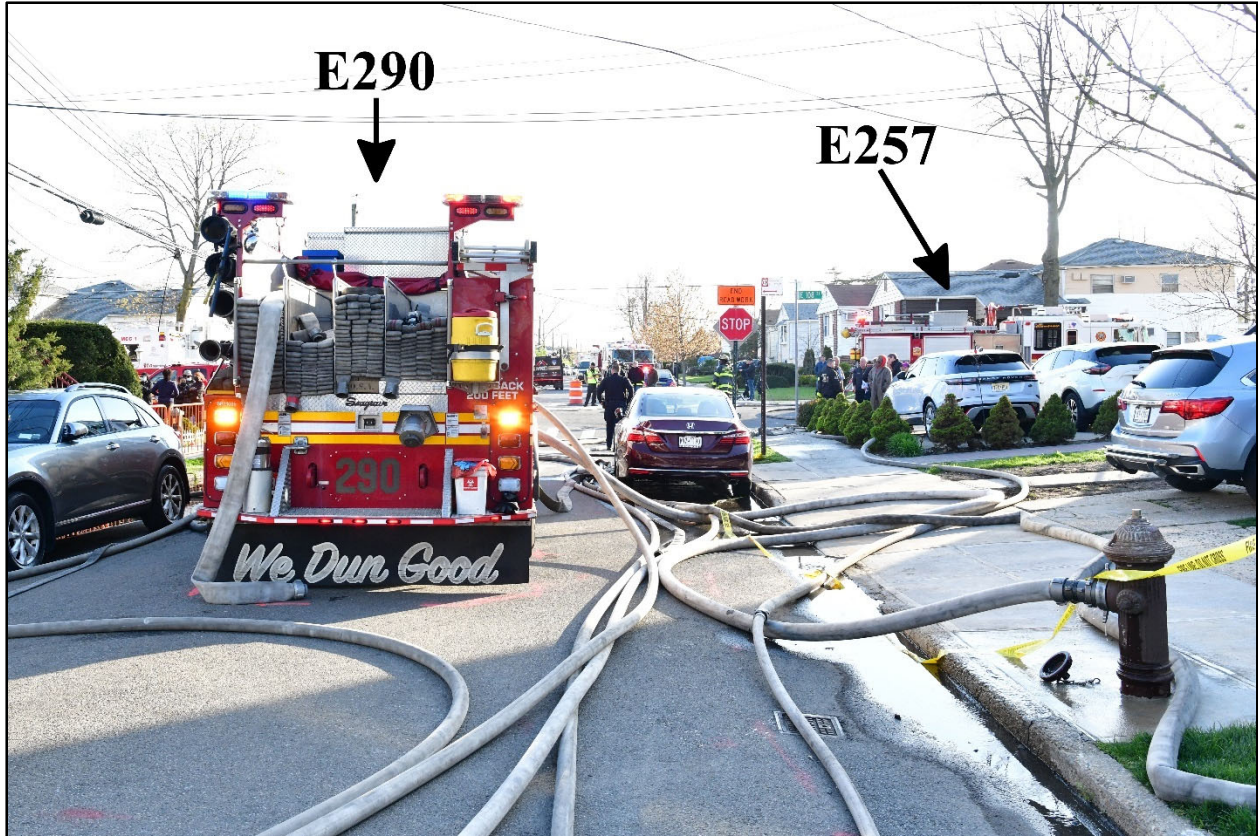
At approximately 1359 hours, The E290 Chauffeur repositioned E290’s apparatus, backing down the block onto Avenue N in front of a hydrant (H331087). The hydrant supply line connected to E257 was disconnected, and E290 connected its 3½-inch supply line to the same hydrant. The two handlines that had been connected to E257’s outlets were disconnected and connected to outlets on E290 (see Figures 30 and 31).

Figure 31. E290 connected to hydrant H331087 in front of 10807 Avenue N.

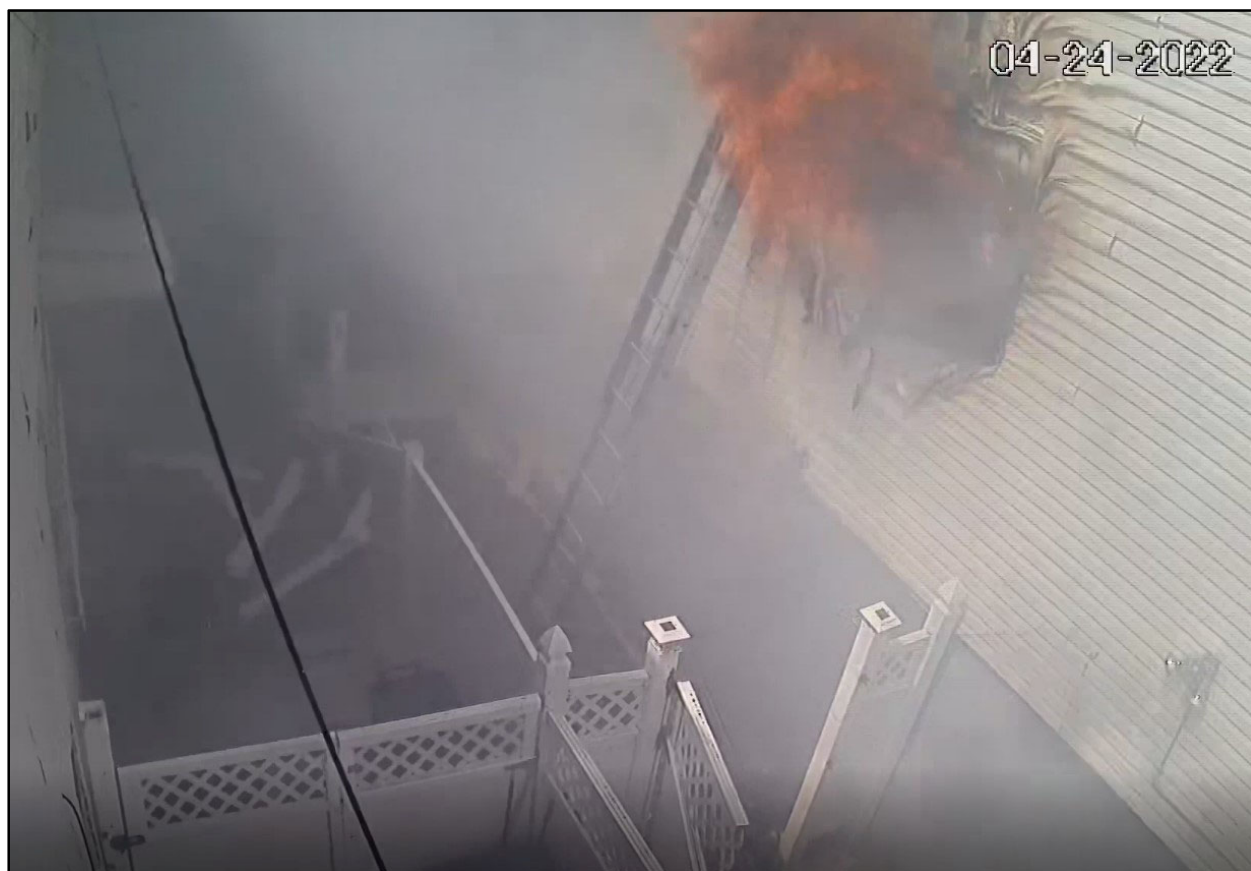
At 14:10:16, the SQ252 Officer transmitted via handie-talkie, “Brothers upstairs. You got fire, heavy fire on the first floor.” At this point, heavy fire on the first floor was traveling up the interior stairs. Seconds later, at 14:10:21, the B58 Chief transmitted via handie-talkie, “Command to all units, Command to all units. Everybody back out, back out of the building. Everybody back out. Command to all units.” As this message was transmitted at 14:10:22, fire vented out the Exposure #4 Building second-floor side window (see Figure 33).

Figure 33. View of exposure #4 side of 10824 Avenue N, as provided by security camera footage from 10820 Avenue N.

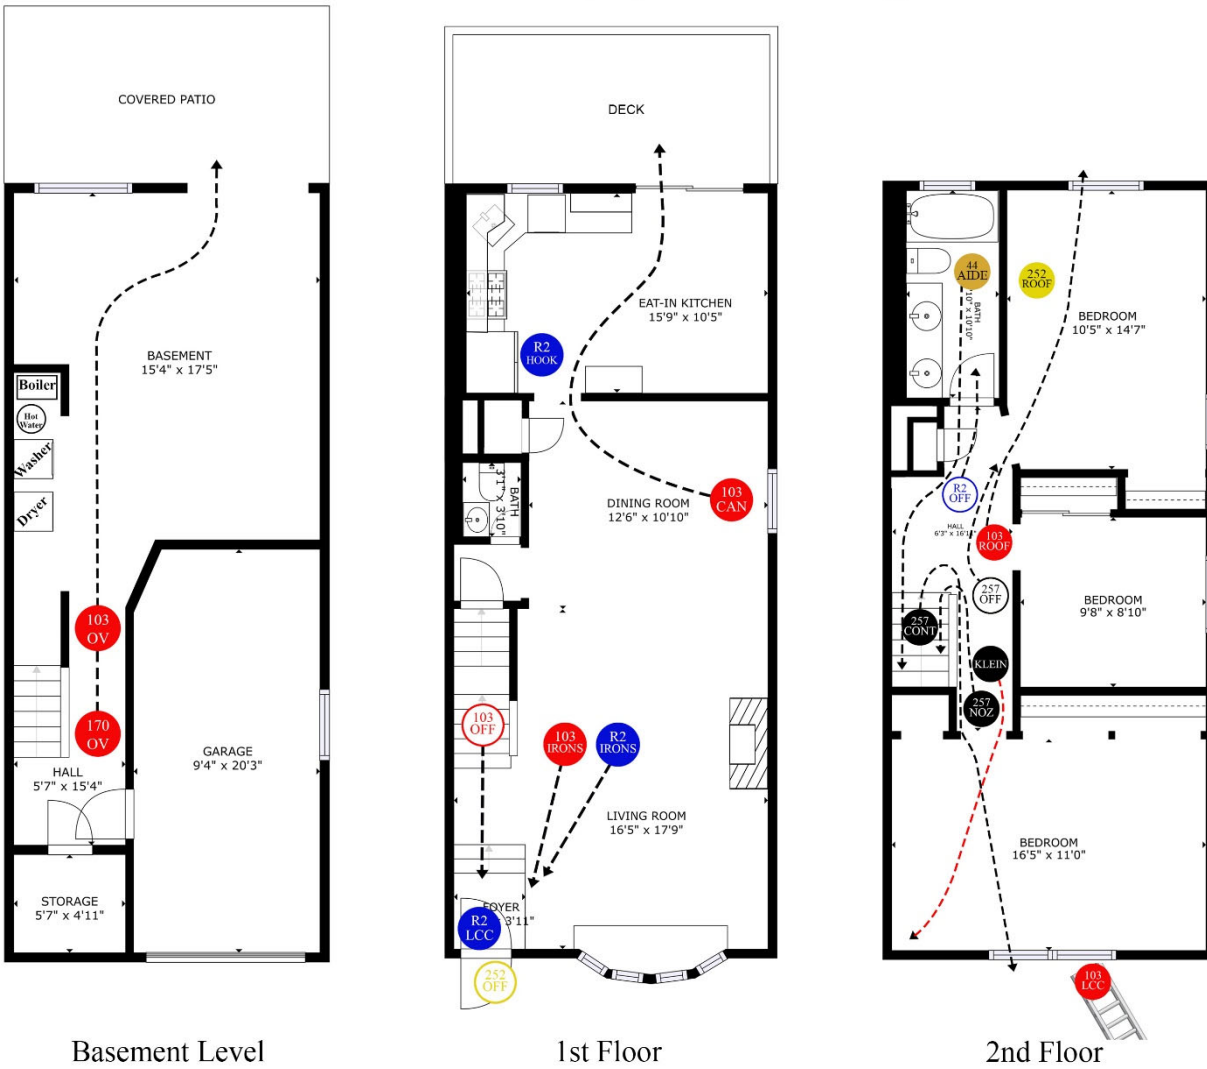
10824 AVENUE N (Exposure #4 Building)

- The E257 Control Firefighter, who was forced from the stairway up the stairs and down the hallway to the front bedroom, jumped out the front window to the driveway below.
- The E257 Nozzle Firefighter dove down the interior stairs and escaped out the front door at the bottom of the stairs.
- The B44 Firefighter dove down the interior stairs and escaped out the front door at the bottom of the stairs.
- The E257 Officer was forced down to the floor in the hallway near the top of the stairs.
- The L103 Roof Firefighter was forced down to the floor in the hallway near the top of the stairs.
- The R2 Officer took refuge in the rear bathroom, at the top of the stairs.
- The SQ252 Roof Firefighter, located toward the rear of the building, took refuge in the rear bedroom (see Figures 34 and 35).

Figure 34. Approximate location and movement of members during or immediately after the event at the Exposure #4 Building. See Chapter 4 for enlarged diagrams of each floor.

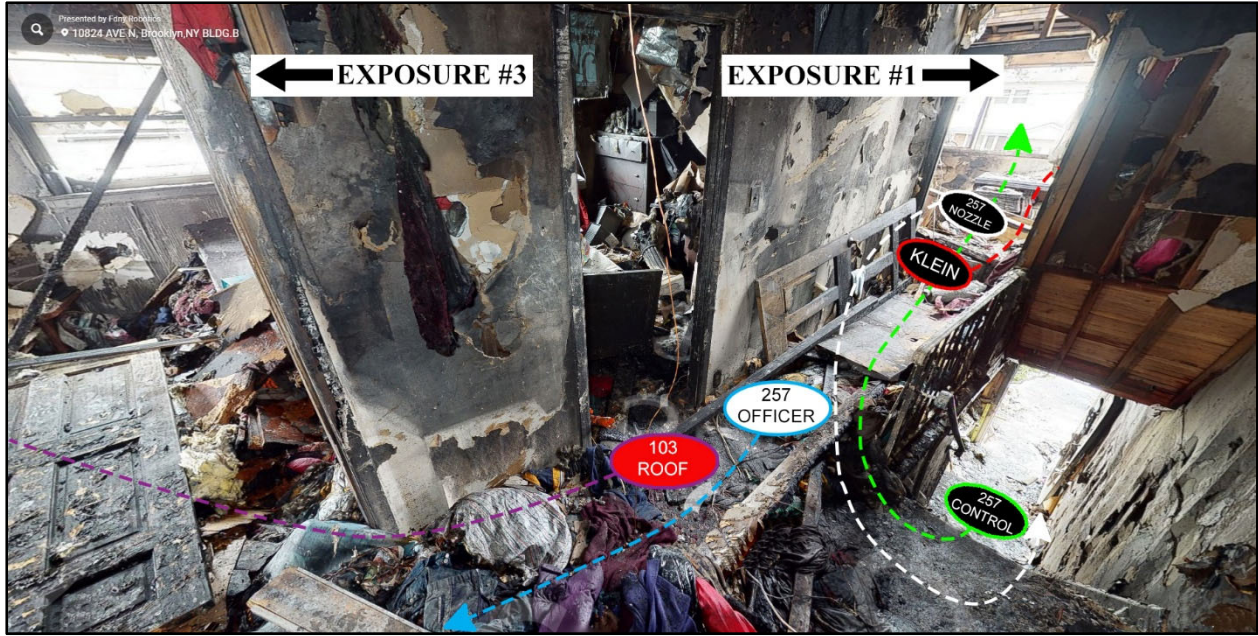
Figure 35. 3D Scan approximating locations of members on the second floor of 10824 Avenue N during the event, courtesy of FDNY Robotic Unit.

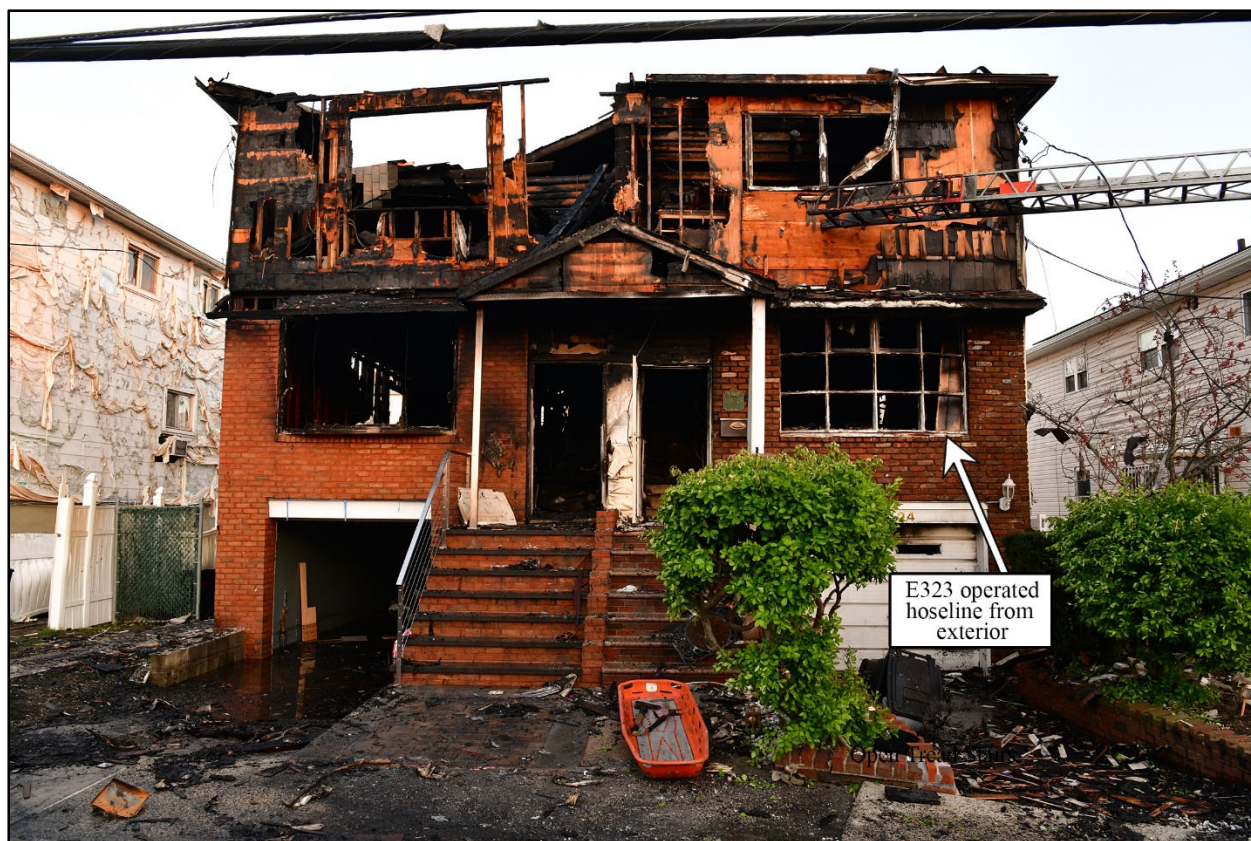
As the heavy fire continued venting out every front window and door of the Exposure #4 Building, E323 positioned a 2½-inch hoseline in the driveway and prepared to apply water from the exterior of the building (see Figure 37).

Figure 37. E323's hoseline placement and operation at 10826 and 10824 Avenue N.

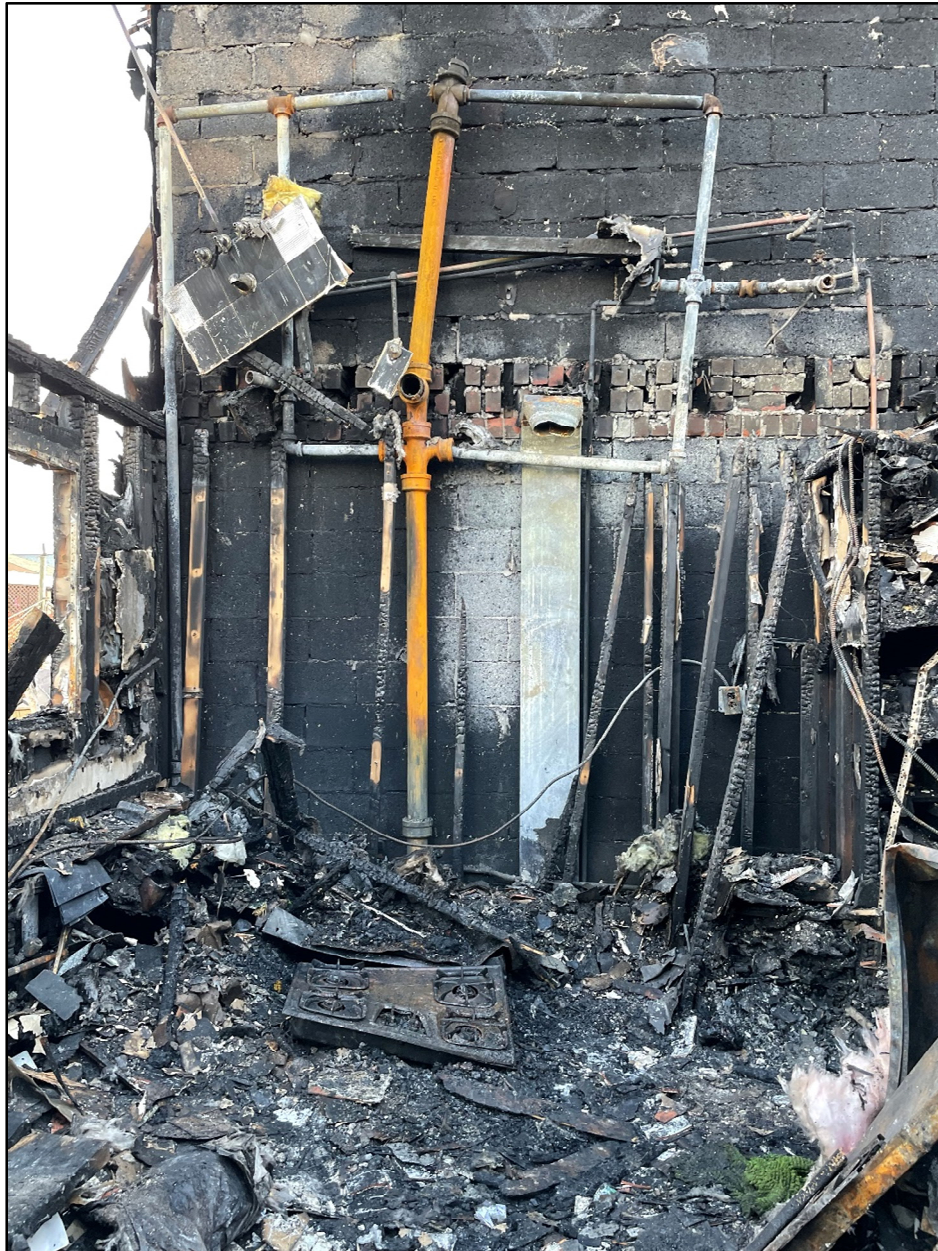
From the point of origin in the kitchen in the rear of the first floor of the Fire Building, the fire extended to the attic space of the Fire Building through vertical voids between the back of the kitchen wall and the central demising wall. This space was the depth of a two-by-four stud (3.5 inches), plus additional piping clearance, resulting in a space of roughly 6 inches (see Figure 40).

Figure 40. View of kitchen area against the demising wall of the Fire Building on the first floor.

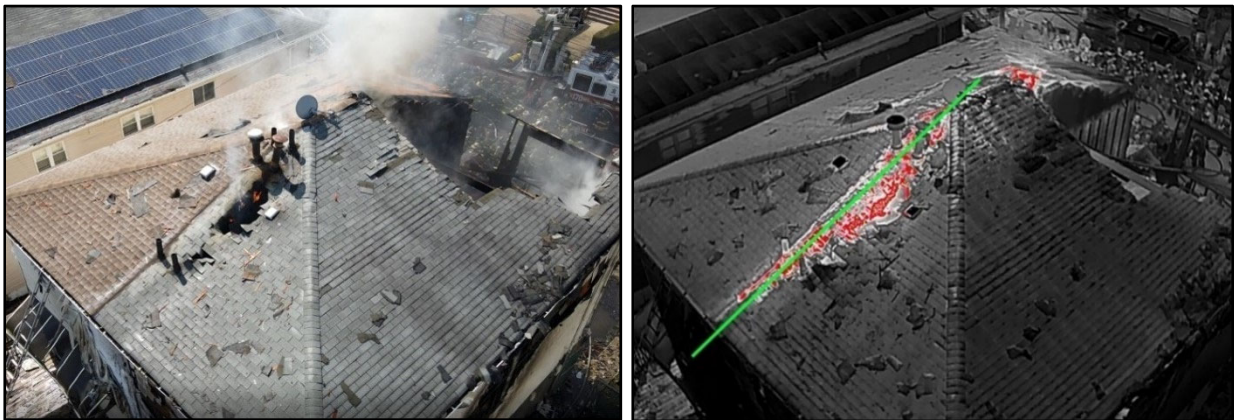
Figure 43. Photos of the top rear section of the Fire Building and Exposure #4 Building with thermal imaging, courtesy of FDNY Robotic Unit Drone. The green line represents the top of the demising wall showing heat and fire on both sides.

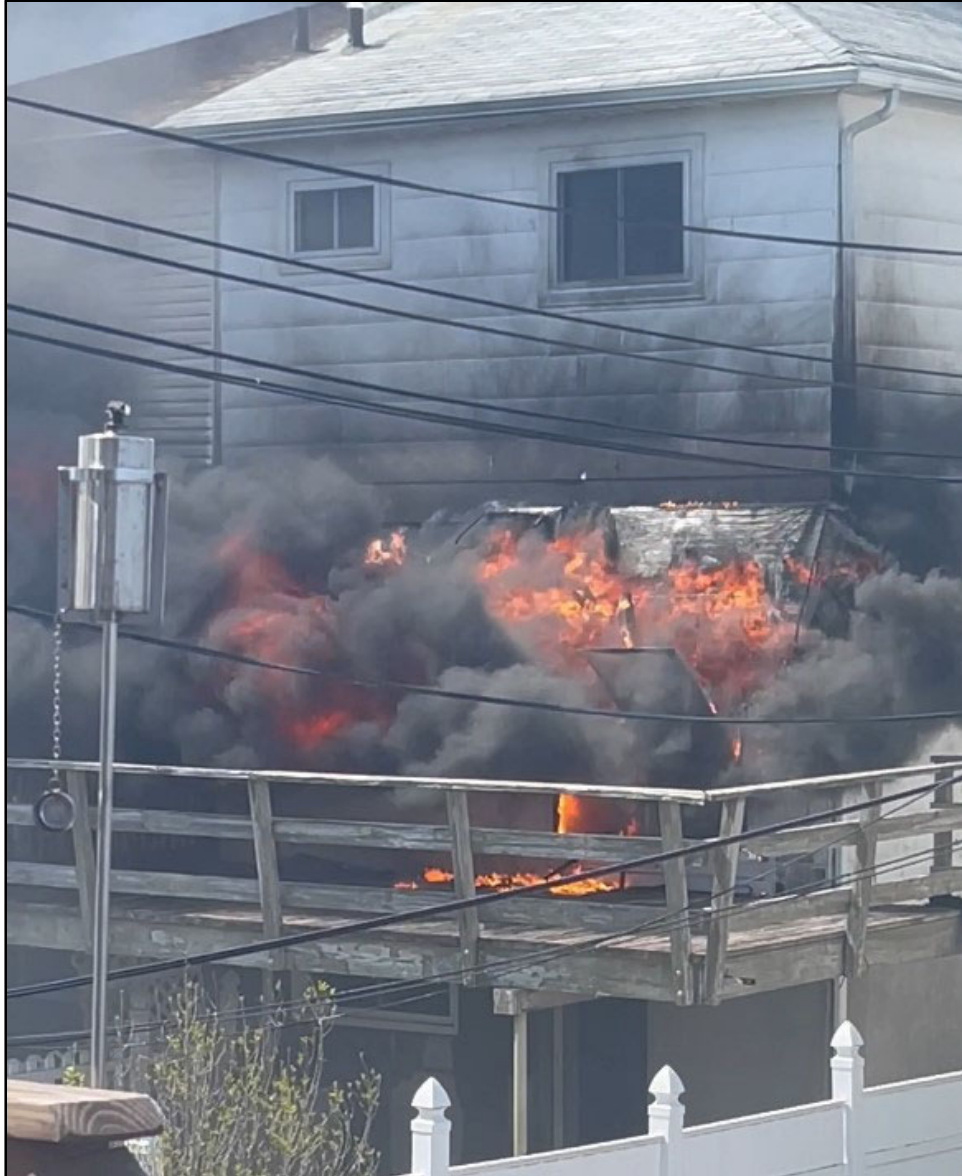
As units arrived at 1353 hours, video evidence shows the impact of the wind on the self-vented sliding glass door and windows in the rear on the first floor of the Fire Building, the windward (high-pressure) side of the building (see Figure 47). The visible heavy fire exhibited a ventilation profile characteristic of wind-impacted conditions (see also Chapter 7). By 1355 hours, the front door on the first floor of the Fire Building was opened, and wind-impacted fire conditions met units as they attempted to make entry. The front door was on the building's leeward (low-pressure) side.

Figure 47. Still frame photo taken from cellphone video of the rear of 10826 Avenue N, the Fire Building.

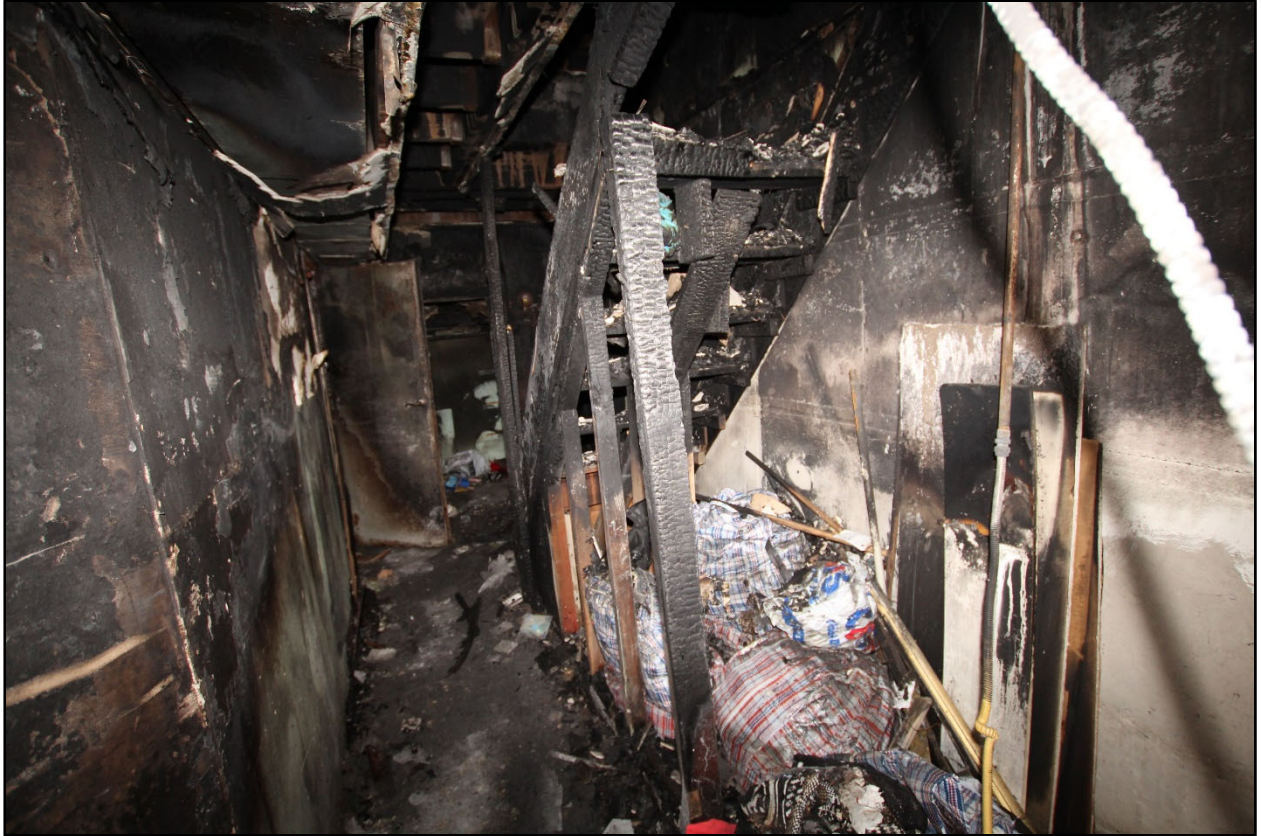
In the basement of the Exposure #4 Building, the fire extended in all directions from the base of the vertical shaft, but the primary path of the extension was forward from the shaft area toward the interior stairway, which was of open-tread construction, and provided an unimpeded path to the top of the stairway. Fire also traveled at the ceiling level toward the open sliding glass door in the rear, but the in-rushing air from the sliding glass door drove the fire forward and up the flow path of the interior stairs. The wind condition increased this ventilation and enabled rapid and sustained fire growth (see Figure 49).

Figure 49. View from the basement level of the Exposure #4 Building from the hallway looking at the staircase to the first floor.

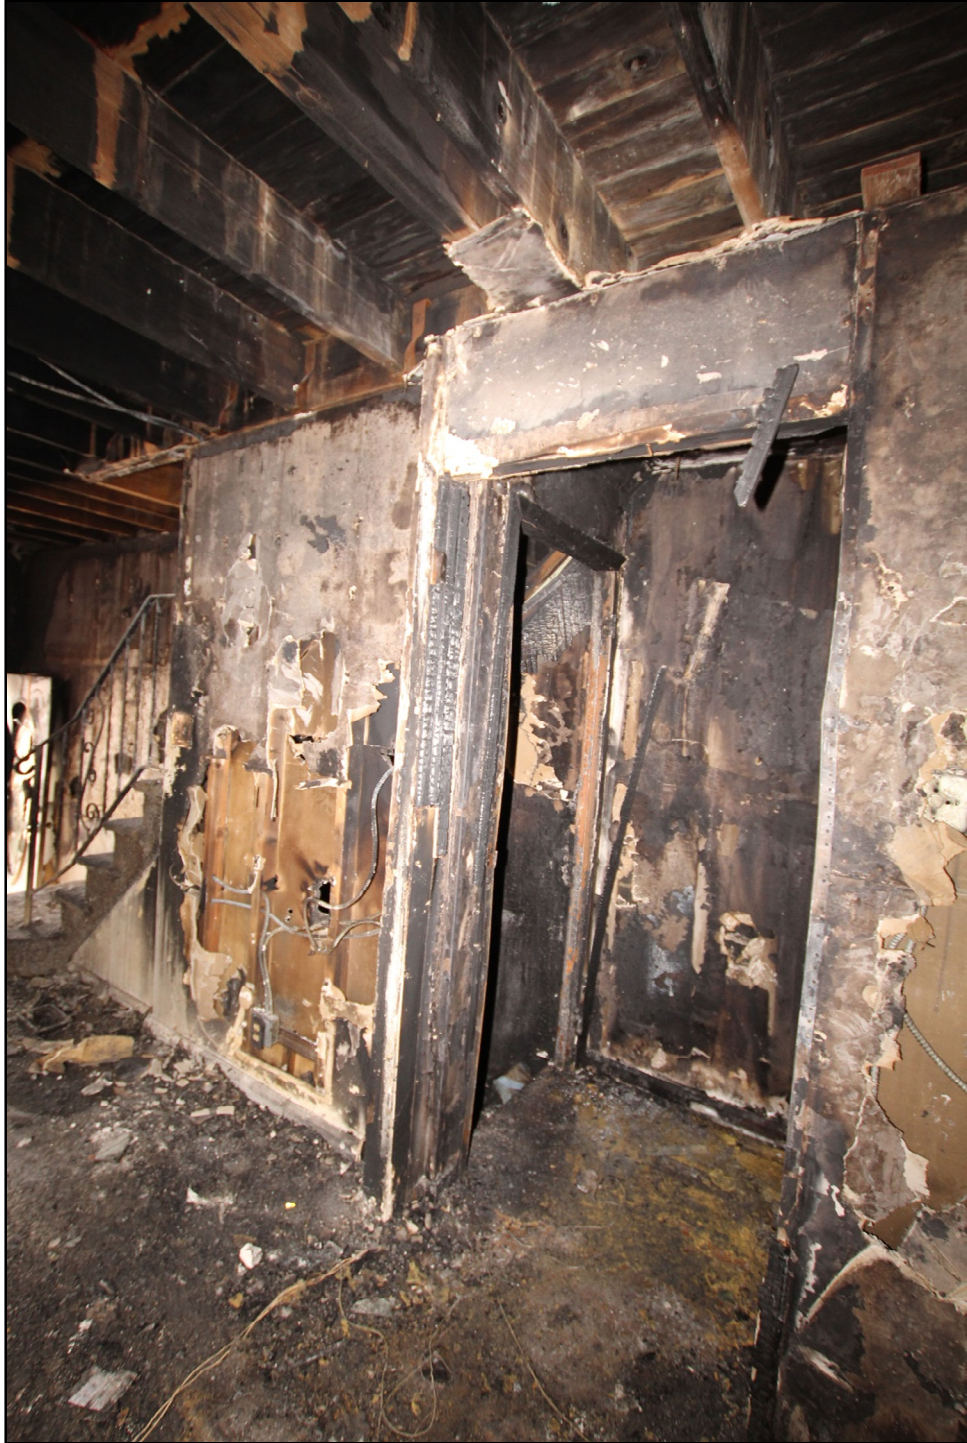
Fire did not extend to the rear of the first floor, as the in-flowing air from the windward (high-pressure) openings in the rear limited extension in that direction. These openings acted as air inlets and allowed the wind condition at the rear of the building to drive air toward the extending fire, which added to its intensity and quickly overwhelmed the available ventilation outlets on the leeward (low-pressure) side. At 14:11:06, the large bay window in the front of the first floor self-vented under heavy fire conditions, and fire vented out the new vent point (see Figures 50 and 51).

Figure 50. View from the first floor in the Exposure #4 Building of the doorway leading to the basement level.

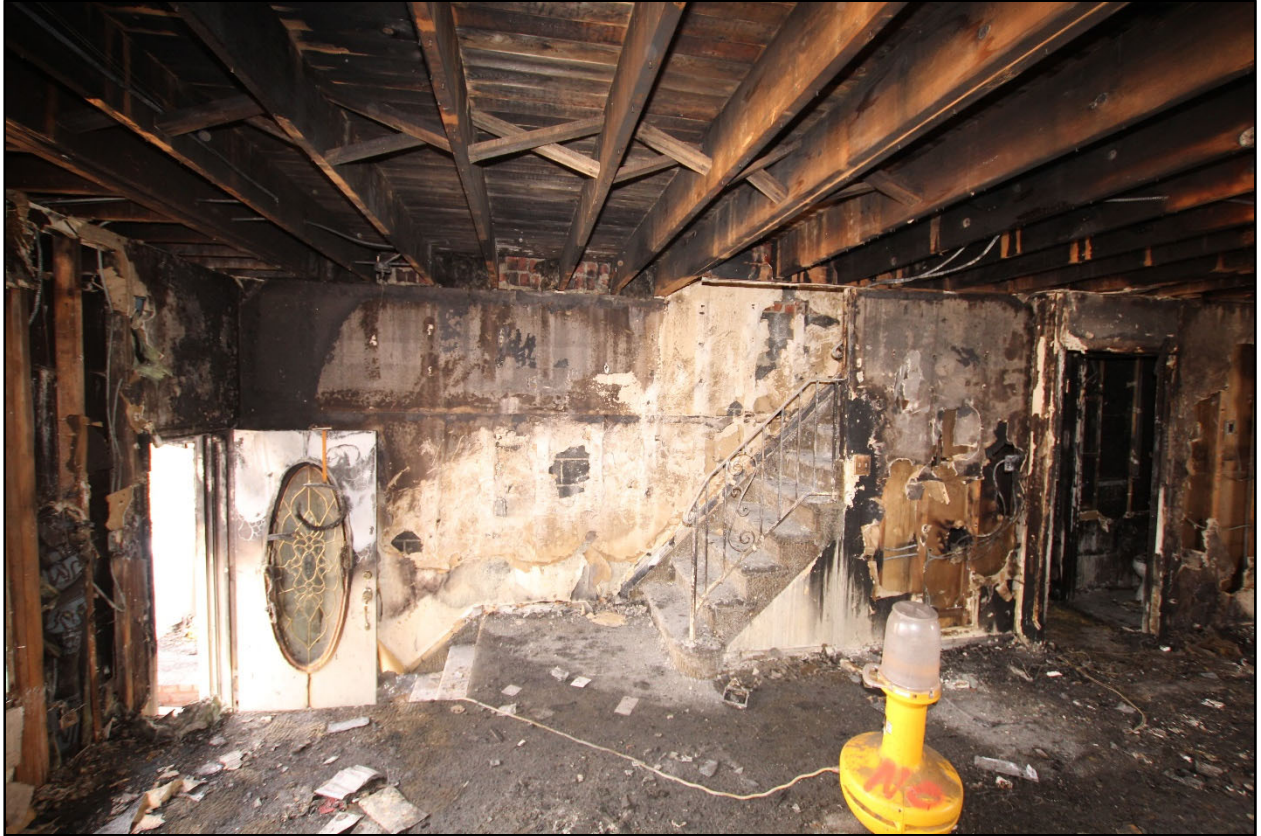
Figure 51. View from the first-floor living room of the Exposure #4 Building.
