FIRE DEPARTMENT CITY OF NEW YORK

INVESTIGATIVE REPORT

10826 AVENUE N, BROOKLYN, NY

FATAL INJURY

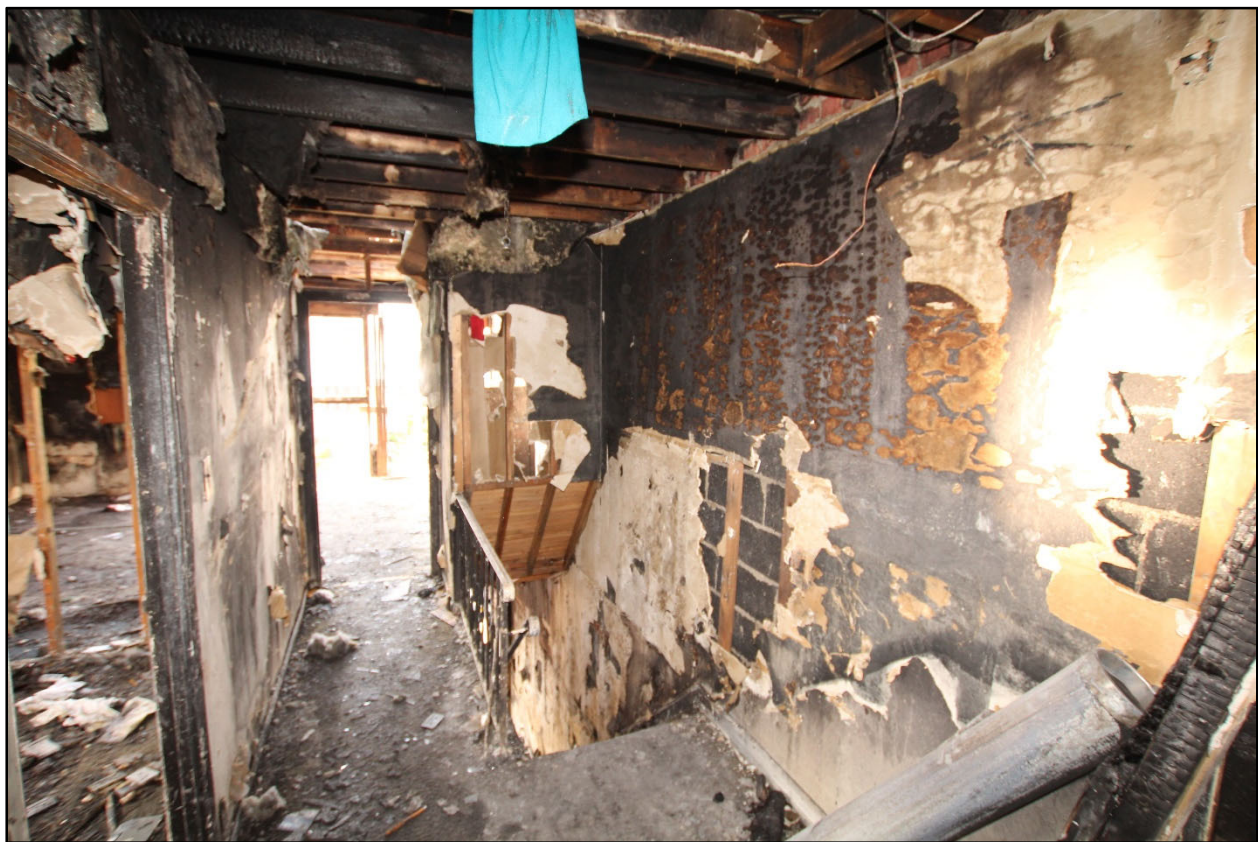
surge of heat coming from two different directions: below them and above them. The heat from below was caused by fire extending up the interior stairs while the heat from above was caused by fire extending out from the top of the vertical shaft, which terminated just above the area near the top of the interior stairs on the second floor (see Figure 52).

The combined impact of heavy fire traveling up the uncontrolled flow path of the open interior stairs and the fire traveling up the vertical shaft led to rapid fire development on the second floor, where the situation became immediately untenable.

Figure 52. View from the hallway on the second floor of the Exposure #4 Building looking toward the front.

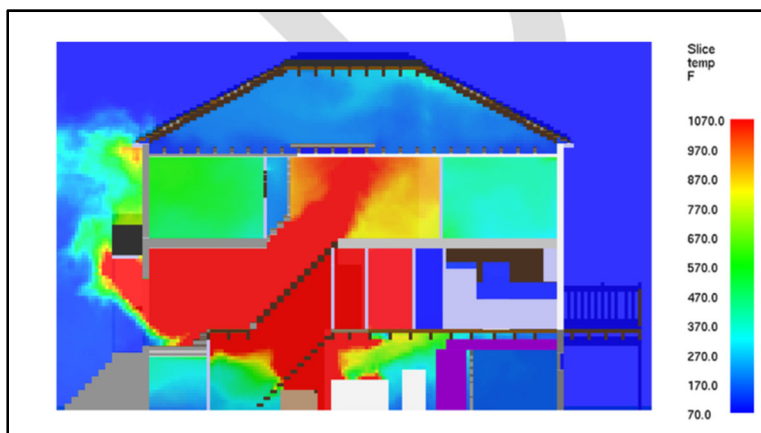
Specifically, the model found that temperatures on the first and second floors dramatically increased in the minute following the venting of the first floor window across from the basement stairway. At this time, temperatures in the flow path reached over 1000° Fahrenheit on the first floor and over 900° on the second floor. Similarly, the air flow velocity increased dramatically at this point, with speeds of over 15 mph in the stairway and 6 mph in the second floor hallway (see Figure 53). A full accounting of the results of the FDS model is provided in Appendix D.

Figure 53. UL Research Institute model of the cross section of Exposure #4 Building.

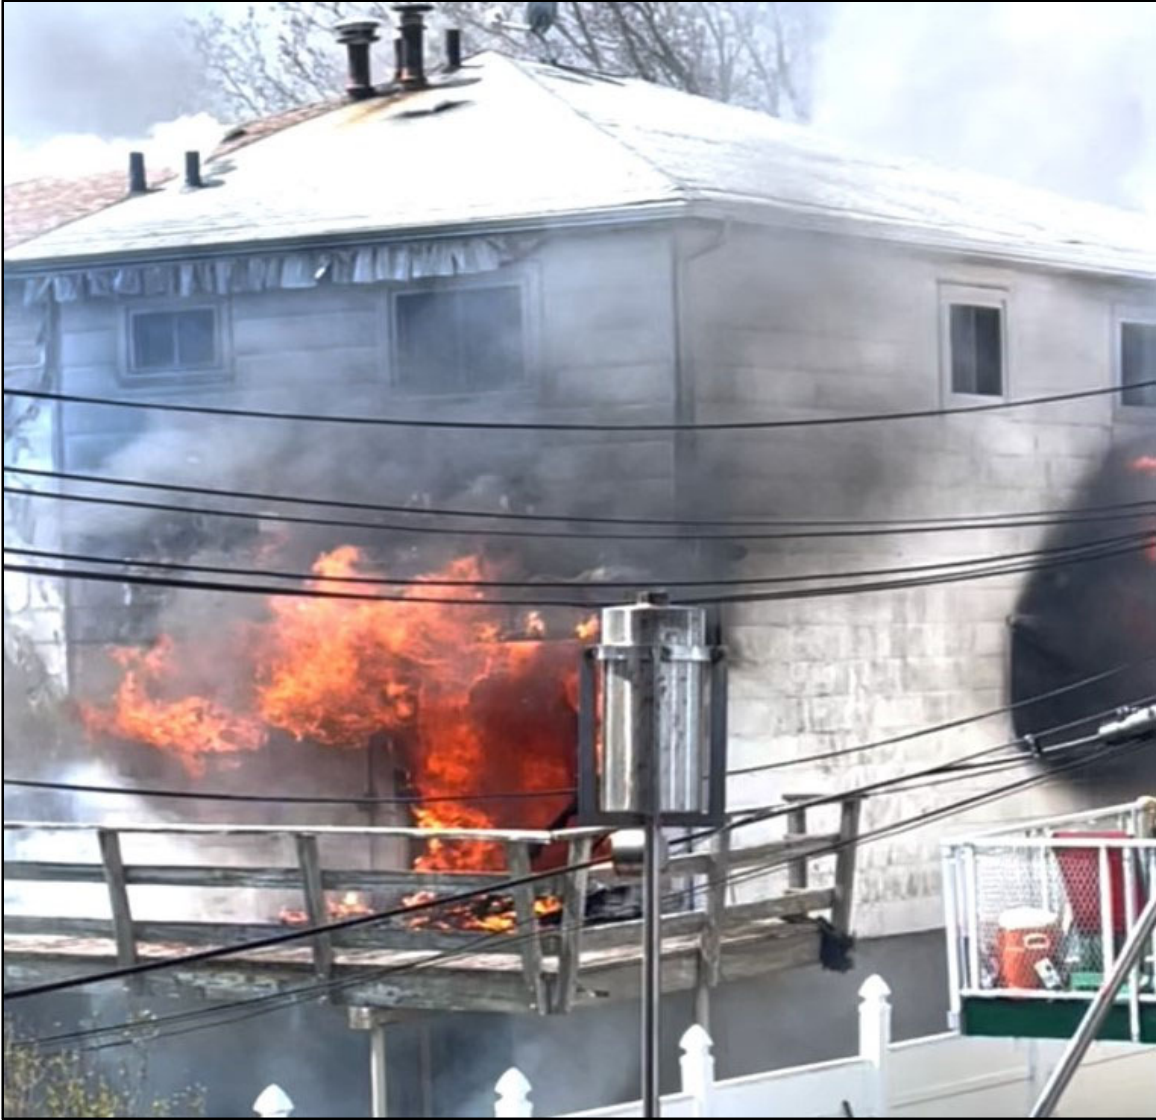
In addition to driving the fire, smoke, and hot gases forward through the building, the wind condition also increased the burning rate in the fire area by providing a steady supply of air. This condition led to heavier fire and increased the volume of combustion products. The steady inflow of air at the rear openings also made it difficult for the products of combustion to exhaust the Fire Building. As a result, the vent openings were overwhelmed, leading to an accumulation of hot gases inside the structure that would have otherwise escaped (see Figure 54).

Figure 54. Rear of 10826 Avenue N, the Fire Building.

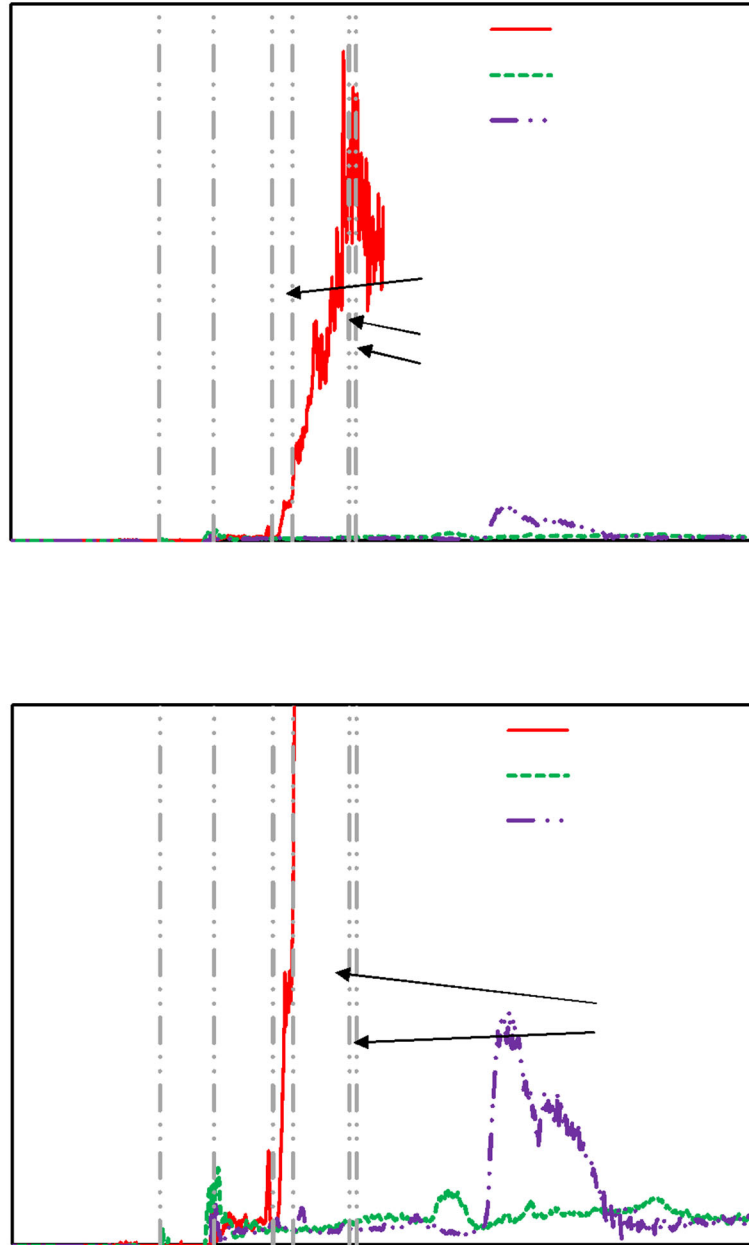
Figure 19 shows the FDS predicted heat release rates for each of the three scenarios. These are the heat release rate values in excess of the prescribed fires. All three scenarios show spikes above the prescribed fire size when the front bedroom window fails and when the front bedroom door is opened for suppression. This is a result of increased mixing due the new flow path enabling more rapid combustion and combustion of any accumulated unburned fuel. Shortly after fires start in the basement there is a sustained increase in heat release rate above the prescribed fires of 200 to 300 kW in all scenarios. There is some spreading of the fire in the basement, but it is not experiencing sustained, rapid growth.

In the actual scenario, just before the dining window is vented, the fire in the basement briefly spikes up to 1.6 MW indicating that in this scenario the conditions in the basement are ripe for rapid growth. After the window is vented, the fire grows to 5 MW over the next half a minute. Venting the window created a drop in pressure on the first floor allowing for more leakage flow through the basement door. An increase in 5 MW would only require a few hundred cubic feet per minute (CFM) more airflow in through the basement sliding glass door. This rapid growth would act to increase pressure in the basement compared to the first floor. If the basement door had not been securely latched this pressure or with the addition of pressure from a wind gust could have pushed open the door. Once the basement door is open, a wind driven flow path exists from the basement slider, up the stairs to the first floor and then out the first floor dining window and front door. The flow path continued up into the second floor and out the front bedroom window. As a result of the additional oxygen supply plus wind driven flame spread, the fire in the basement stairs undergoes rapid intensification. At the time of the bay window failure and mayday call, the fire size is ranging between 40 and 60 MW.

In the no wind scenario, the fire in the basement sees brief periods of modest growth followed by decay. The fire never exceeds 1 MW in size. While there is significant uncertainty in predicting fire spread with FDS, these results indicate that wind was a significant factor in the events that day.

In the flow path control scenario, results are similar to the no wind scenario. Near 600 s, the fire in the basement does undergo a period of rapid growth bringing the fire size up to 4 MW before decaying back down. A 4 MW fire requires only a couple of hundred CFM of air to be sustained. This is not an unreasonable amount of air to be forced in under the pressure of sustained 20+ mph winds, given the building's age and construction. The spike in fire size, while large, is only 10 % of the peak for the actual scenario. This again indicates that wind was a primary factor in the events of the day; however, maintaining control of the upwind flow paths would have reduced fire growth and provided a significant increase in safety for firefighters performing search and suppression activities inside the home.

Figure 19: Heat release rates of the three FDS models. Top – full view of all scenarios. Bottom – zoomed view to visualize peak HRR for no wind and flow path control scenarios.

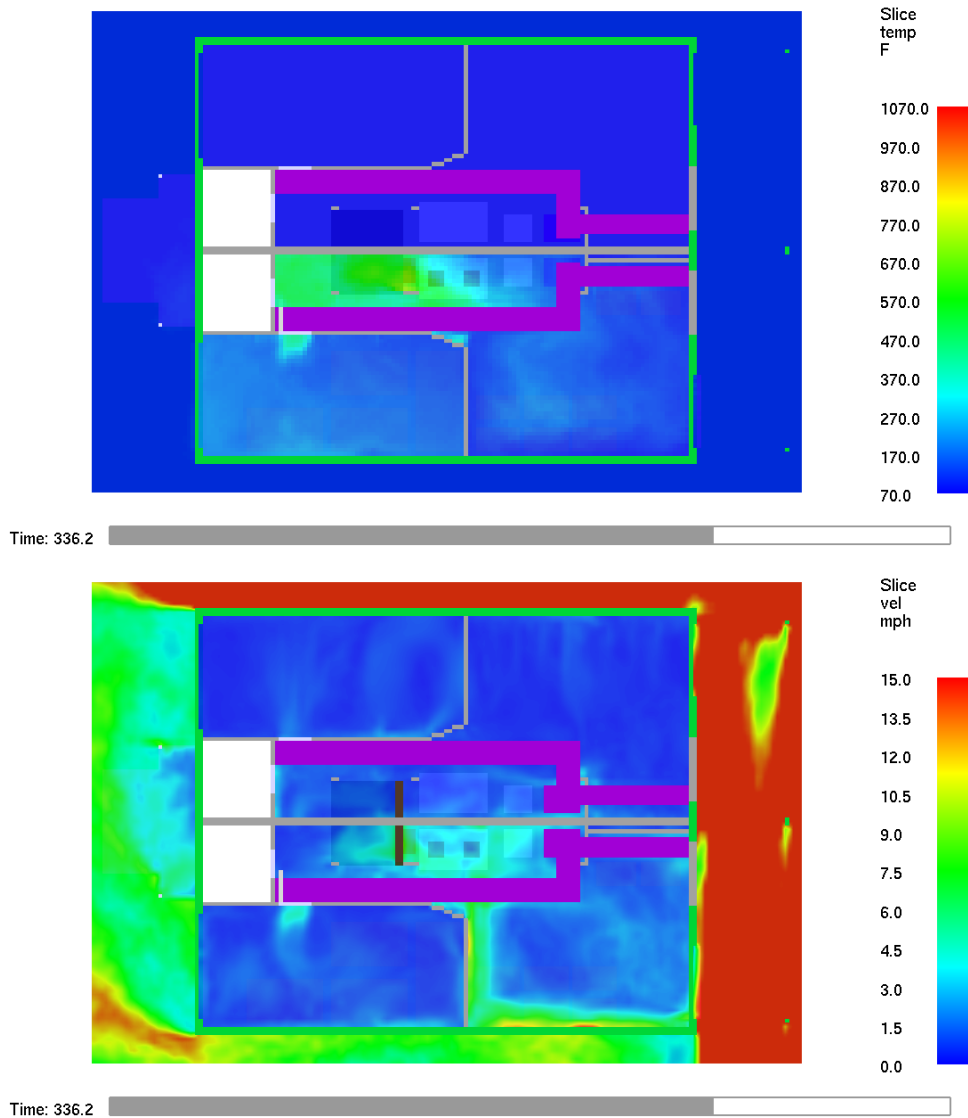
As the dining window is being vented conditions in the basement are not very severe (Figure 20). Heat is rising up the stairwell and venting into the first floor via the unlatched basement door. Temperatures in the garage and in the back room of the basement are below 300 °F. At those temperatures little to no thermal damage would be expected. The flow field shows a significant amount of air is entering the basement from the open slider. Wind is impinging at an angle (at the upper right corner of the Fire Building), and this can be seen as the flow entering the basement is pushed towards the downwind walls.

Figure 20: Temperature (top) and velocity (bottom) at 6 ft above the basement floor at 14:09:36 (as the dining window is being vented).

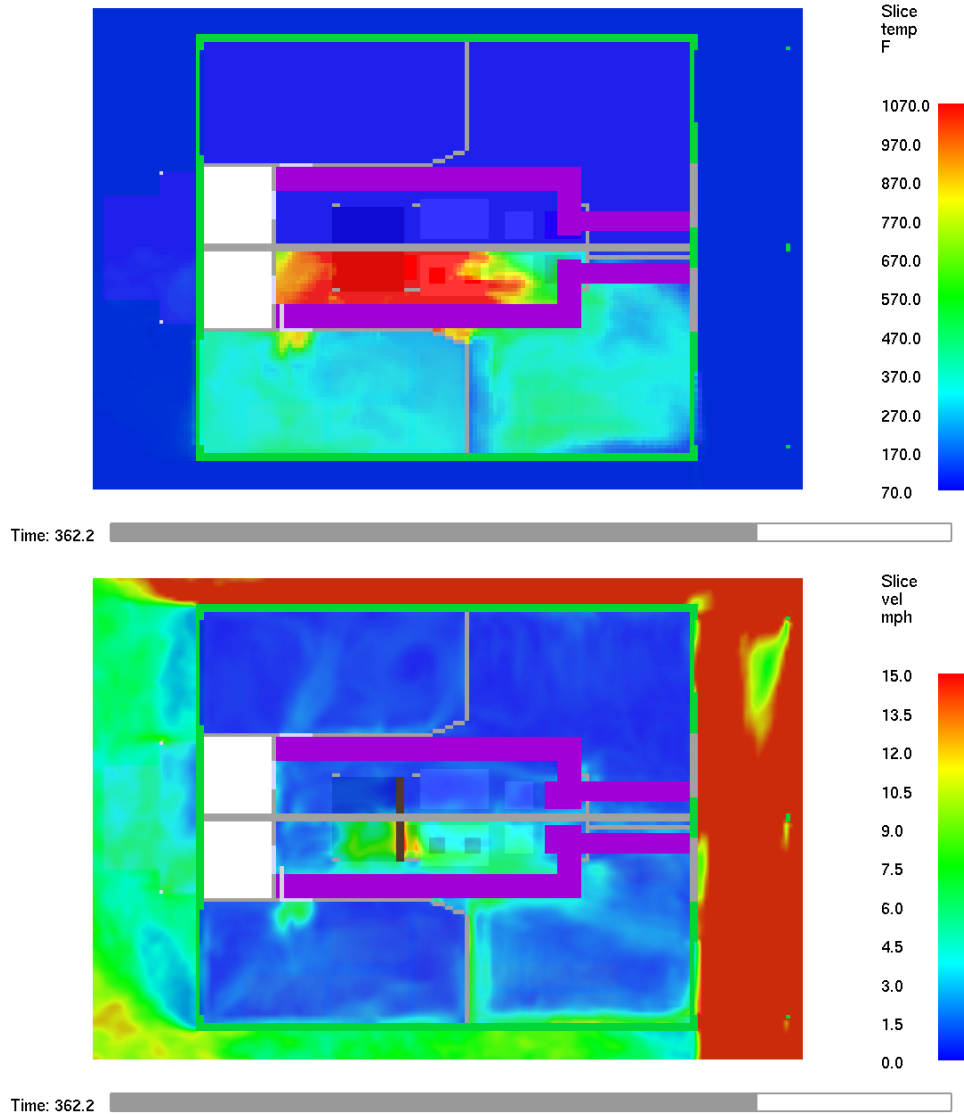
After the dining window is vented, the fire starts growing. As the basement door opens shows that the stairwell is filling with hot gasses in excess of 1000 °F (Figure 21). Temperatures in the garage are reaching 300 to 330 °F along the back wall of the garage. At these temperatures, softening of plastics would be expected but not active combustion. The front half of the back room is reaching temperatures of 400 to 525 °F at 6 ft. These temperatures are in the range where pyrolysis of wood begins to occur in earnest. Temperatures at the ceiling will be hotter than at 6 ft. This is consistent with the observations of charred joists. Velocities entering the basement show a similar pattern to

the prior image. Higher velocities are seen in the stairwell reflecting the increased flow up the stairs resulting from opening door.

Figure 21: Temperature (top) and velocity (bottom) at 6 ft above the basement floor at 14:10:22 (as the basement stair door opens).

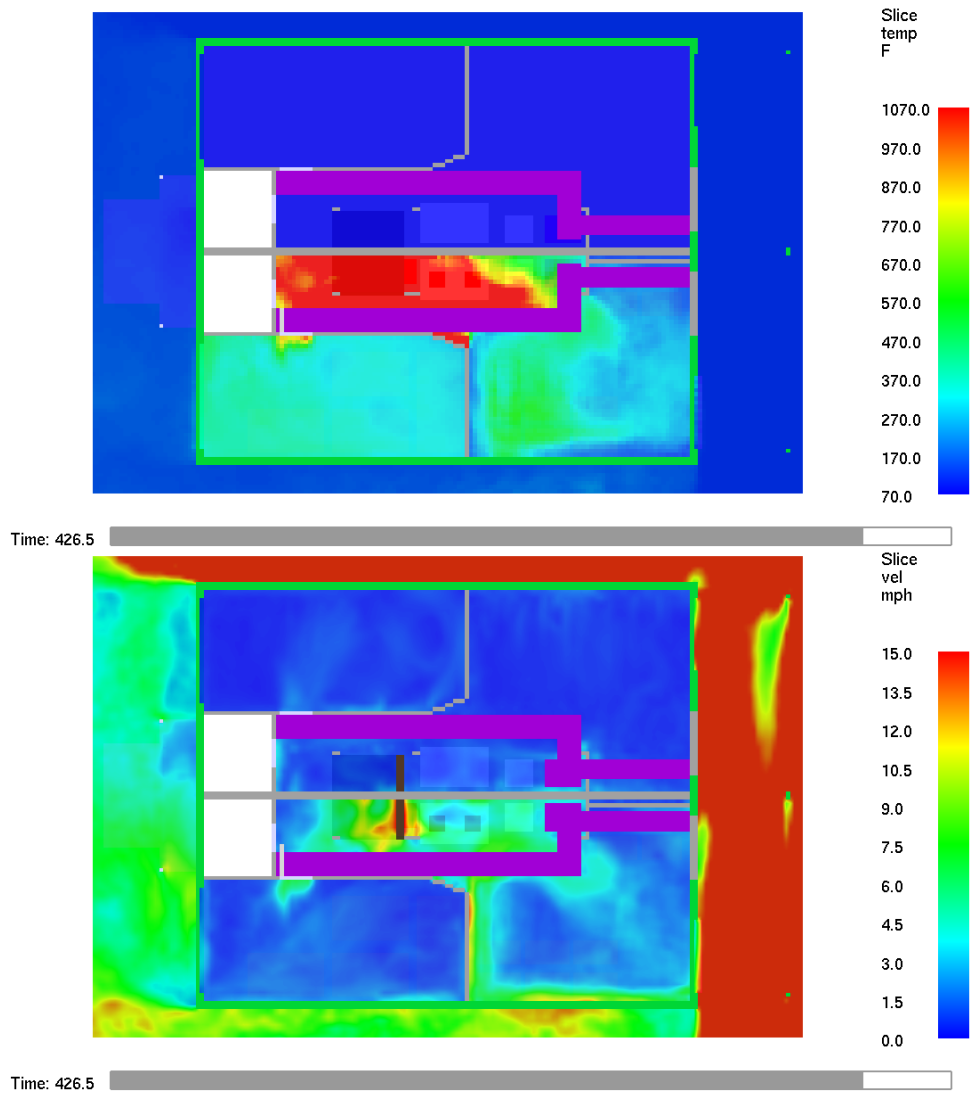
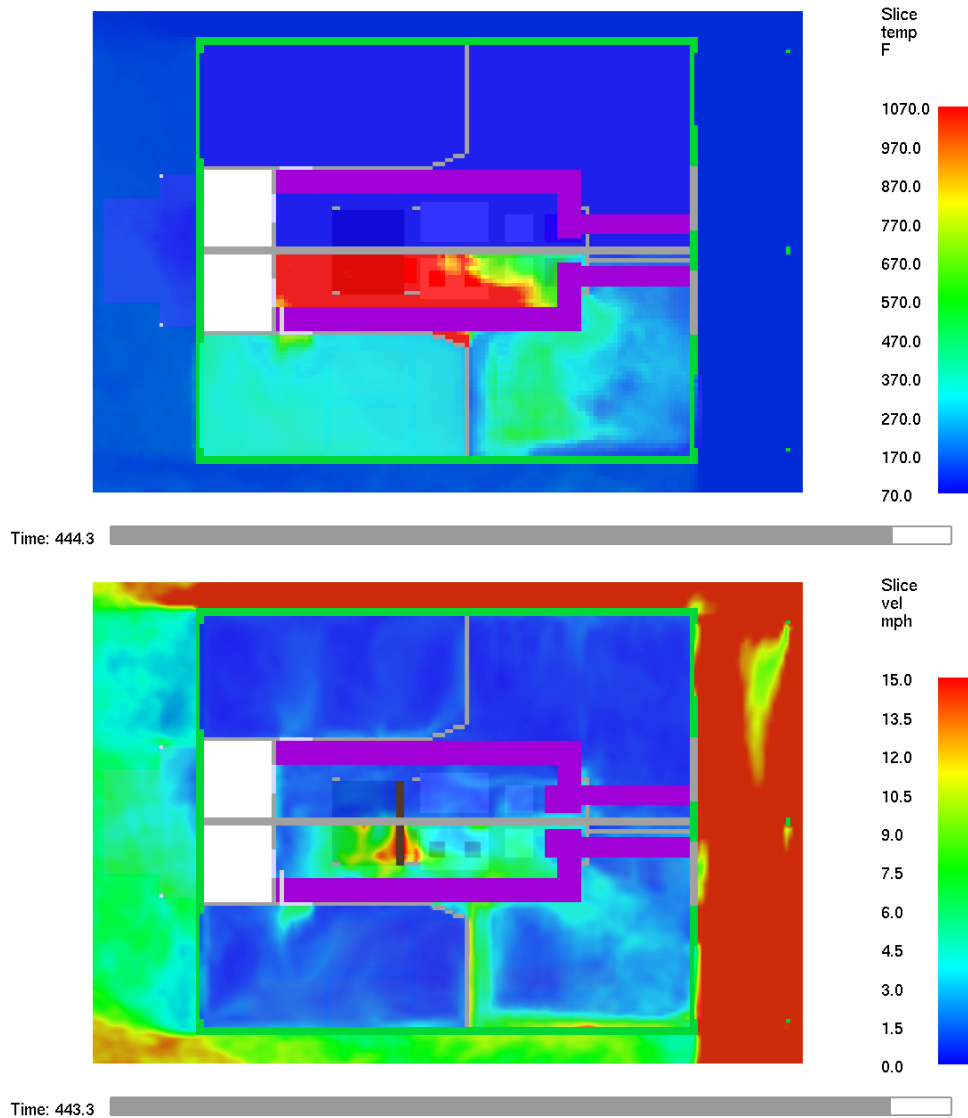
As the basement fire continues its rapid growth through the mayday call conditions in the basement do not significantly change (Figure 22 and Figure 23). The garage temperatures increase slightly; however, most of the heat is venting upwards into the first floor with the basement temperatures being moderated by cool air flowing in through the slider.

Figure 22: Temperature (top) and velocity (bottom) at 6 ft above the basement floor at 14:10:22 (as fire was seen venting from the dining window).

Figure 23: Temperature (top) and velocity (bottom) at 6 ft above the basement floor at 14:11:15 (as the mayday is called).

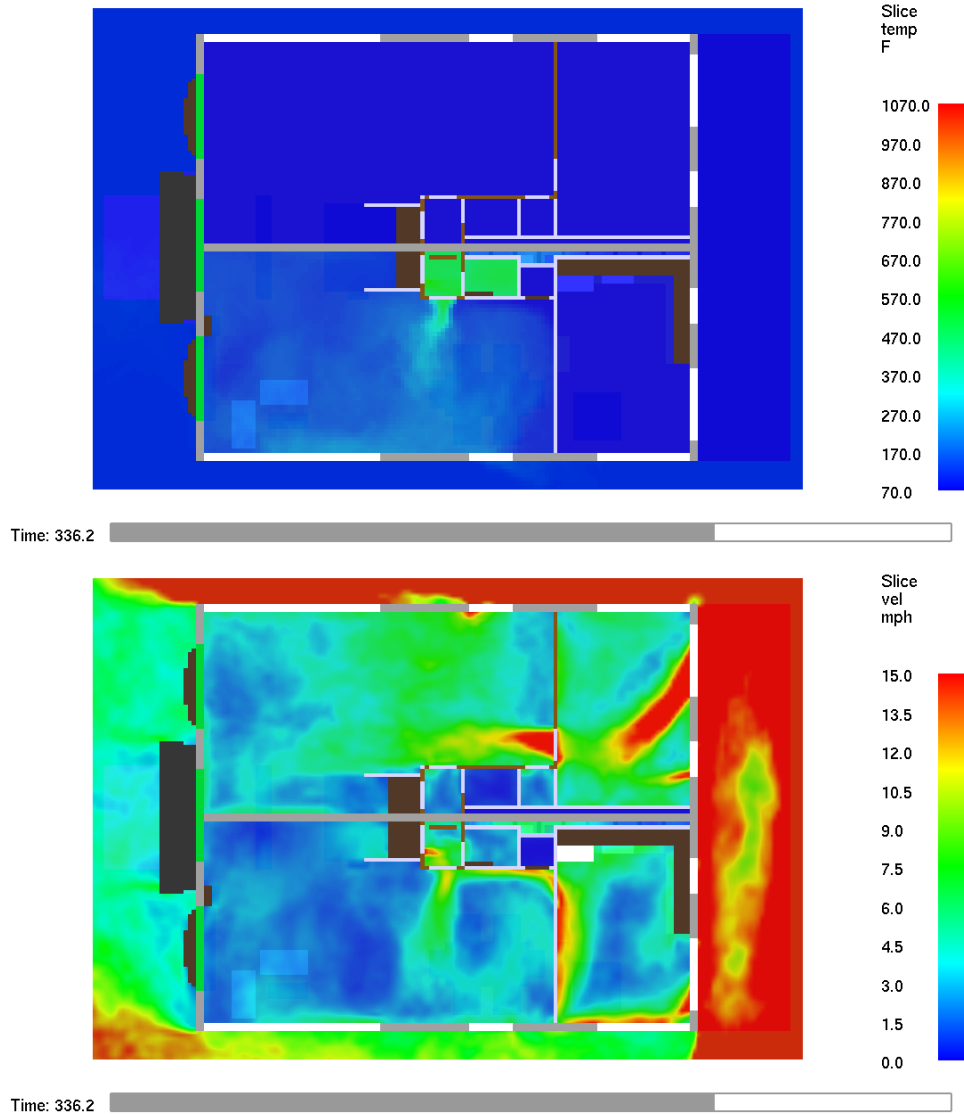
At the time the dining window is being vented, temperatures are over 500 °F in the landing for the staircase and in the half bathroom. Heat venting up from the basement is trapped by the archway leading from the dining area to the stairs. While some heat is spilling into the first floor, temperatures in most of the first floor are below 200 °F. A similar flow field is seen in the kitchen

with air moving along the downwind walls and then through the archway into the dining area. At this point conditions in the kitchen are still at ambient.

Figure 24: Temperature (top) and velocity (bottom) at 6 ft above the first floor at 14:09:36 (as the dining window is being vented).

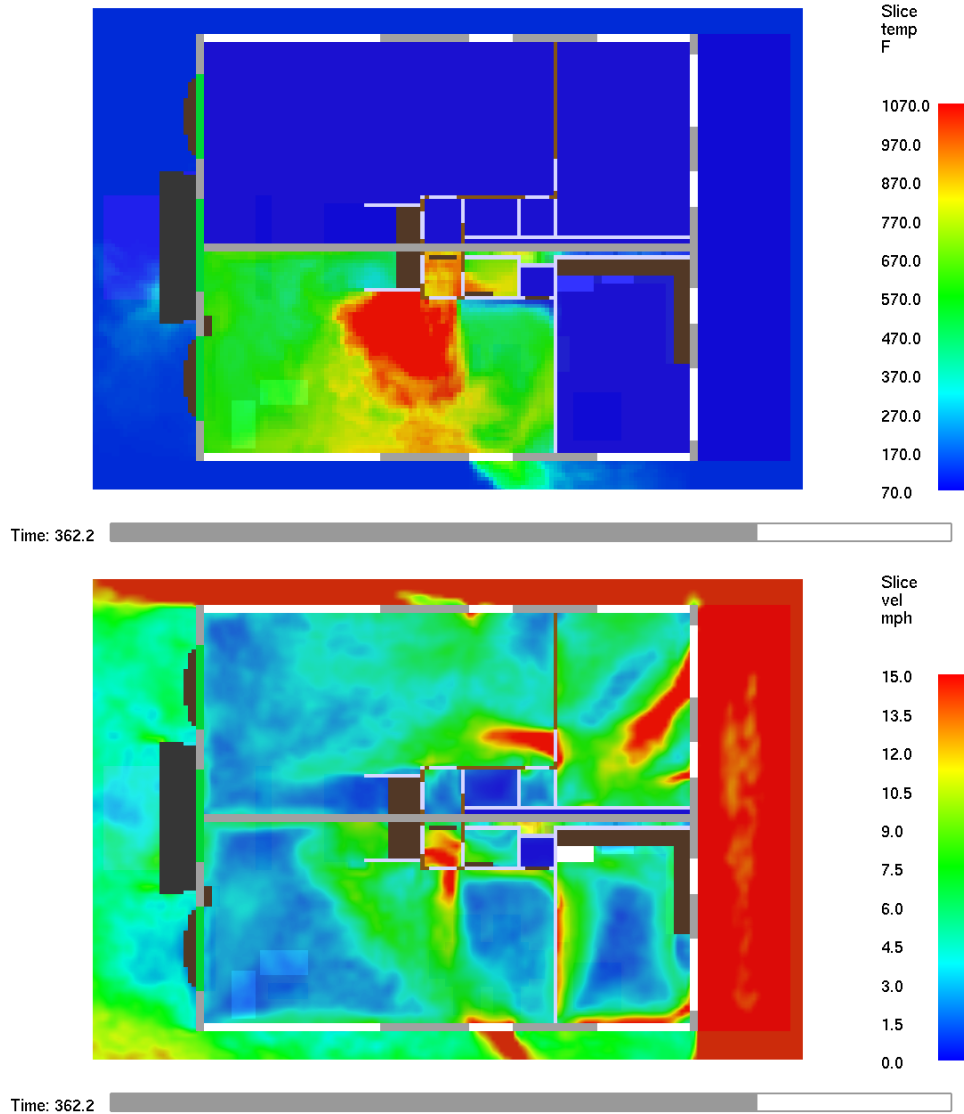
As the fire grows post venting of the dining window, high temperature outflow increases into the first floor. As the door is opened to the basement, there is a region of the first floor with temperatures in excess of 1000 °F with the entire floor (except for the kitchen) reaching temperature over 500 °F at 6 ft. The velocity image shows the large increase in outflow as the fire begins its period of rapid growth. Kitchen flows are similar, however, there is now an increase in

the recirculating flow in the kitchen as the increased pressure on the dining side from the basement fire acts to limit flow in from the kitchen. Kitchen conditions are still near ambient but some flow into the kitchen is beginning to occur. Flows of 6 to 9 mph are seen in the stairs to the second floor.

Figure 25: Temperature (top) and velocity (bottom) at 6 ft above the first floor at 14:10:02 (as the basement stair door opens).

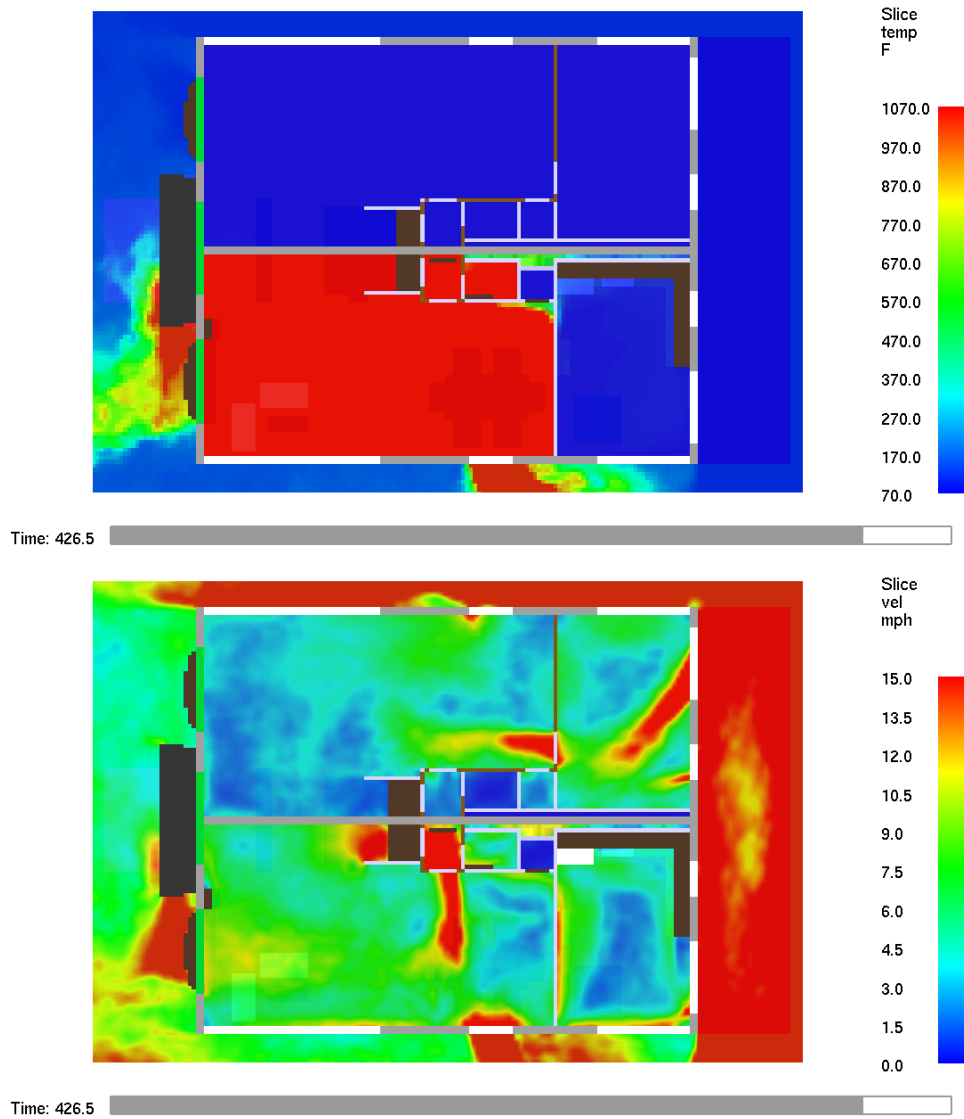
One minute later, the entire first floor outside of the kitchen is seeing temperature over 1000 °F with 1000 °F outflow from the front door and dining window (Figure 26). These temperatures are hot enough to support ignition of any unburned fuel leaving the structure and ignition of many materials in the first floor. Flows up into the second floor now exceed 15 mph, and a strong jet

Figure 26: Temperature (top) and velocity (bottom) at 6 ft above the first floor at 14:10:22 (as fire was seen venting from the dining window).

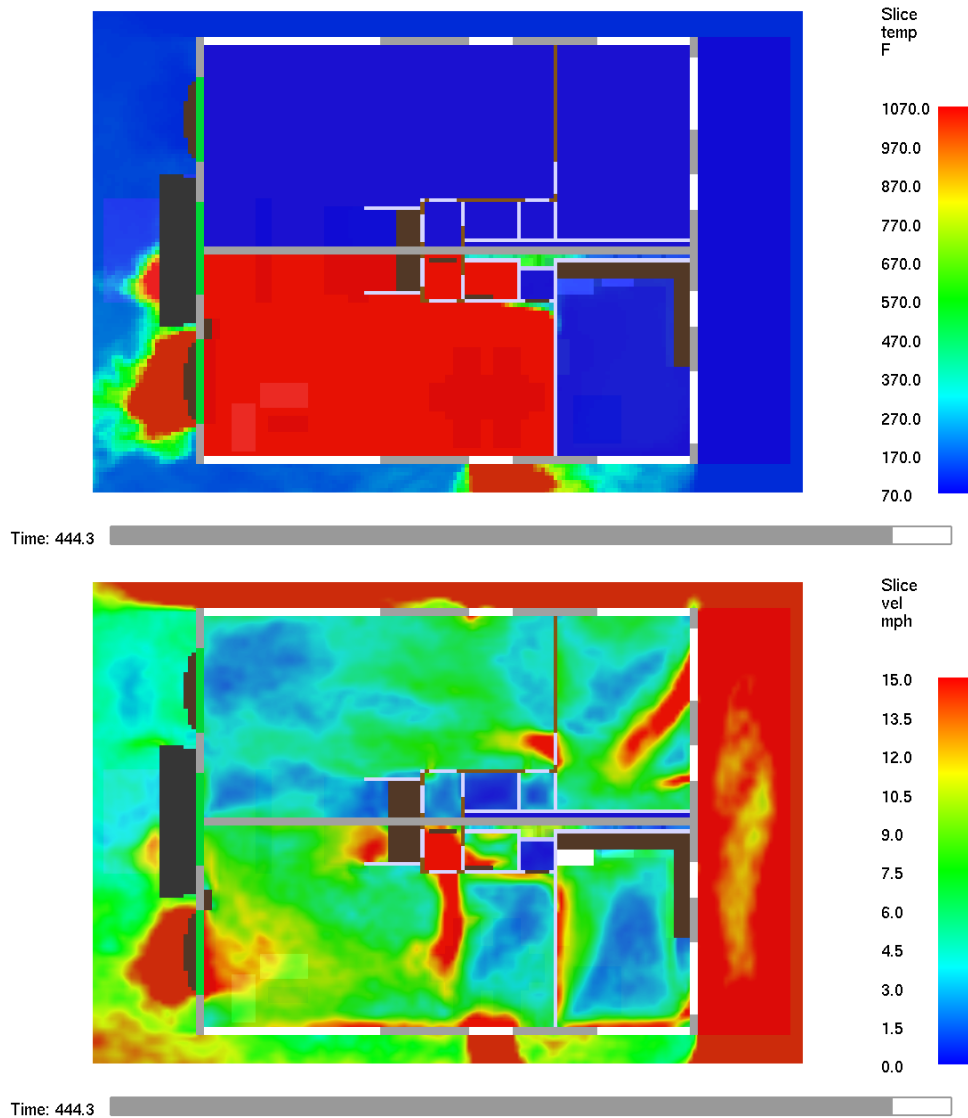
stretches from the basement doors to the dining window. Once the bay window breaks, strong outflow of high temperature gas occurs in the bay window (Figure 27). During this time conditions at the kitchen archway are over 400 °F with 200 °F temperatures near the refrigerator and freezer. The remainder of the kitchen is below 100 °F. This region of high temperature at the archway is consistent with the damage.

Figure 27: Temperature (top) and velocity (bottom) at 6 ft above the first floor at 14:11:15 (as the mayday is called).

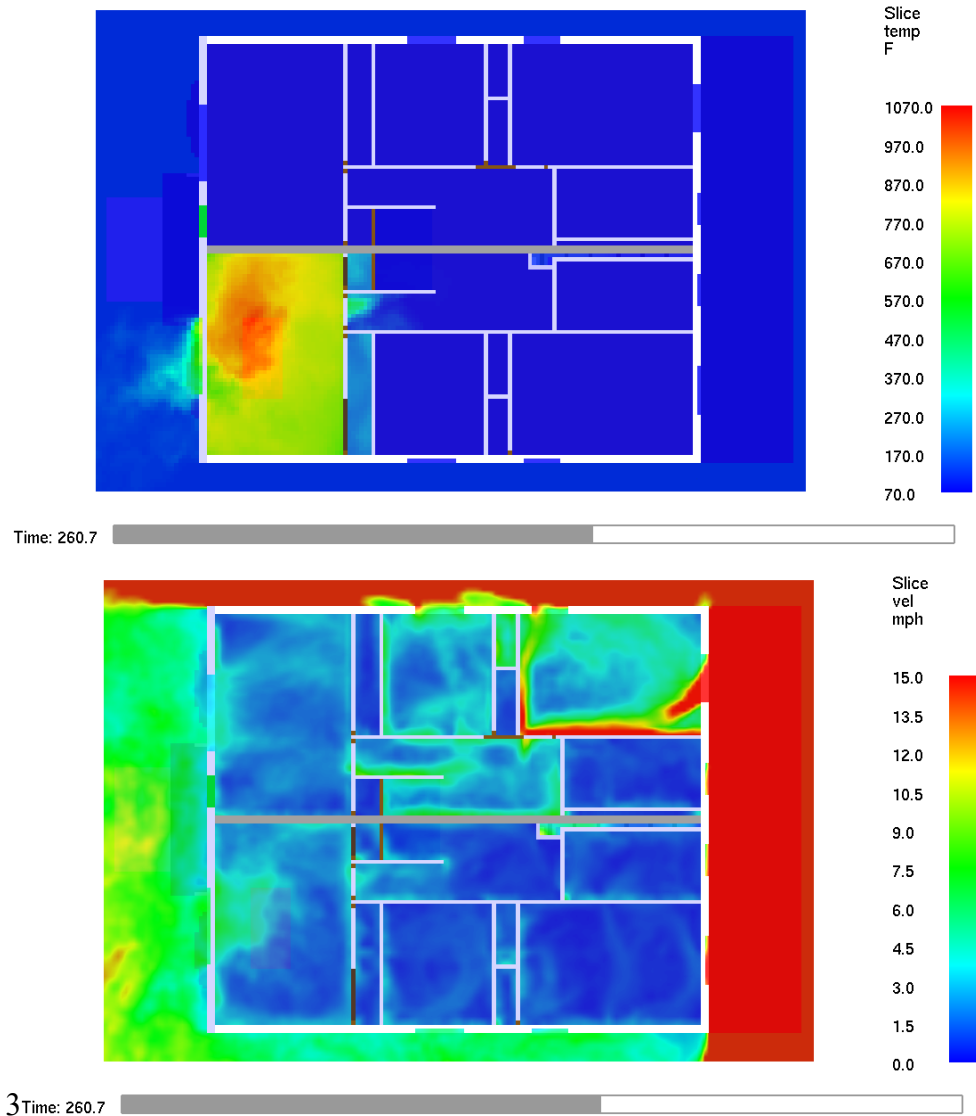
As the door is opened to fight the fire in the front bedroom, the front bedroom shows post-flashover temperatures with the remainder of the second floor at ambient (Figure 28). The velocity image shows only slight flows on the second floor, largely a result of leakage from the rear to the front

due to the pressure loading of the wind. Up flow can be seen in the void space leading from the basement.

Figure 28: Temperature (top) and velocity (bottom) at 6 ft above the second floor at 14:08:20 (as the front bedroom door is opened for suppression).

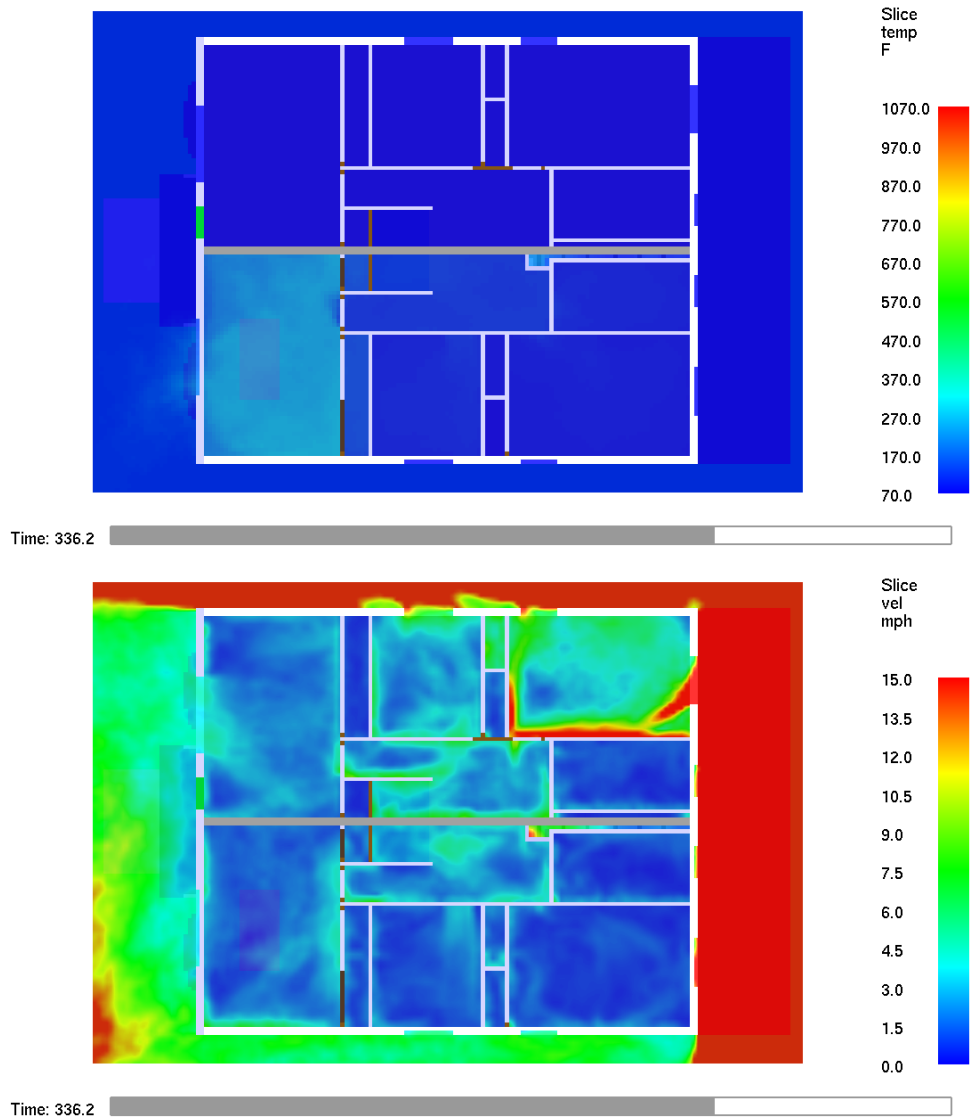
As the dining room window is vented and the fire in the basement has begun growth, conditions are still near ambient on the second floor (Figure 29); however, stronger up flow is beginning in the staircase. Up flow in the void space is also increasing. Up flow and temperatures continue increasing as the basement stair door opens.

Figure 29: Temperature (top) and velocity (bottom) at 6 ft above the second floor at 14:09:36 (as the dining window is being vented).

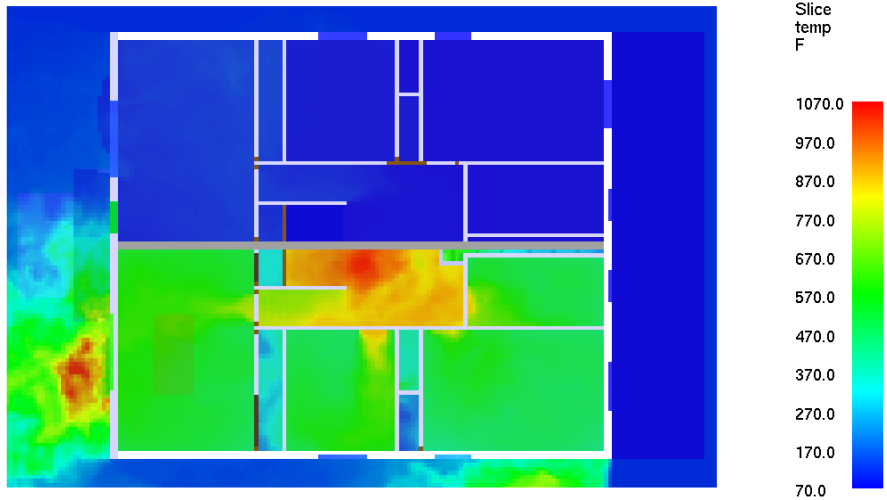
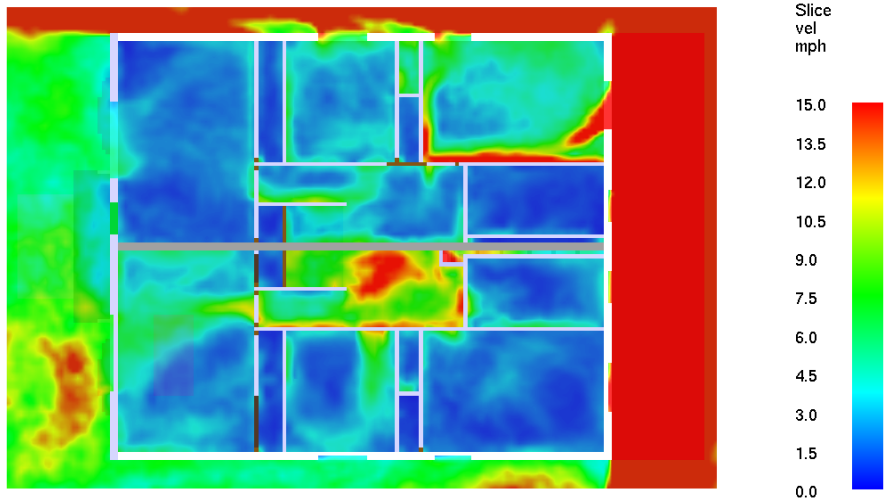
By the time flames are seen in the dining window, temperatures at the second floor landing and in the hallway have exceeded 800 °F. Flow up the staircase exceeds 15 mph and flows in excess of 6 to mph move down the hallway towards the front bedroom. The combination of high temperature and the flow rate would result in high rates of heat transfer to turnout gear. At the mayday call, temperatures in much of the landing and hallway are over 900 °F with high rates of outflow still occurring through the hallway.

Figure 31: Temperature (top) and velocity (bottom) at 6 ft above the second floor at 14:10:22 (as fire was seen venting from the dining window).

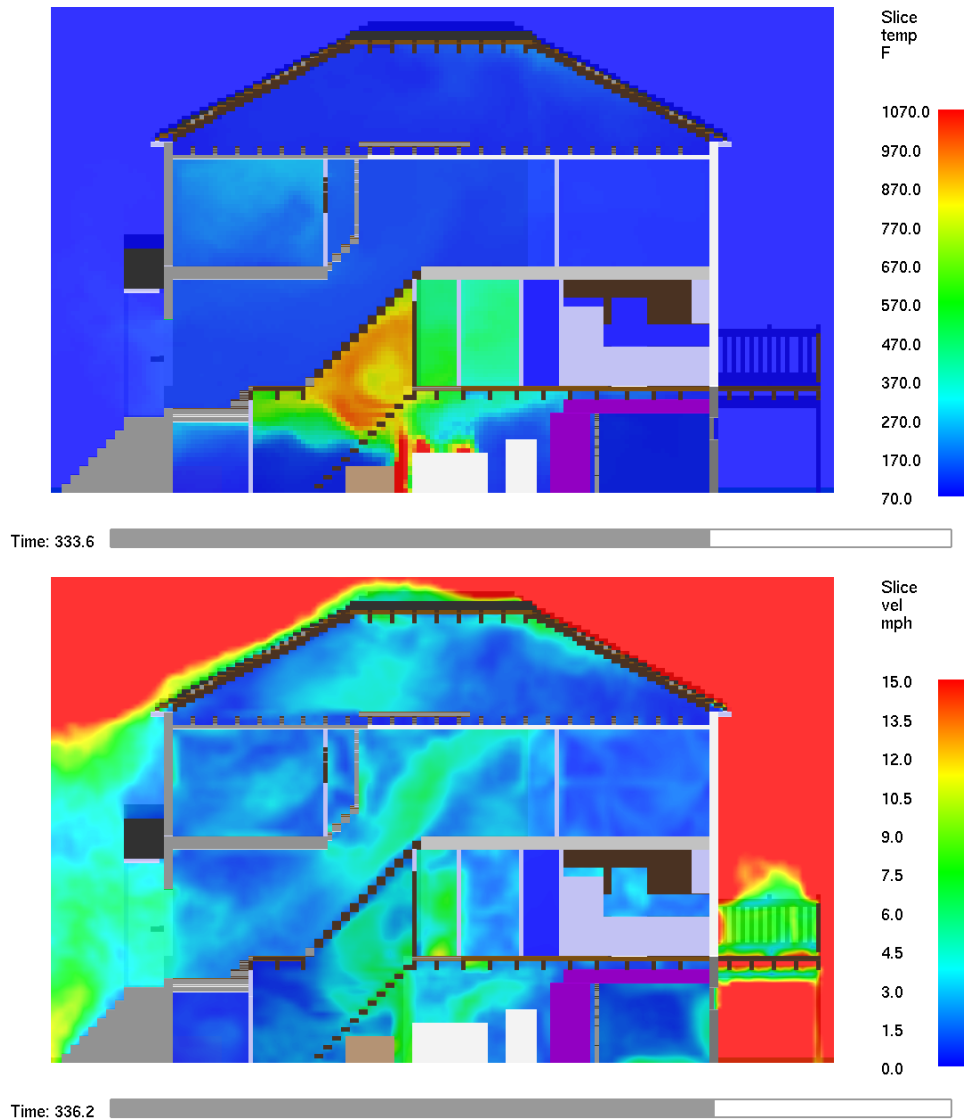
As the dining room window is vented and the fire in the basement has begun to grow gases at temperatures of 800 °F and higher begin collecting in the upper portion of the staircase, heating the wood walls and staircase door (Figure 33). Conditions are still near ambient on the second

floor; however, there is up flow in the staircase resulting from venting from the first floor out the open front bedroom door and window.

Figure 33: Temperature (top) and velocity (bottom) at the staircase at 14:09:36 (as the dining window is being vented).

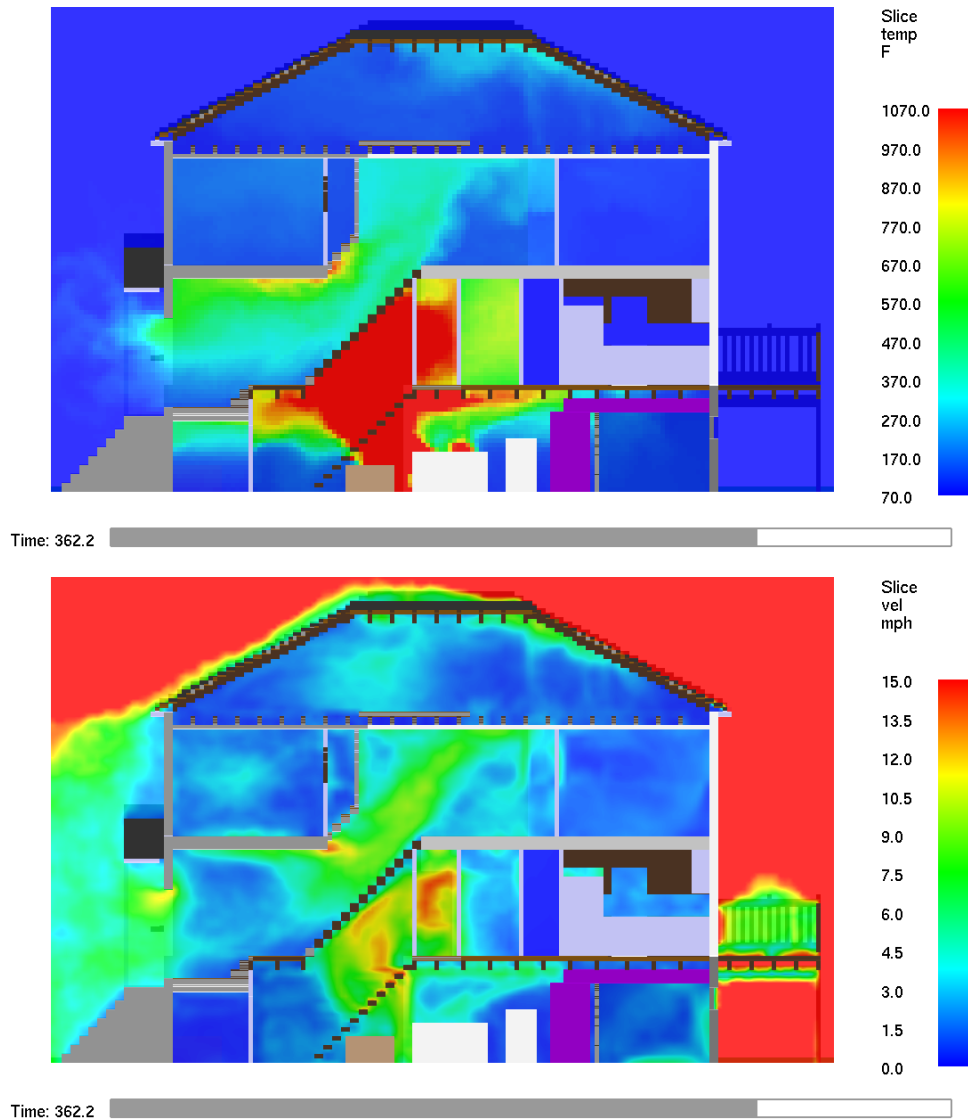
As the basement stair is opening, flame temperatures fill the basement staircase and first floor landing and extend along the ceiling towards the back room of the basement (Figure 34). High temperature gasses are beginning to collect on the first floor ceiling. Flows up to the second floor have doubled in speed. The effect of the deep soffit for the front door can be seen in the deep layer forming between the door and the stairs.

Figure 34: Temperature (top) and velocity (bottom) at the staircase at 14:10:02 (as the basement stair door opens).

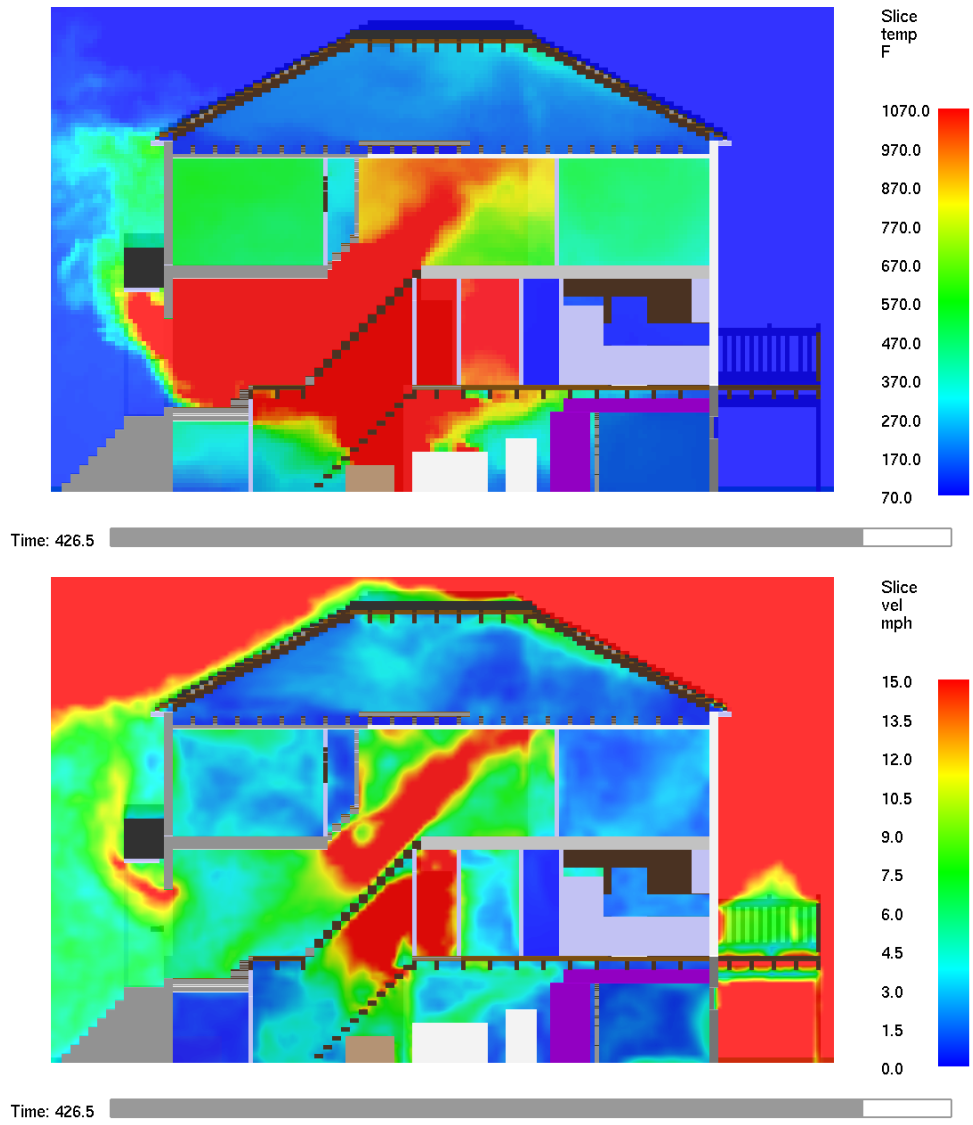
As fire is seen venting out the dining window, the first floor is filled from floor to ceiling with temperatures in excess of 900 °F (Figure 35). Flow up the stairs has nearly doubled again. A very high temperature layer is forming on the second floor with over 900 °F temperatures at the ceiling and over 600 °F temperatures at the floor. By the time the mayday is called, temperatures near 900 °F exist down to the floor of the second floor with strong outflow continuing.

Figure 35: Temperature (top) and velocity (bottom) at the staircase at 14:10:22 (as fire was seen venting from the dining window).
