FIRE DEPARTMENT CITY OF NEW YORK

INVESTIGATIVE REPORT

10826 AVENUE N, BROOKLYN, NY

FATAL INJURY

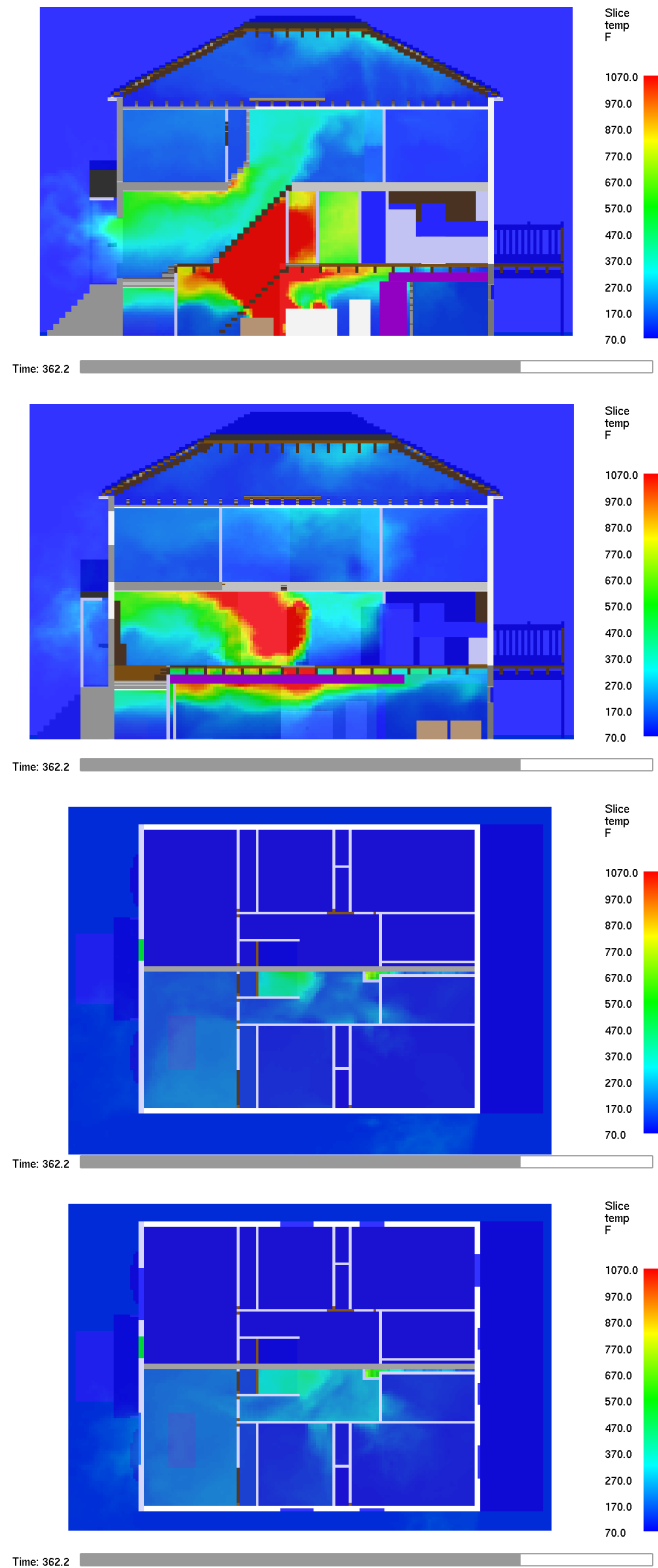
Figure 37 shows conditions as fire is coming up the basement stairs into the dining area. Flow up the stairs is just beginning to show extreme temperatures entering the stairs at the first floor landing. Conditions upstairs are near 200 °F in the hallway and in the front bedroom. The latter is

mostly due to residual heat from the recently suppressed fire in the front bedroom. The rear bedroom and bathroom are near ambient except for 200 °F temperatures near the doors.

Figure 37: Temperature at the staircase at 14:10:02 (as the basement stair door opens). Top – side view through stairs. Top/Middle – side view through hallway. Bottom/Middle – 3 ft above the second floor. Bottom – 6 ft above the second floor.

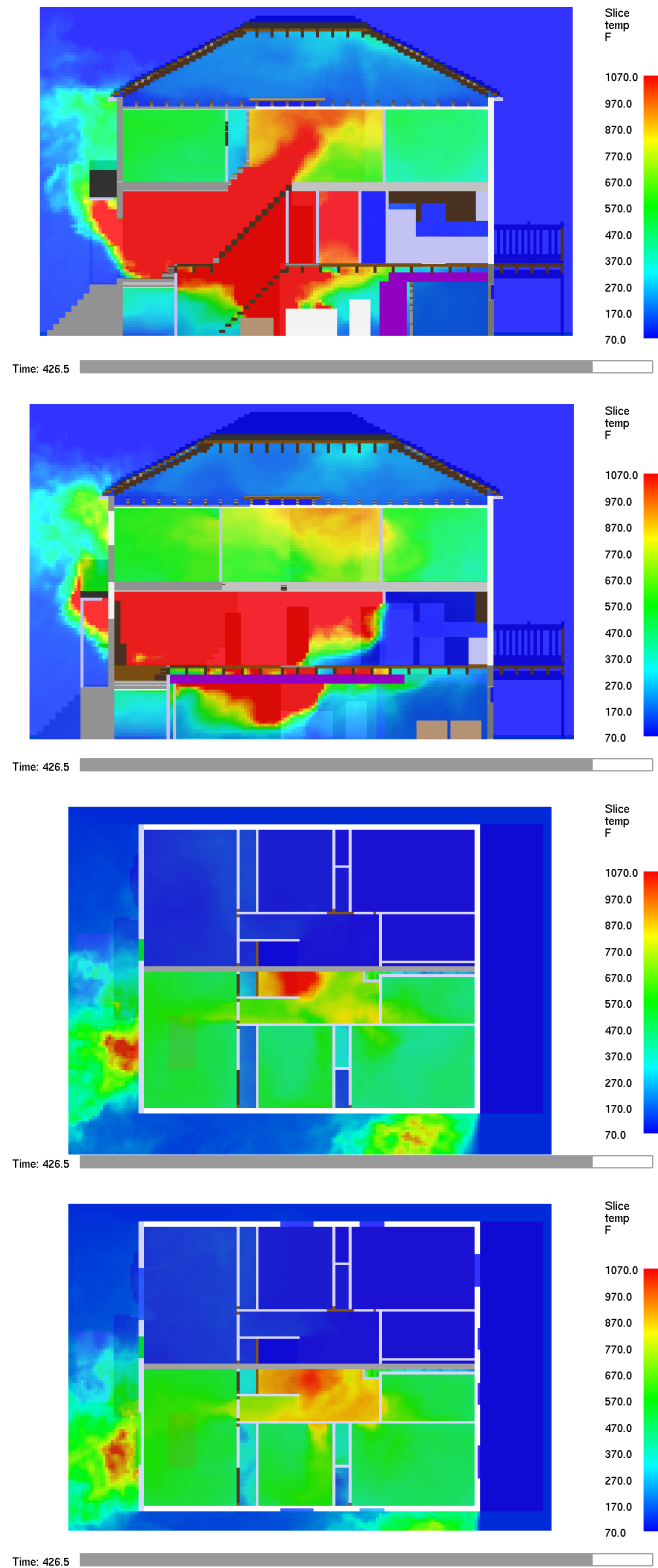
Figure 38 shows conditions one minute later as fire begins to vent out the dining window. Extreme temperatures fill the staircase to the second floor. Temperatures at the stair landing and in the hallway near the bathroom door are 800 °F to 900 °F at 6 ft. Temperatures at the same height in the front bedroom are 500 °F to 600 °F. In the rear bedroom and bathroom, they are 50 °F lower. At 3 ft above the floor hall temperatures are 100 °F lower than 6 ft, and in the rear bedroom and bathroom they are 50 °F lower than at 6 ft. Conditions do not change significantly as members seek refuge in the rear rooms (Figure 39).

Figure 38: Temperature at 14:10:22 (as fire was seen venting from the dining window). Top – side view through stairs. Top/Middle – side view through hallway. Bottom/Middle – 3 ft above the second floor. Bottom – 6 ft above the second floor.

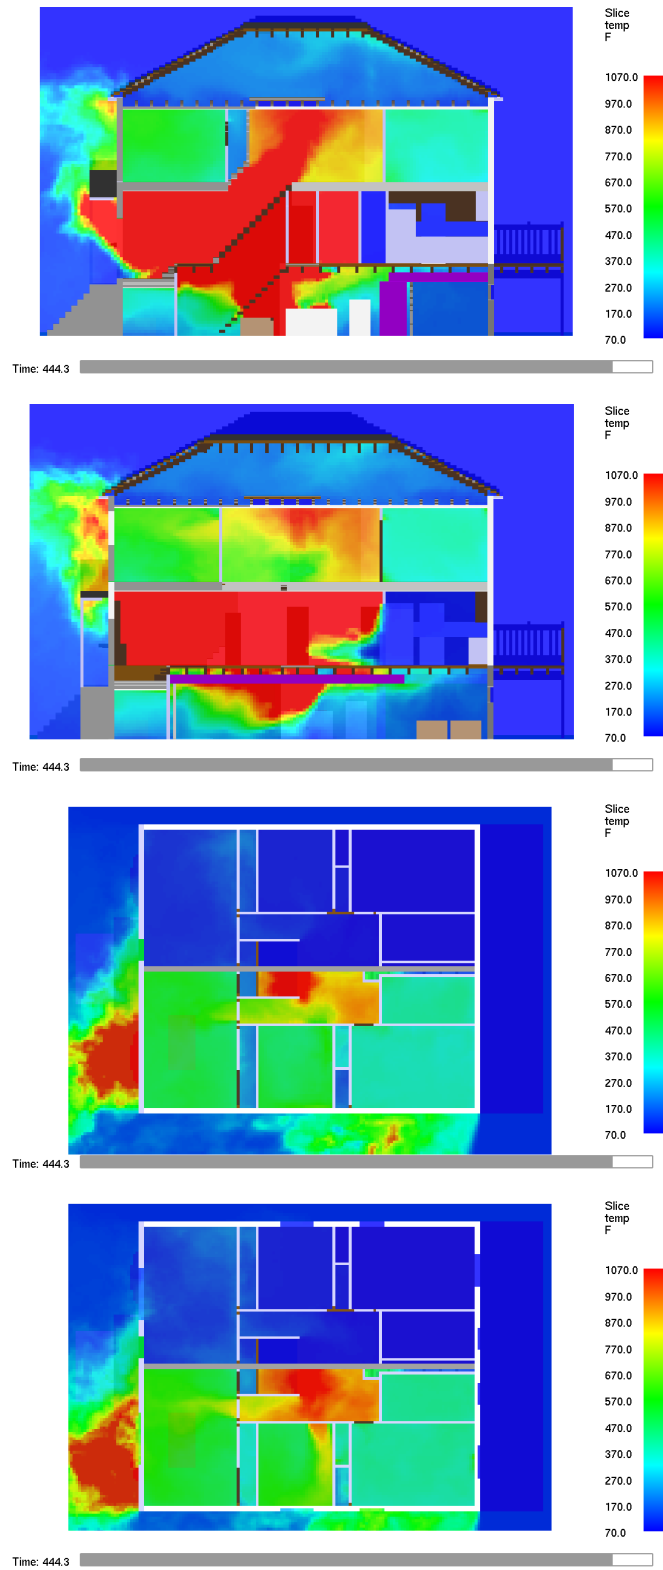
As the mayday is being called, conditions have worsened on the second floor outside the bathroom and rear bedroom where members are taken refuge (Figure 40). In the rear bedroom and bathroom temperatures have dropped over this 10 s period to 300 to 400 °F. The walls and ceiling in the room have not had time to heat up. With the doors closed and no more heat entering, the gas is quickly cooling as heat is lost to cooler surfaces. Within 30 s of taking refuge temperatures drop further to 250 °F to 300 °F. The mass of air in the bedroom at 400 °F is near 50 lbs. equivalent in weight to a single sheet of drywall. The much larger mass of cooler drywall, plus additional cooling due to cooler air being forced into the room from leakage at the rear windows, was able to remove approximately 15 °F of gas heat for every 1 °F in temperature rise.

Figure 40: Temperature at the staircase as the mayday is called. Top – side view through stairs. Top/Middle – side view through hallway. Bottom/Middle – 3 ft above the second floor. Bottom – 6 ft above the second floor.

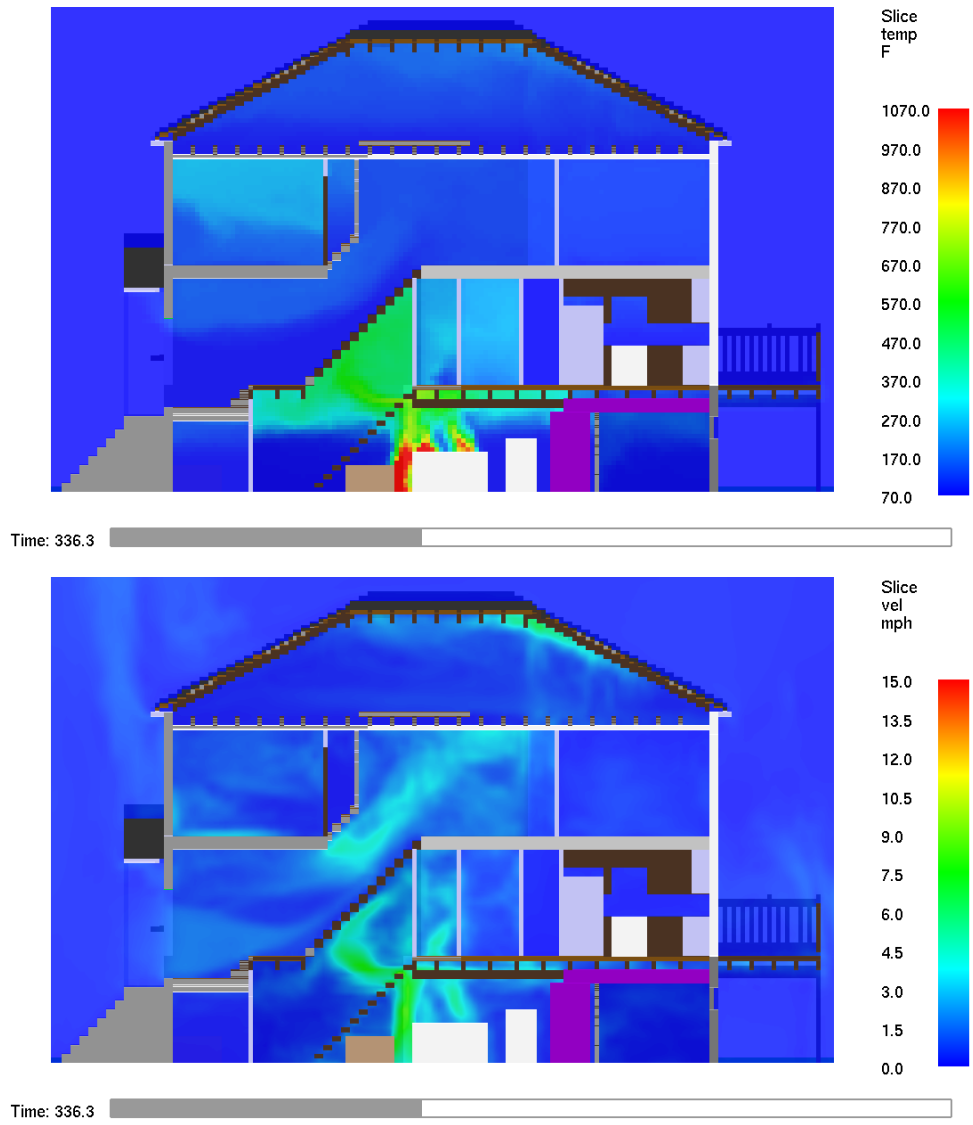
Figure 41 through Figure 45 show temperature and velocity at the staircase as the dining window was being vented, as the basement stair door opened, as fire was seen venting out the dining window, as the mayday was being called, and at simulation end for the alternate scenario with no wind. The simulation results show steady slow growth of the fire in the basement, but the fire never enters a period of rapid growth. While predicting fire growth and spread has large uncertainties, these results do show that with no wind conditions for fire spread were far less favorable than during the actual event. With no wind, flow in through the basement is limited to buoyant flow rather than the flow imposed by the pressure of 20+ mph winds. Without the higher flow from the wind, the small fires in the basement are not fanned by the wind enhancing the potential for rapid fire growth.

Figure 41: Temperature (top) and velocity (bottom) at the staircase at 14:09:36 (as the dining window is being vented).

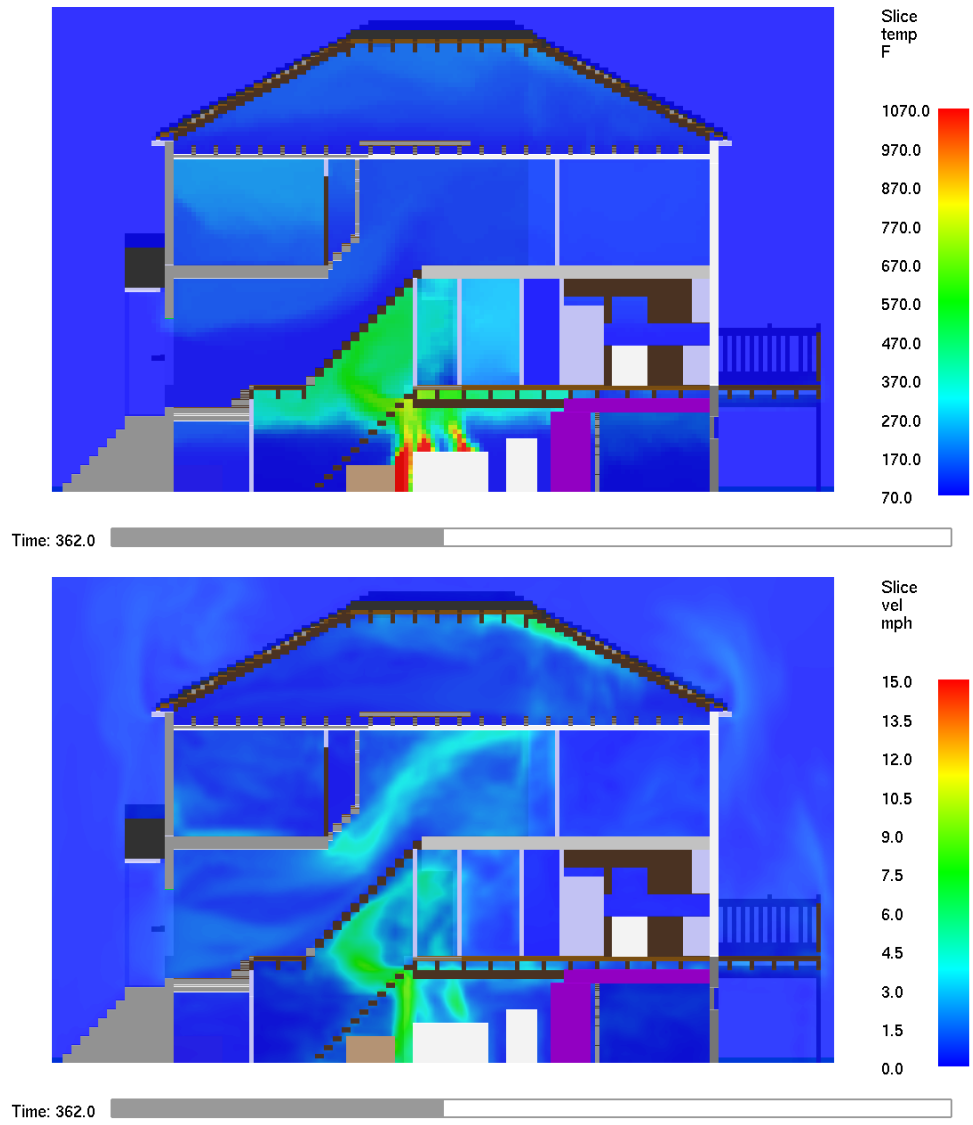
Figure 42: Temperature (top) and velocity (bottom) at the staircase at 14:10:20 (as the basement stair door opens).

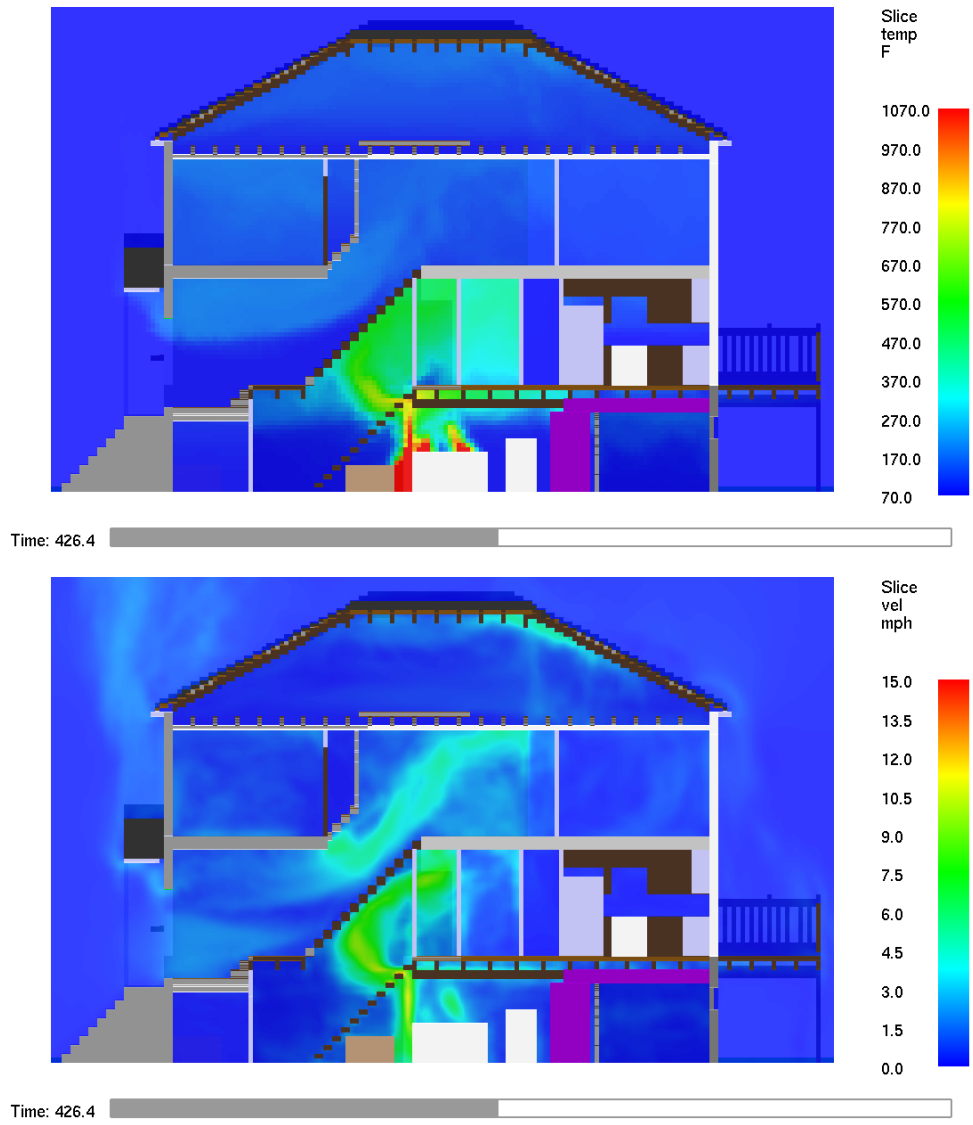
Figure 43: Temperature (top) and velocity (bottom) at 14:10:22 (as fire was seen venting from the dining window).

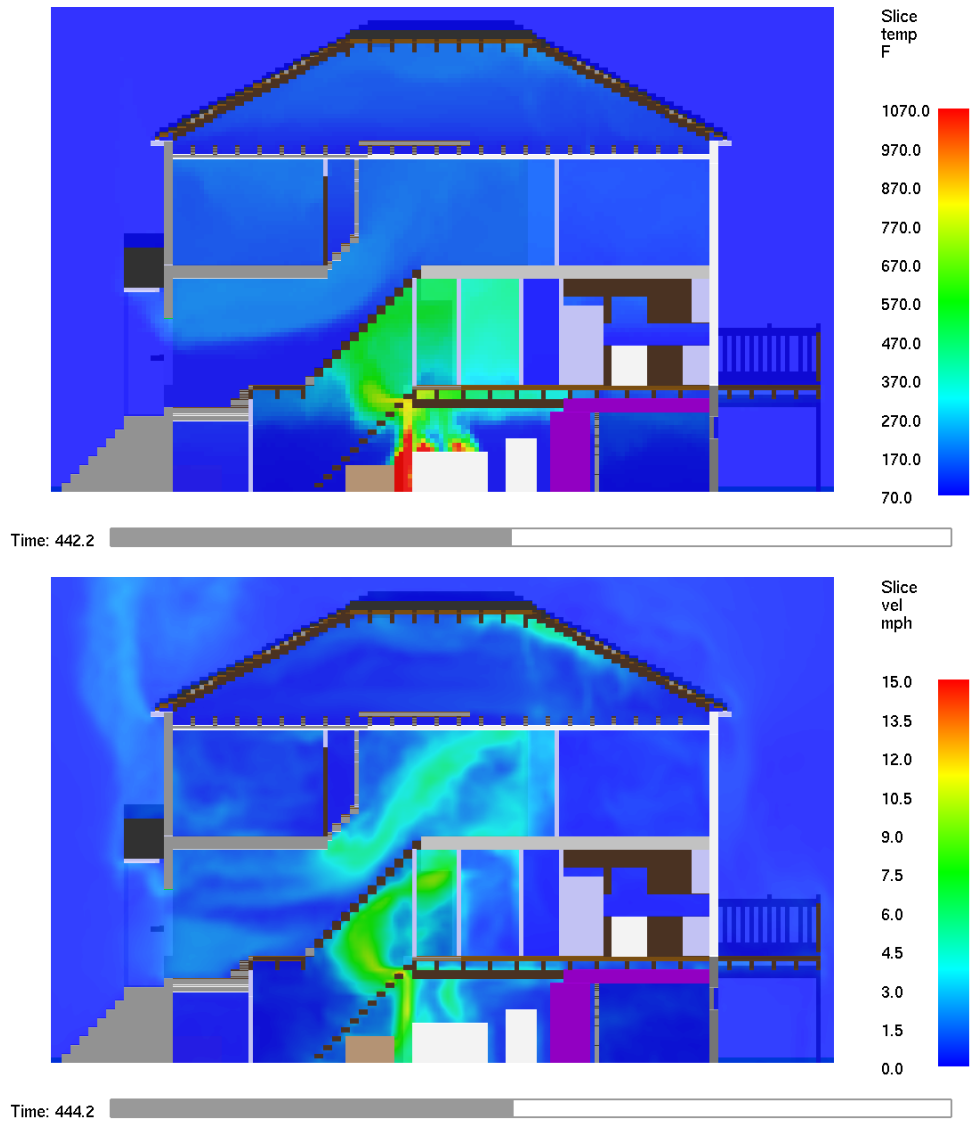
Figure 44: Temperature (top) and velocity (bottom) at 14:11:15 (as the mayday is called).

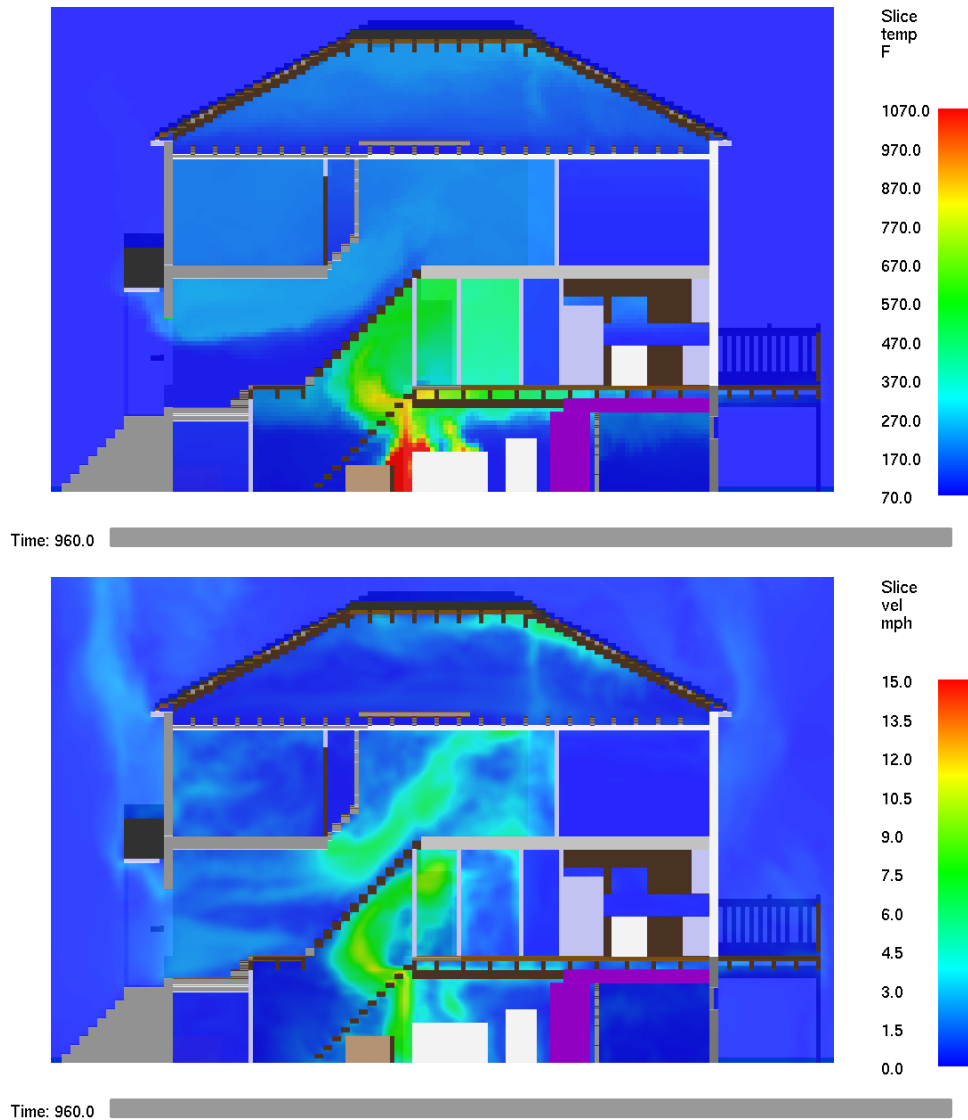
Figure 45: Temperature (top) and velocity (bottom) at simulation end.

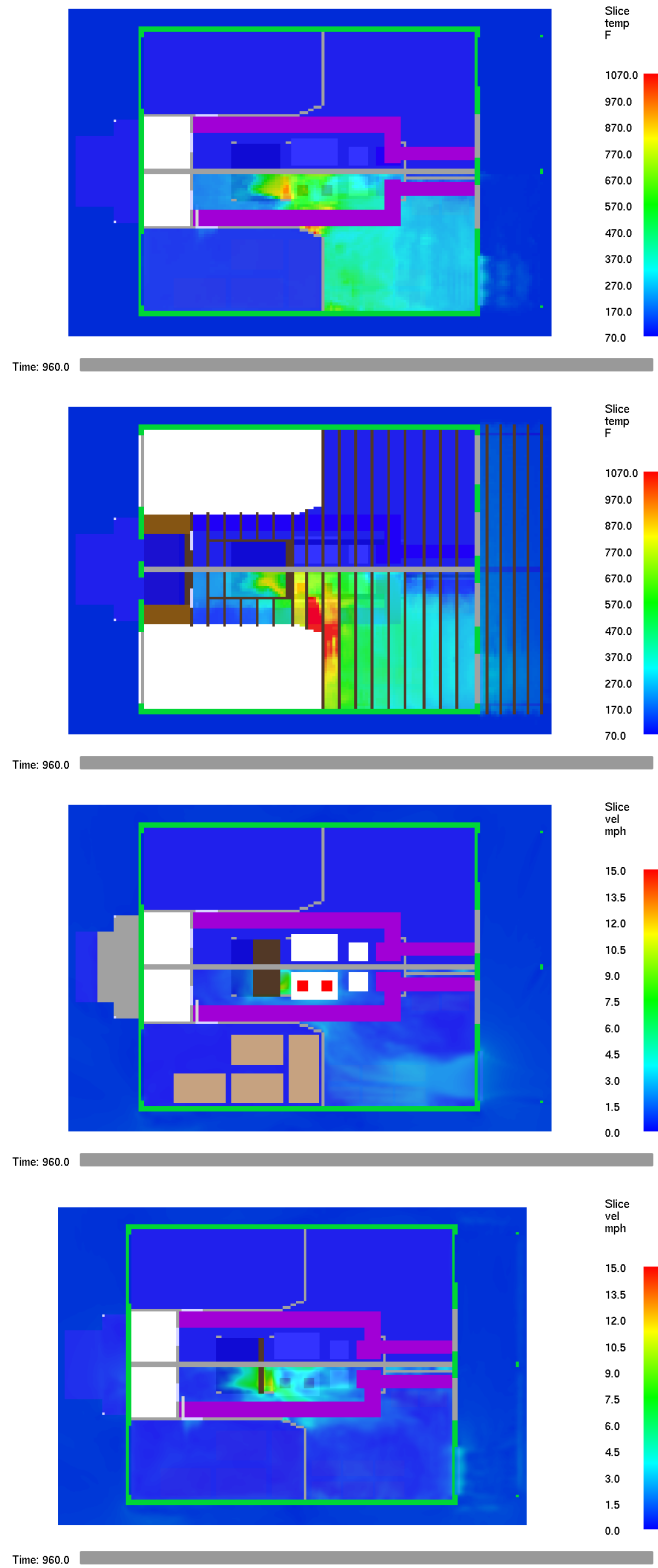
Figure 46 shows temperatures and velocities in the basement at the end of the simulation. The temperature slices are at 6 ft and 7 ft and the velocity at 3 ft and 6 ft. The temperature slices show that burning has started in the joists and on the bottom of the subfloor. Over time this would continue to spread and grow. Temperatures at 6 ft have reached 400 °F and further increase in temperature would lead to ignition of wood paneling on the walls. The velocity slices show bi-directional flow in the sliding glass door. At 3 ft air is entering at less than 5 mph. At 6 ft air is leaving at a similar speed. These low flow speeds are in contrast with the much higher flow speeds seen in the actual event with wind.

Figure 46: Basement temperature (Top – 6 ft, Top/Middle – 7 ft.) and velocity (Bottom/Middle – 3 ft, Bottom – 6 ft.) at simulation end.

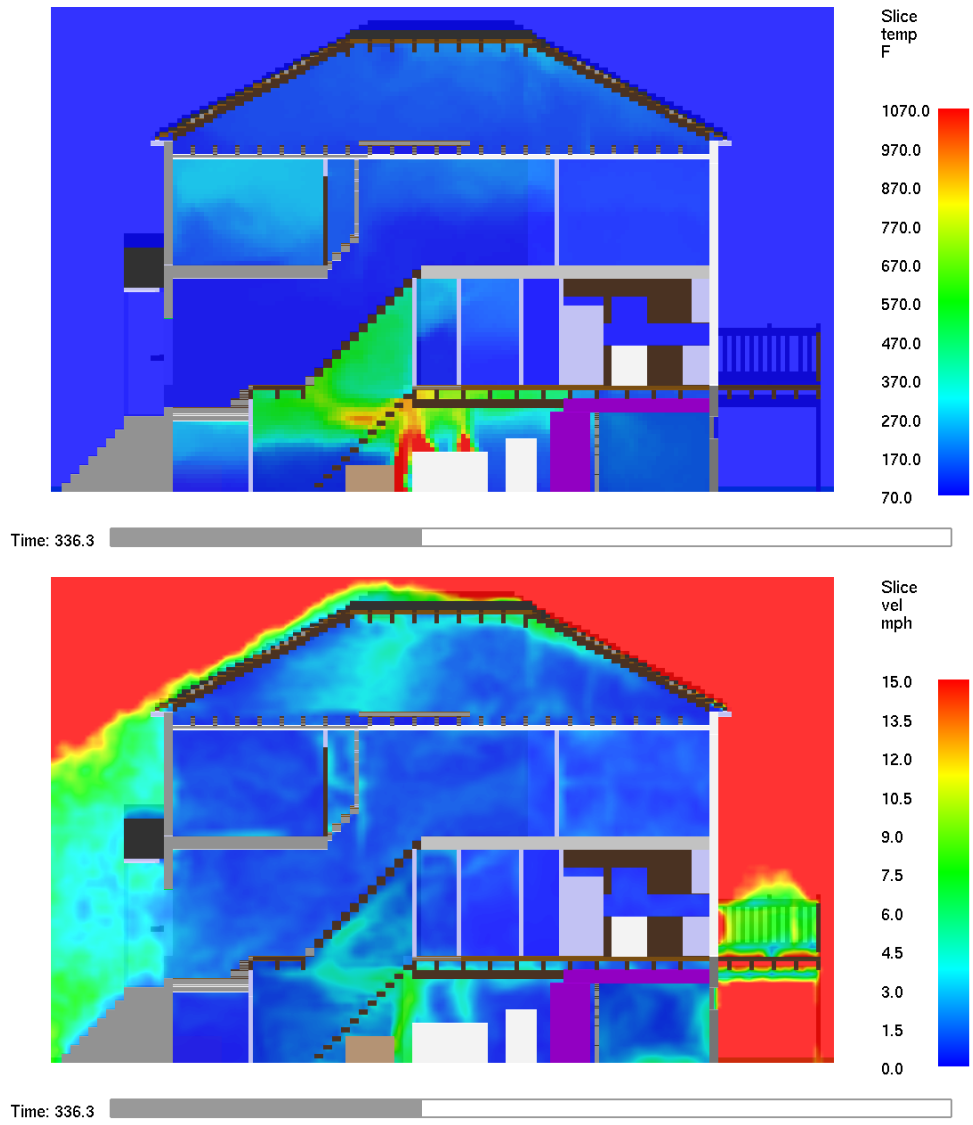
Comparing Figure 41 to Figure 47 and Figure 42 to Figure 48, the flow path control scenario shows that early in the scenario the closed basement slider results in somewhat warmer temperatures in the basement plus a deeper hot layer. The velocity image shows that with the door closed there is little flow from the first floor to the second floor. With only the front door open, in the flow path control scenario, there is a limited ability for air to be pulled through the lower floors of the house into the second floor and out the open front bedroom.

Figure 47: Temperature (top) and velocity (bottom) at the staircase at 14:09:36 (as the dining window is being vented).

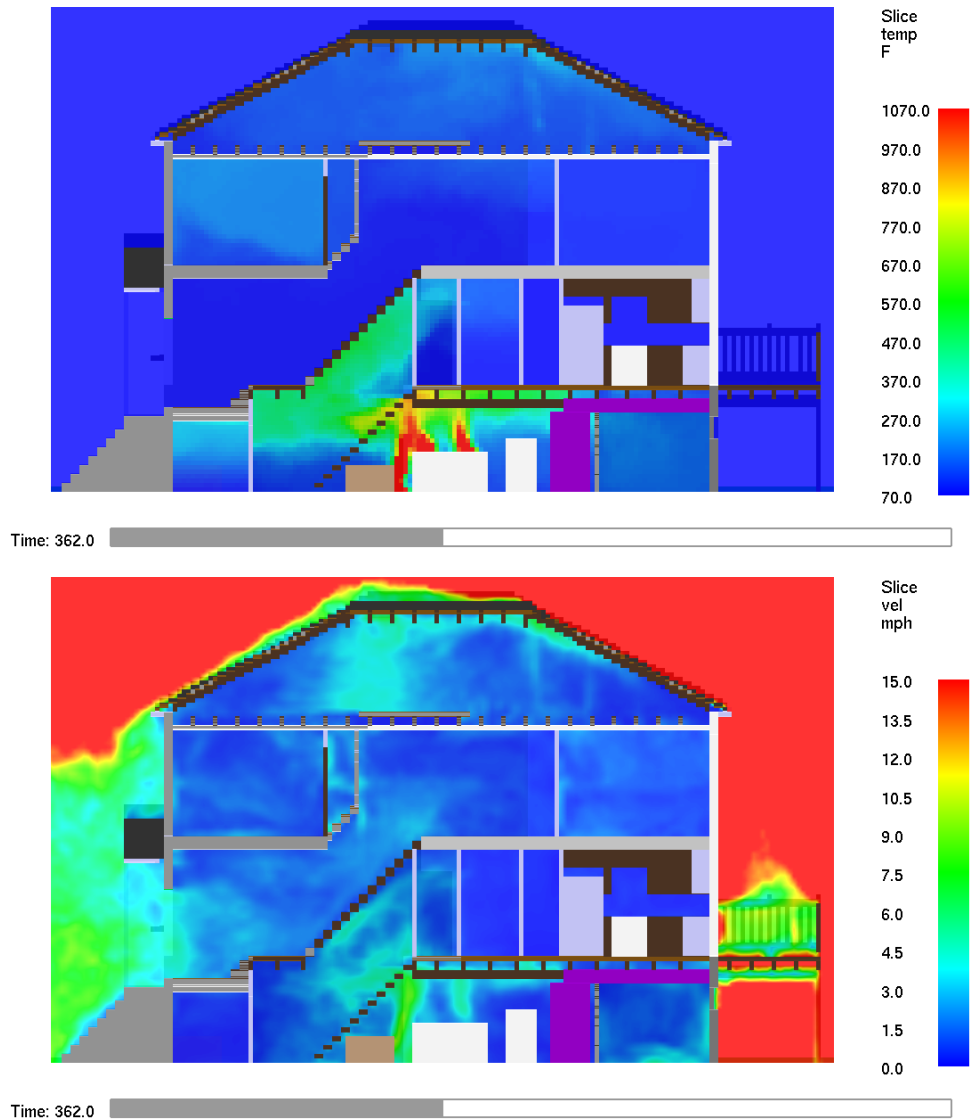
Figure 48: Temperature (top) and velocity (bottom) at the staircase at 14:10:02 (as the basement stair door opens).

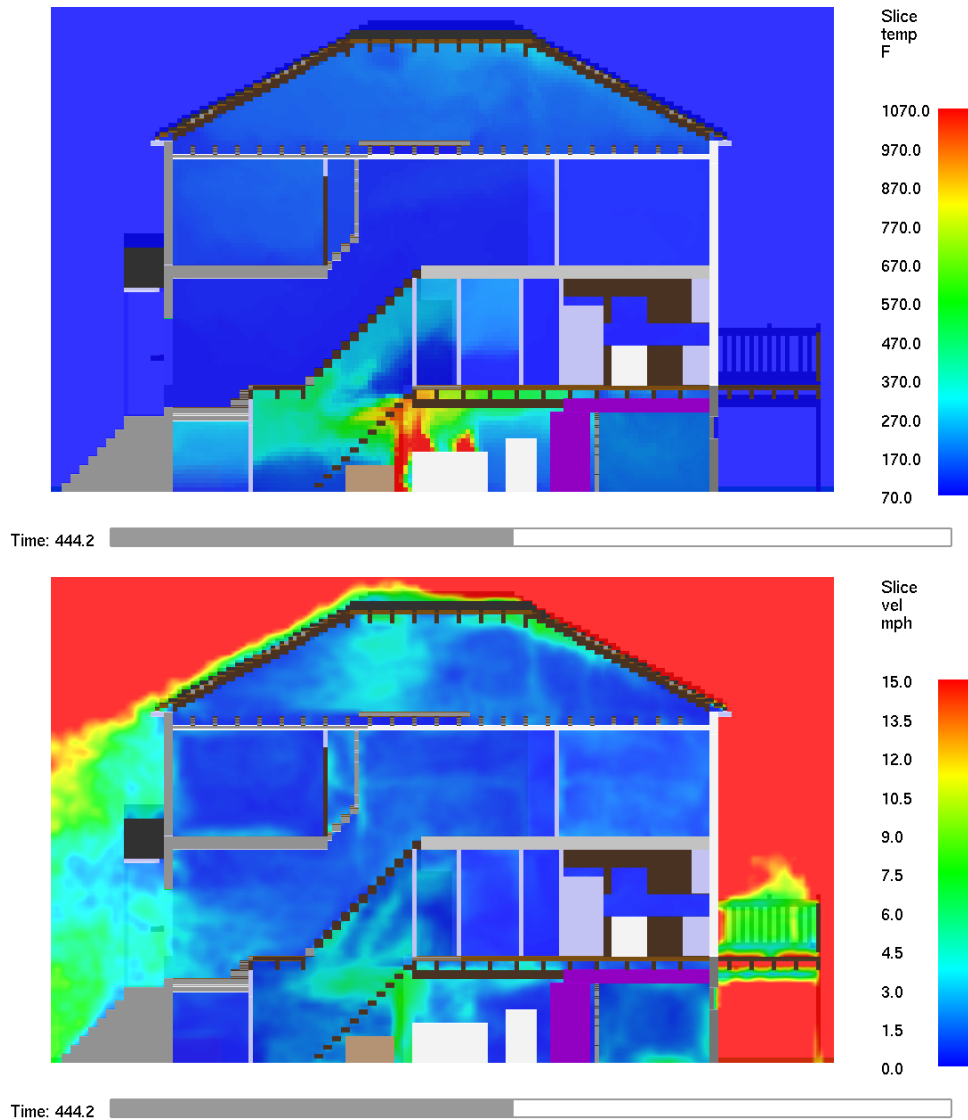
Comparing Figure 43 to Figure 49, the fire in the basement is showing signs of growth in the flow path control scenario that are not observed in the no wind scenario. There is still limited flow up into the second floor when comparing the flow path control scenario with the no wind scenario.

Figure 49: Temperature (top) and velocity (bottom) at 14:10:22 (as fire was seen venting from the dining window).

The conditions seen in Figure 49 persist for another 2.5 minutes. At that time the fire in the basement undergoes a period of rapid growth. Over the next 30 s the fire grows from 250 kW to 4 MW peak that is sustained for 20 s before dropping to a 2 MW plateau that lasts for 60 s before decaying down to 500 kW. This growth was not observed in the no wind scenario. At the peak of the fire, substantial flows are seen in the staircase to the second floor and flame temperatures are seen at the first floor landing of the basement stairs. Very high temperatures, however, are not seen at the second floor landing. Temperatures have increased to 300 °F to 400 °F; however, those temperatures do not persist as the fire decays in the basement.

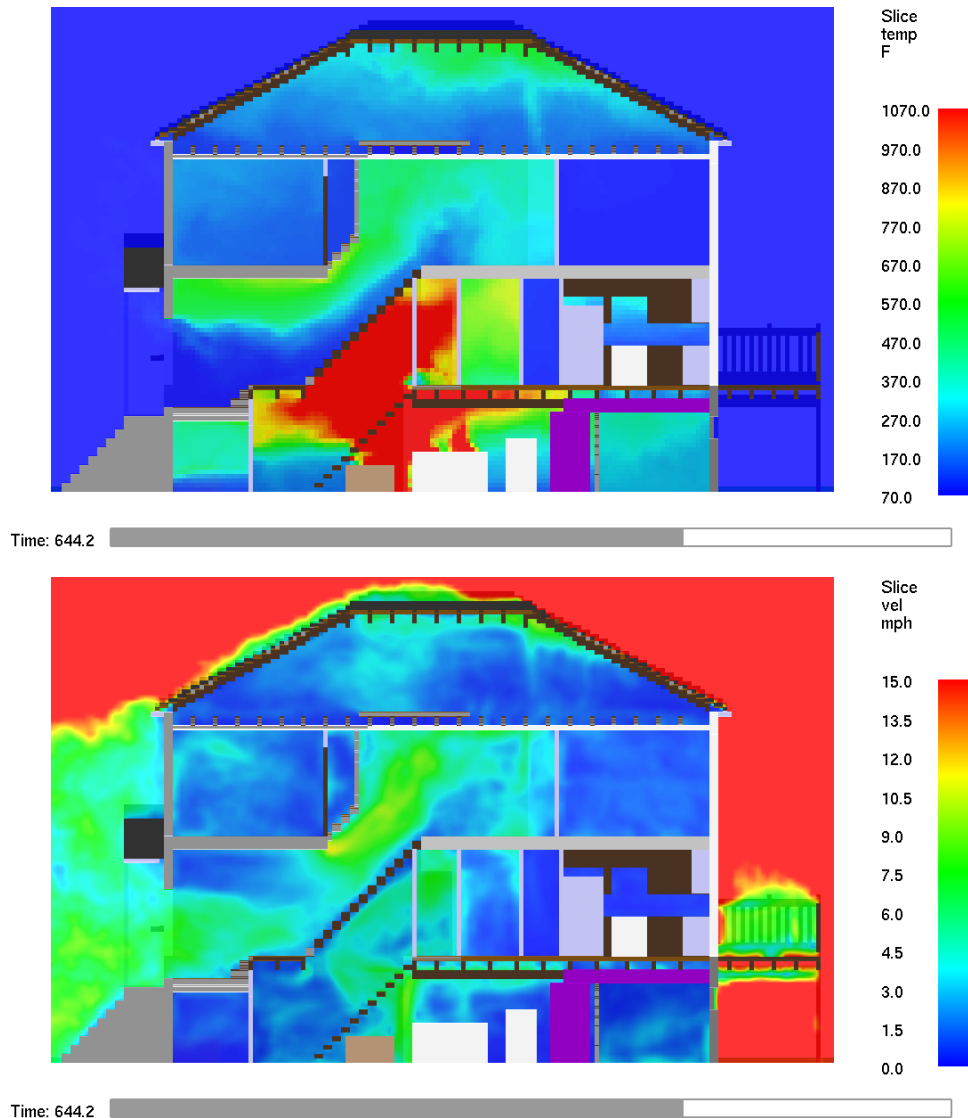
Figure 50: Temperature (top) and velocity (bottom) at the peak of the fire (~14:15).

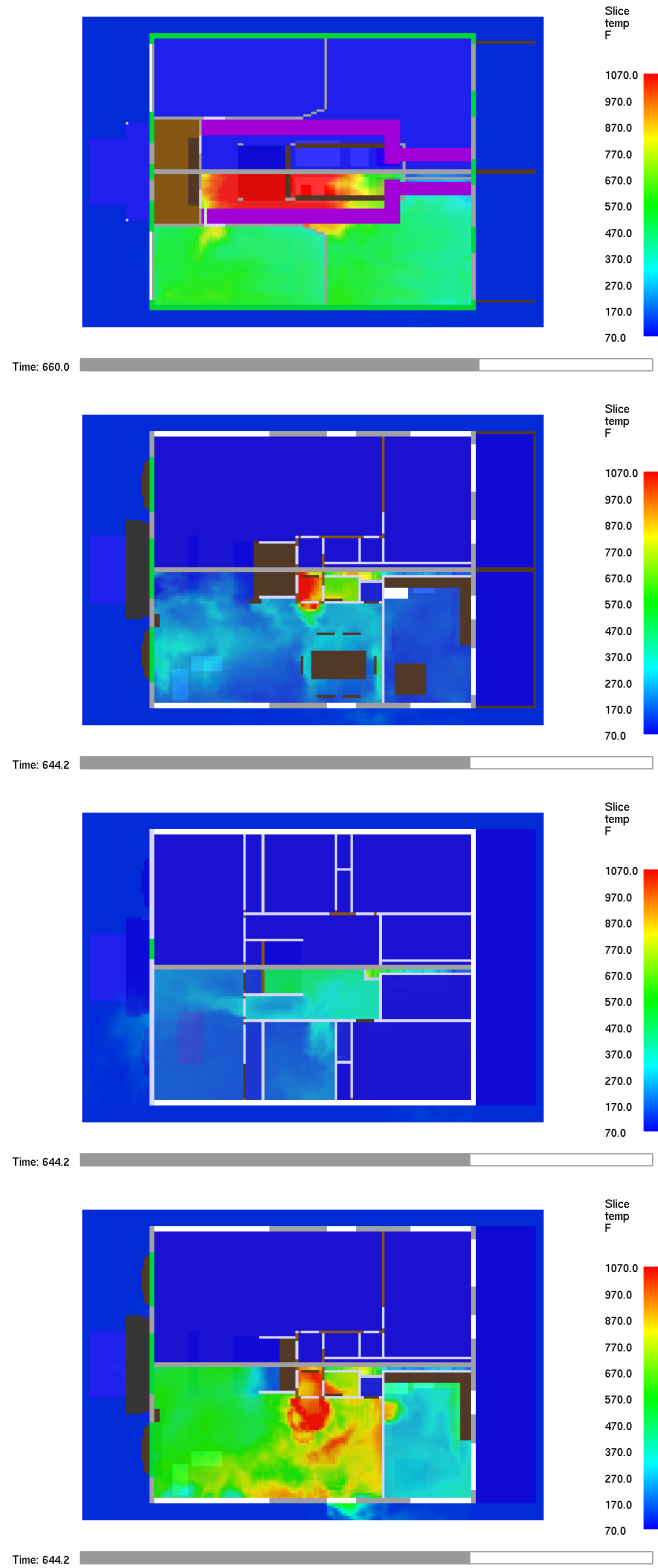
Figure 51 shows temperatures on each floor of the house at the peak of the fire. Temperatures in the garage and rear room of the basement are hot enough to support pyrolysis of cellulosic materials (500 °F). The peak of the basement fire, however, is not sustained long enough for those temperatures to overcome the thermal inertia of materials in those locations. Ignition in these locations did not occur but could have if temperatures were sustained for longer. At 6 ft above the first floor, flame temperatures are observed extending part way into the dining area and through the archway into the kitchen. As in the basement, these temperatures do not persist for sustained ignition to occur in the model. At 3 ft above the first floor, except for the basement stair landing, temperatures remain low (under 300 °F). Firefighters would be able to get below the hot layer. On the second floor, temperatures at 6 ft peak near 350 °F. While not shown in an image, at 3 ft

temperatures peak near 300 °F at the stair landing and near 250 °F in the hallway towards the front bedroom.

Figure 51: Temperature at the peak of the fire (~14:15).. Top – 6 ft above the basement floor. Top/Middle – 3 ft above the first floor. Bottom/Middle 6 ft above the second floor. Bottom – 6 ft above the first floor.
